Canadian Natural

**PRIMROSE FLOW TO SURFACE
CAUSATION REPORT**

**ALBERTA ENERGY REGULATOR AND ALBERTA ENVIRONMENT AND SUSTAINABLE RESOURCE
DEVELOPMENT**

June 27, 2014
Calgary, Alberta

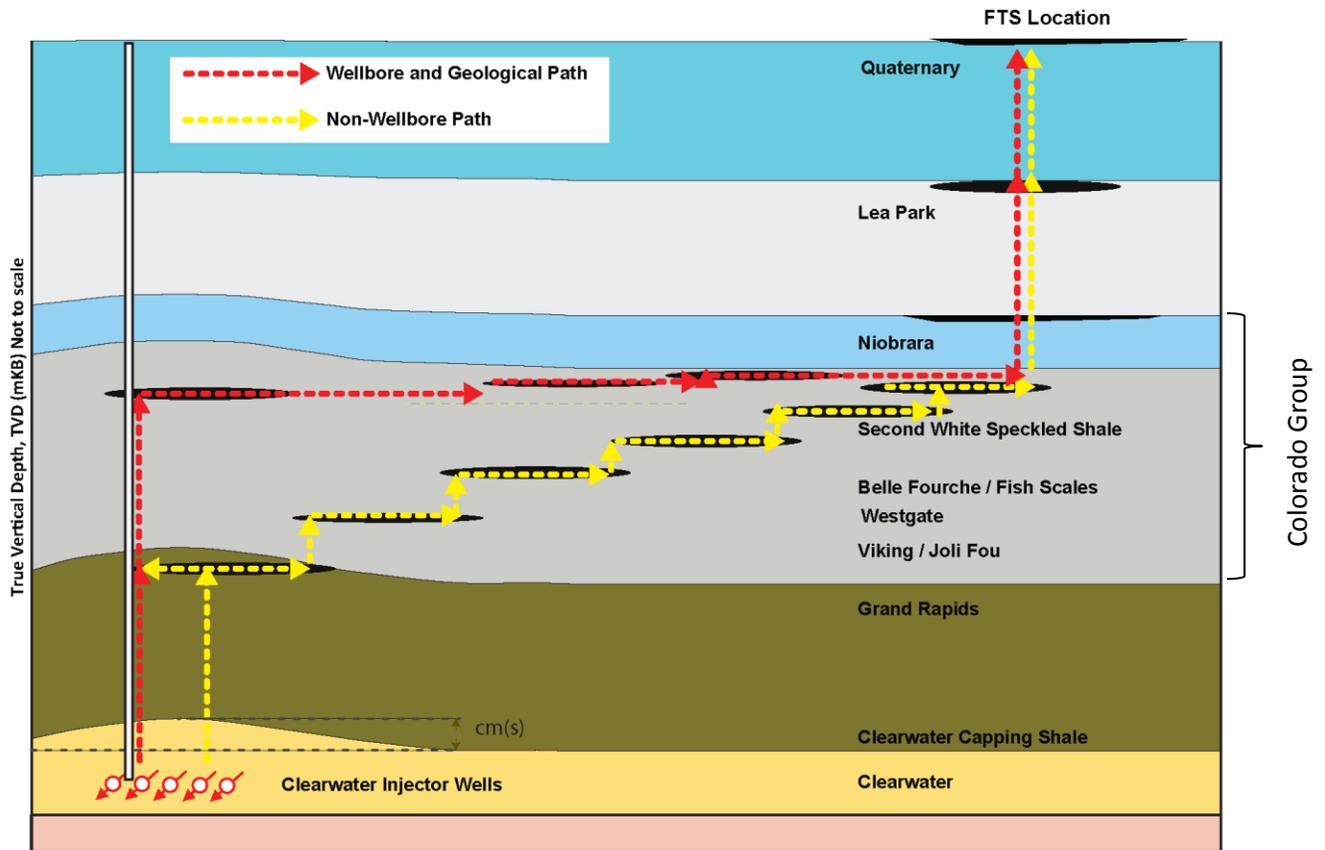
Figure 1-1 Conceptual Schematic of Possible Flow Paths

In summary, the cause of the Primrose FTS events indicates that four enabling conditions have been observed at each FTS location. To ensure a future FTS event cannot occur again, all four conditions must be addressed.

Although not within the scope of this report, the identified causes indicate that changes to steaming strategies and enhanced monitoring, as well as remediation of defective wellbores can prevent the conditions for FTS events.

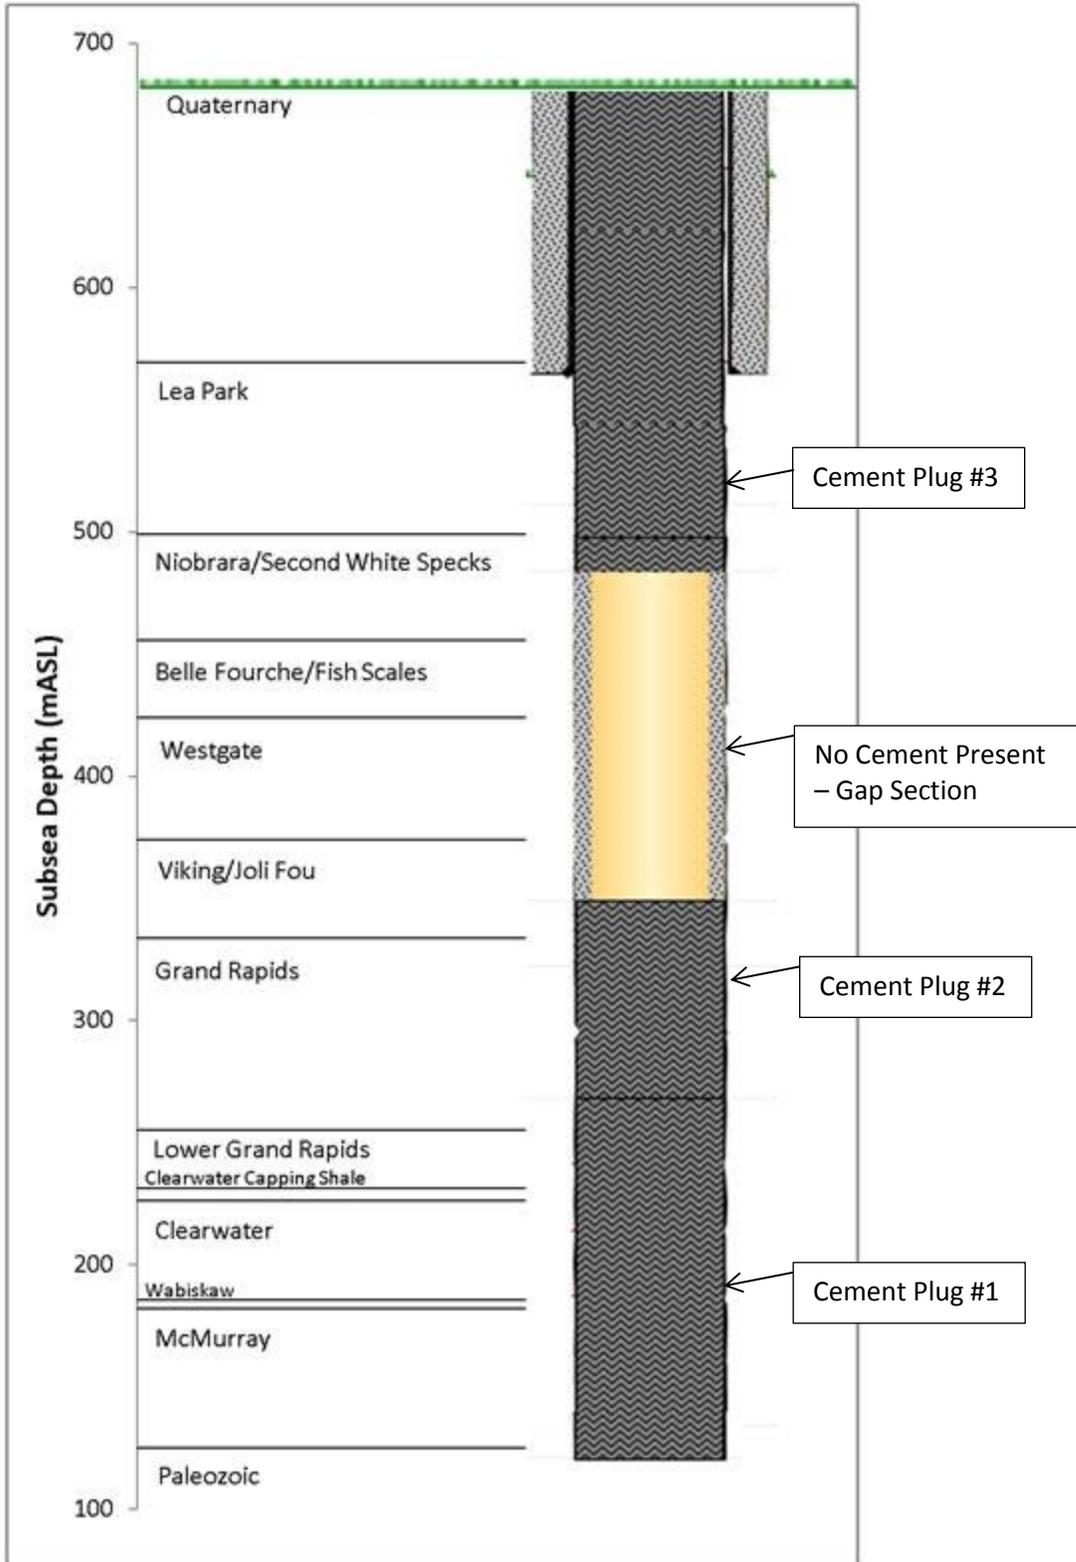
Figure 7-1 Conceptual diagram of the theoretical cement placement for DOME AEC 100/07-22-067-03W4

Review of the DOME AEC 100/7-22-67-3W4 wellbore (drilled in 1984) at the 2-22 FTS location revealed a certain vintage of OSE wells which do not have cement over much of the Colorado Group interval (Figure 7-1). The DOME AEC 100/7-22-67-3W4 wellbore has been shown to be an integral part of the FTS events at the 2-22 location. A review of the region identified a number of other wells with a similar abandonment technique. In addition to the DOME AEC 100/7-22-67-3W4 the re-abandonment of the DOME AEC 100/7-22-67-4W4 well has shown that cement plug #2 was not present. Due to the deficiencies found at the DOME AEC 100/7-22-67-3W4 and DOME AEC 100/7-22-67-4W4 wellbores and the known gap over much of the Colorado Group interval, Canadian Natural has chosen to re-abandon this vintage of wells such that the entire wellbore is abandoned with pipe to ensure the quality of the cement job and allow for future re-entry if necessary. As part of the FTS study, OSE wells that have questionable abandonment practices have been evaluated using plug tracking technology. The only known wellbore abandoned with this practice and involved with FTS events is the DOME AEC 100/7-22-67-3W4.

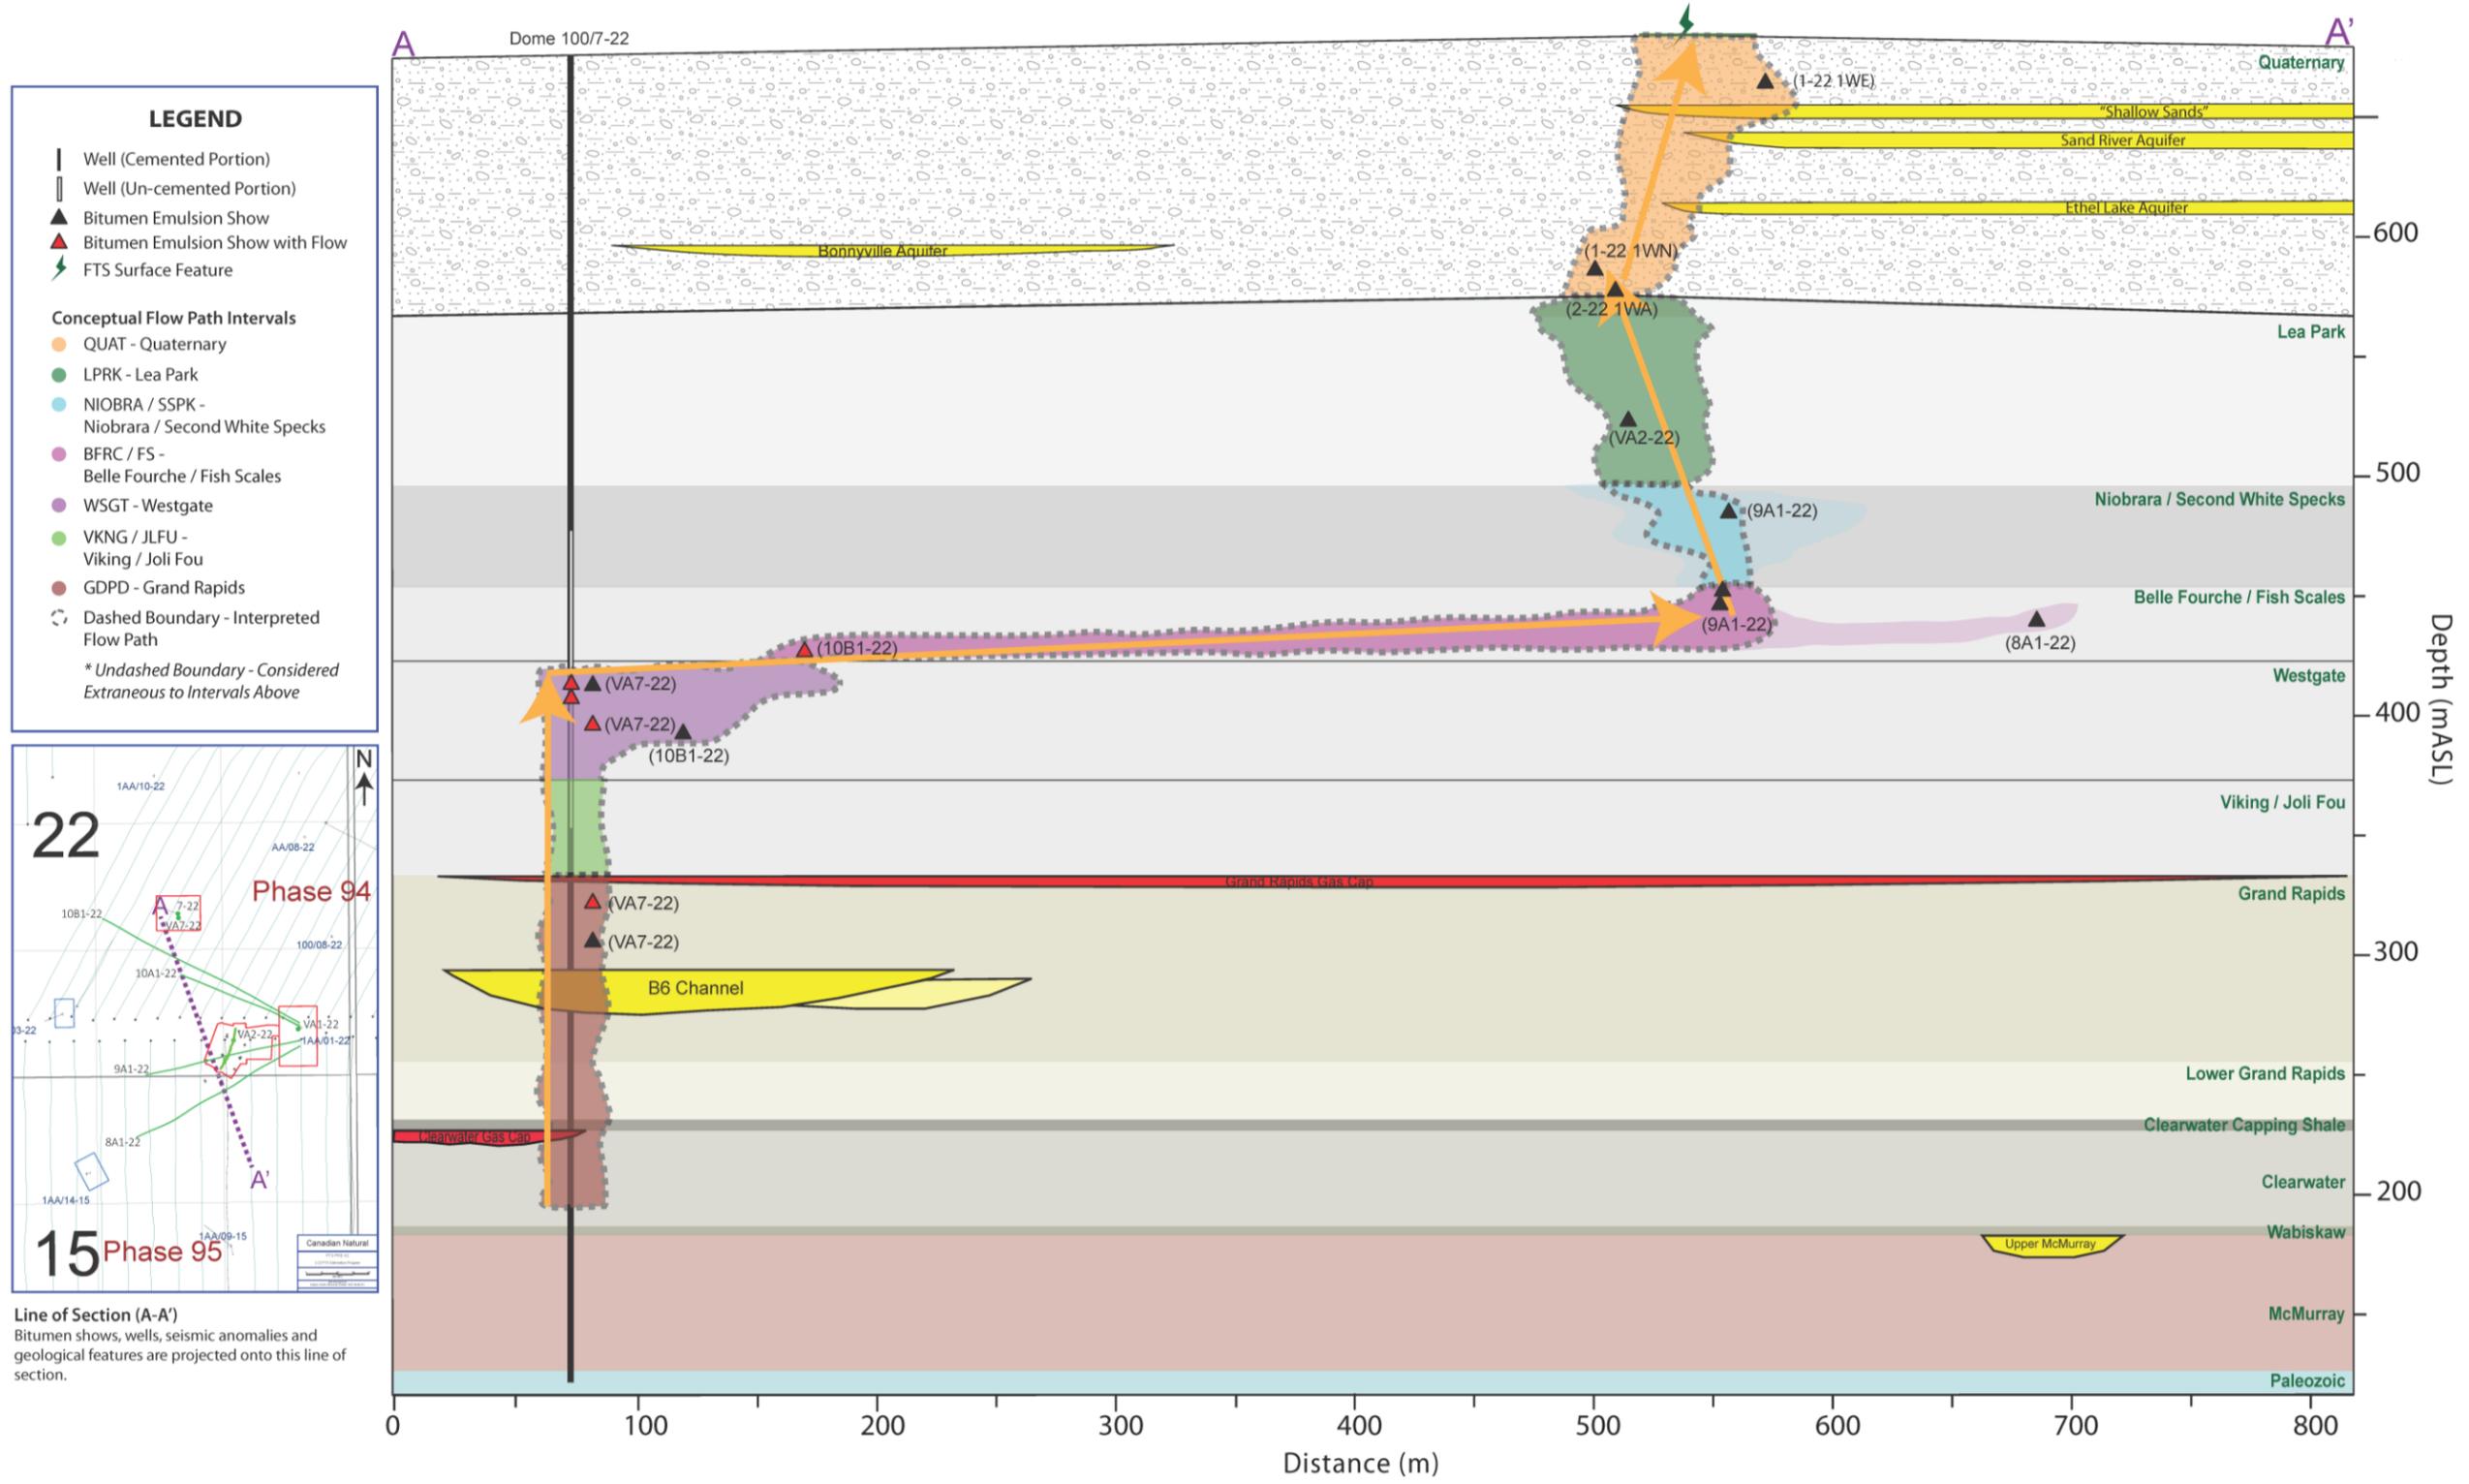
Figure 10-1 2-22 FTS – Features, Data and Conceptual Flow Path Projected on N-S Plane

The failed DOME AEC 100/7-22-67-3W4 OSE wellbore acted as a flow path for fluid migration from the Clearwater reservoir to the top of the Westgate Formation. The mechanism for fluid flow through the remainder of the Colorado Group to surface has been determined using drilling, geological, geomechanical, and geochemical data collected throughout the study of FTS events.

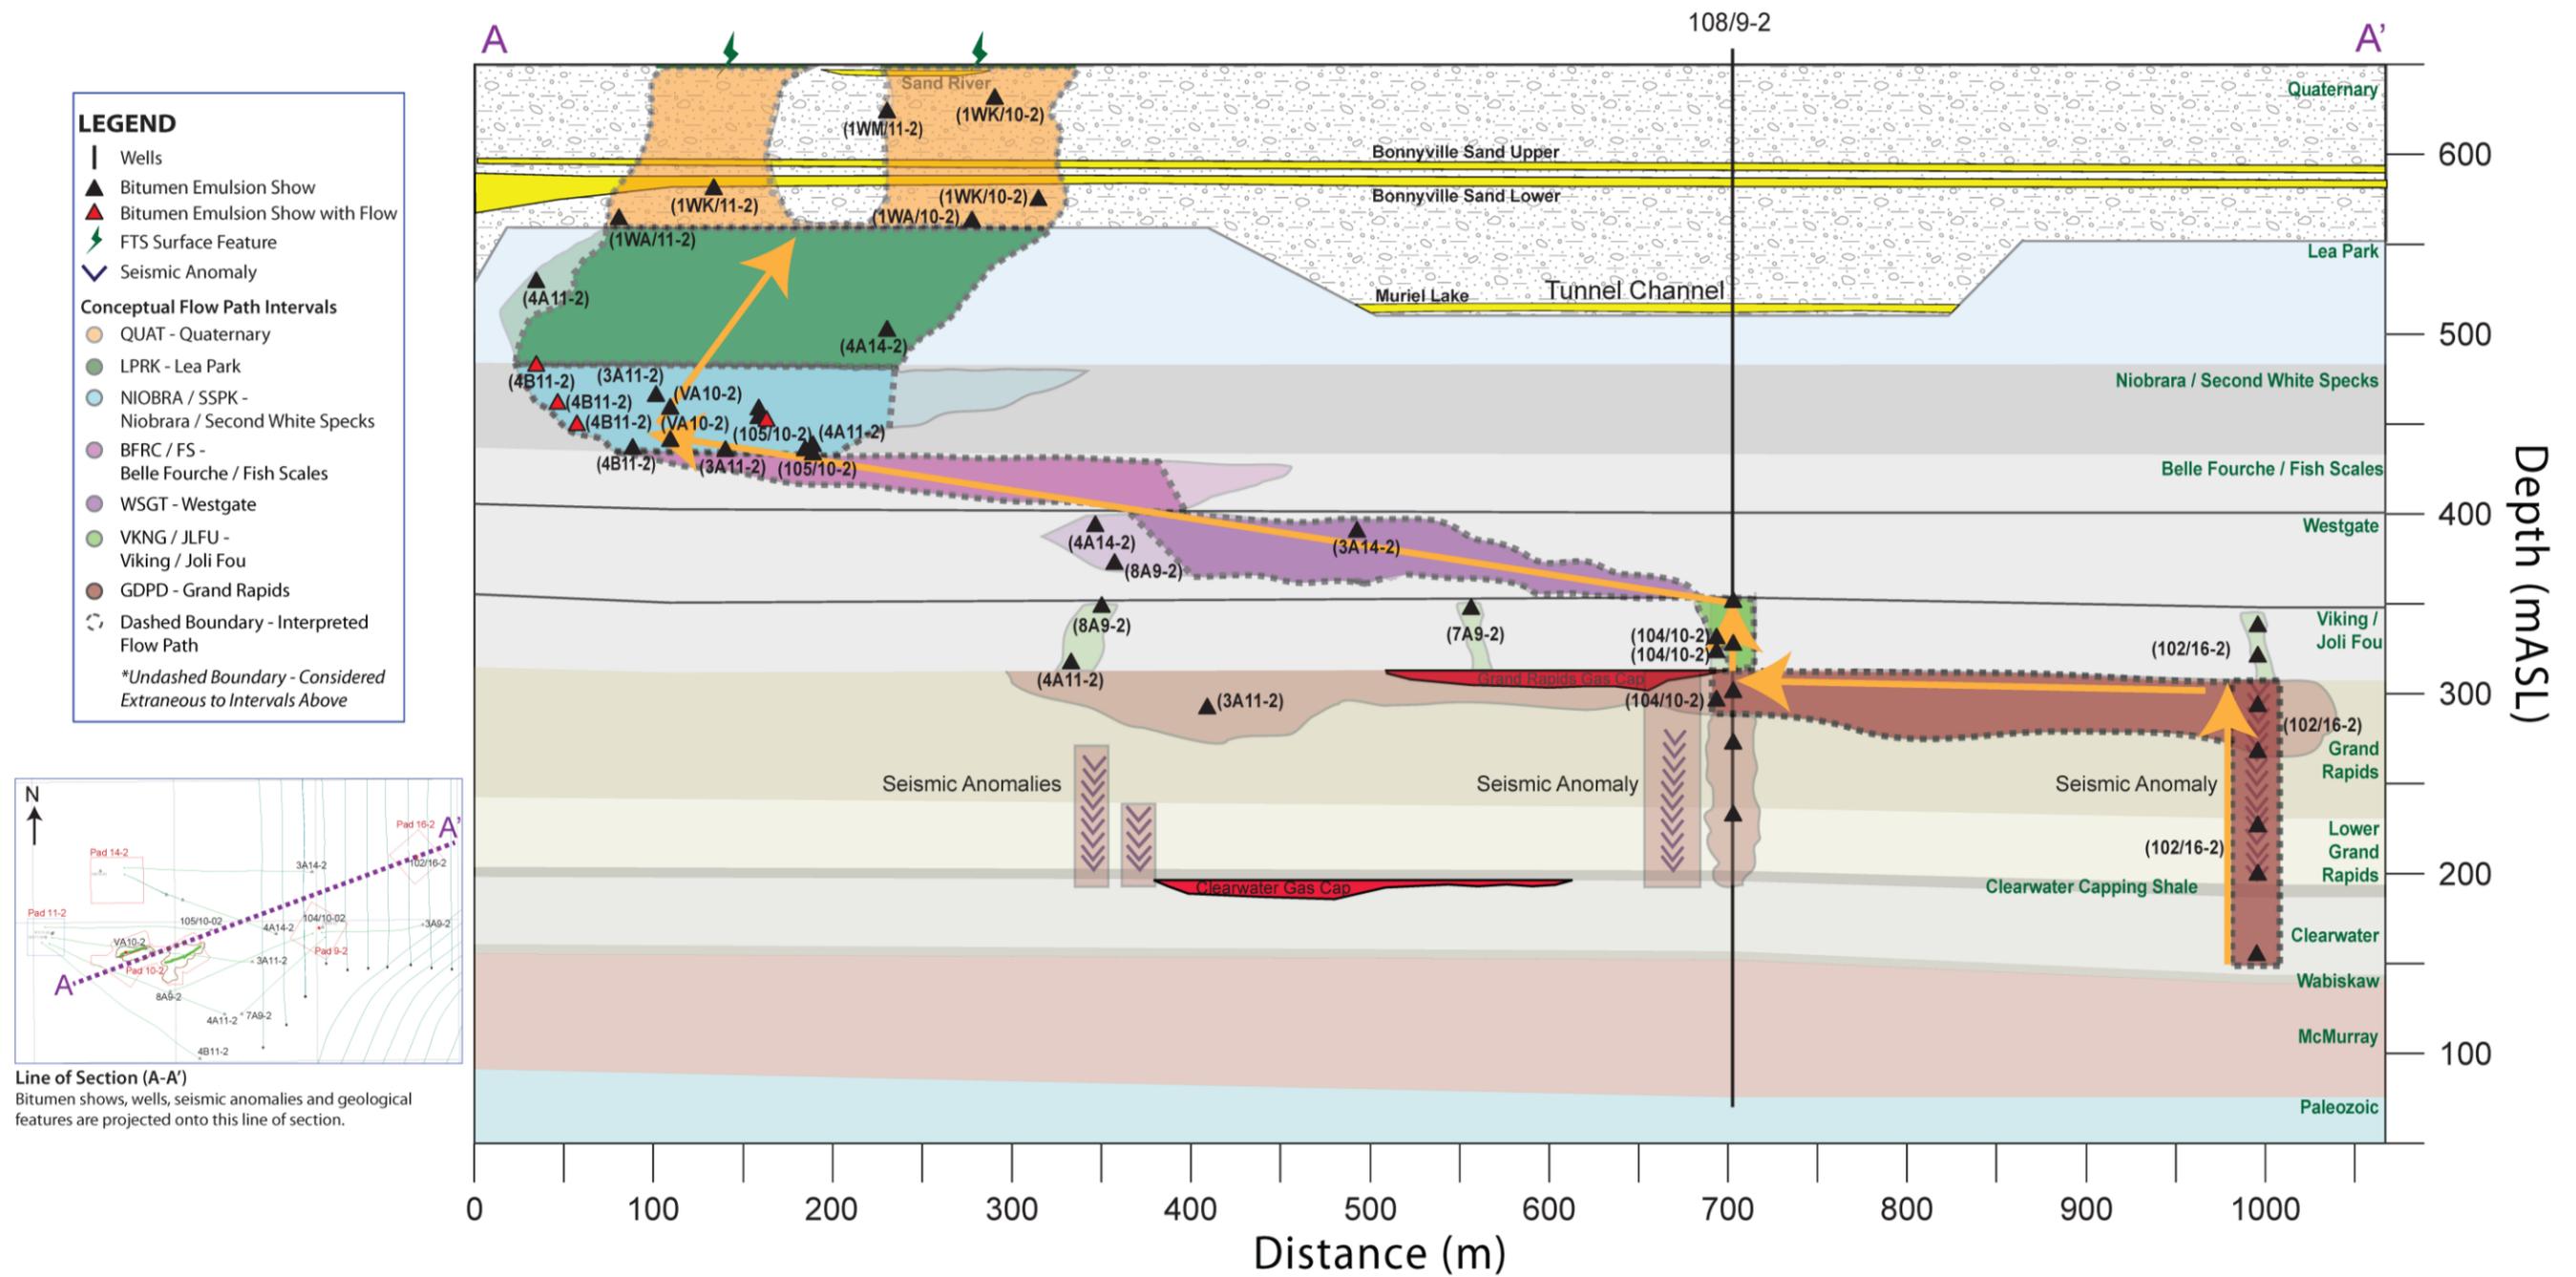
Figure 10-3 10-2 FTS – Features, Data and Conceptual Flow Path Projected on SW-NE Plane

The poor cement bond quality in the 108/9-2-67-3W4 OSE wellbore facilitated fluid migration from the Grand Rapids Formation to the Viking Formation. The mechanism for fluid flow through the remainder of the Colorado Group to surface has been determined using drilling, geological, geomechanical, and geochemical data collected throughout the study of FTS events.

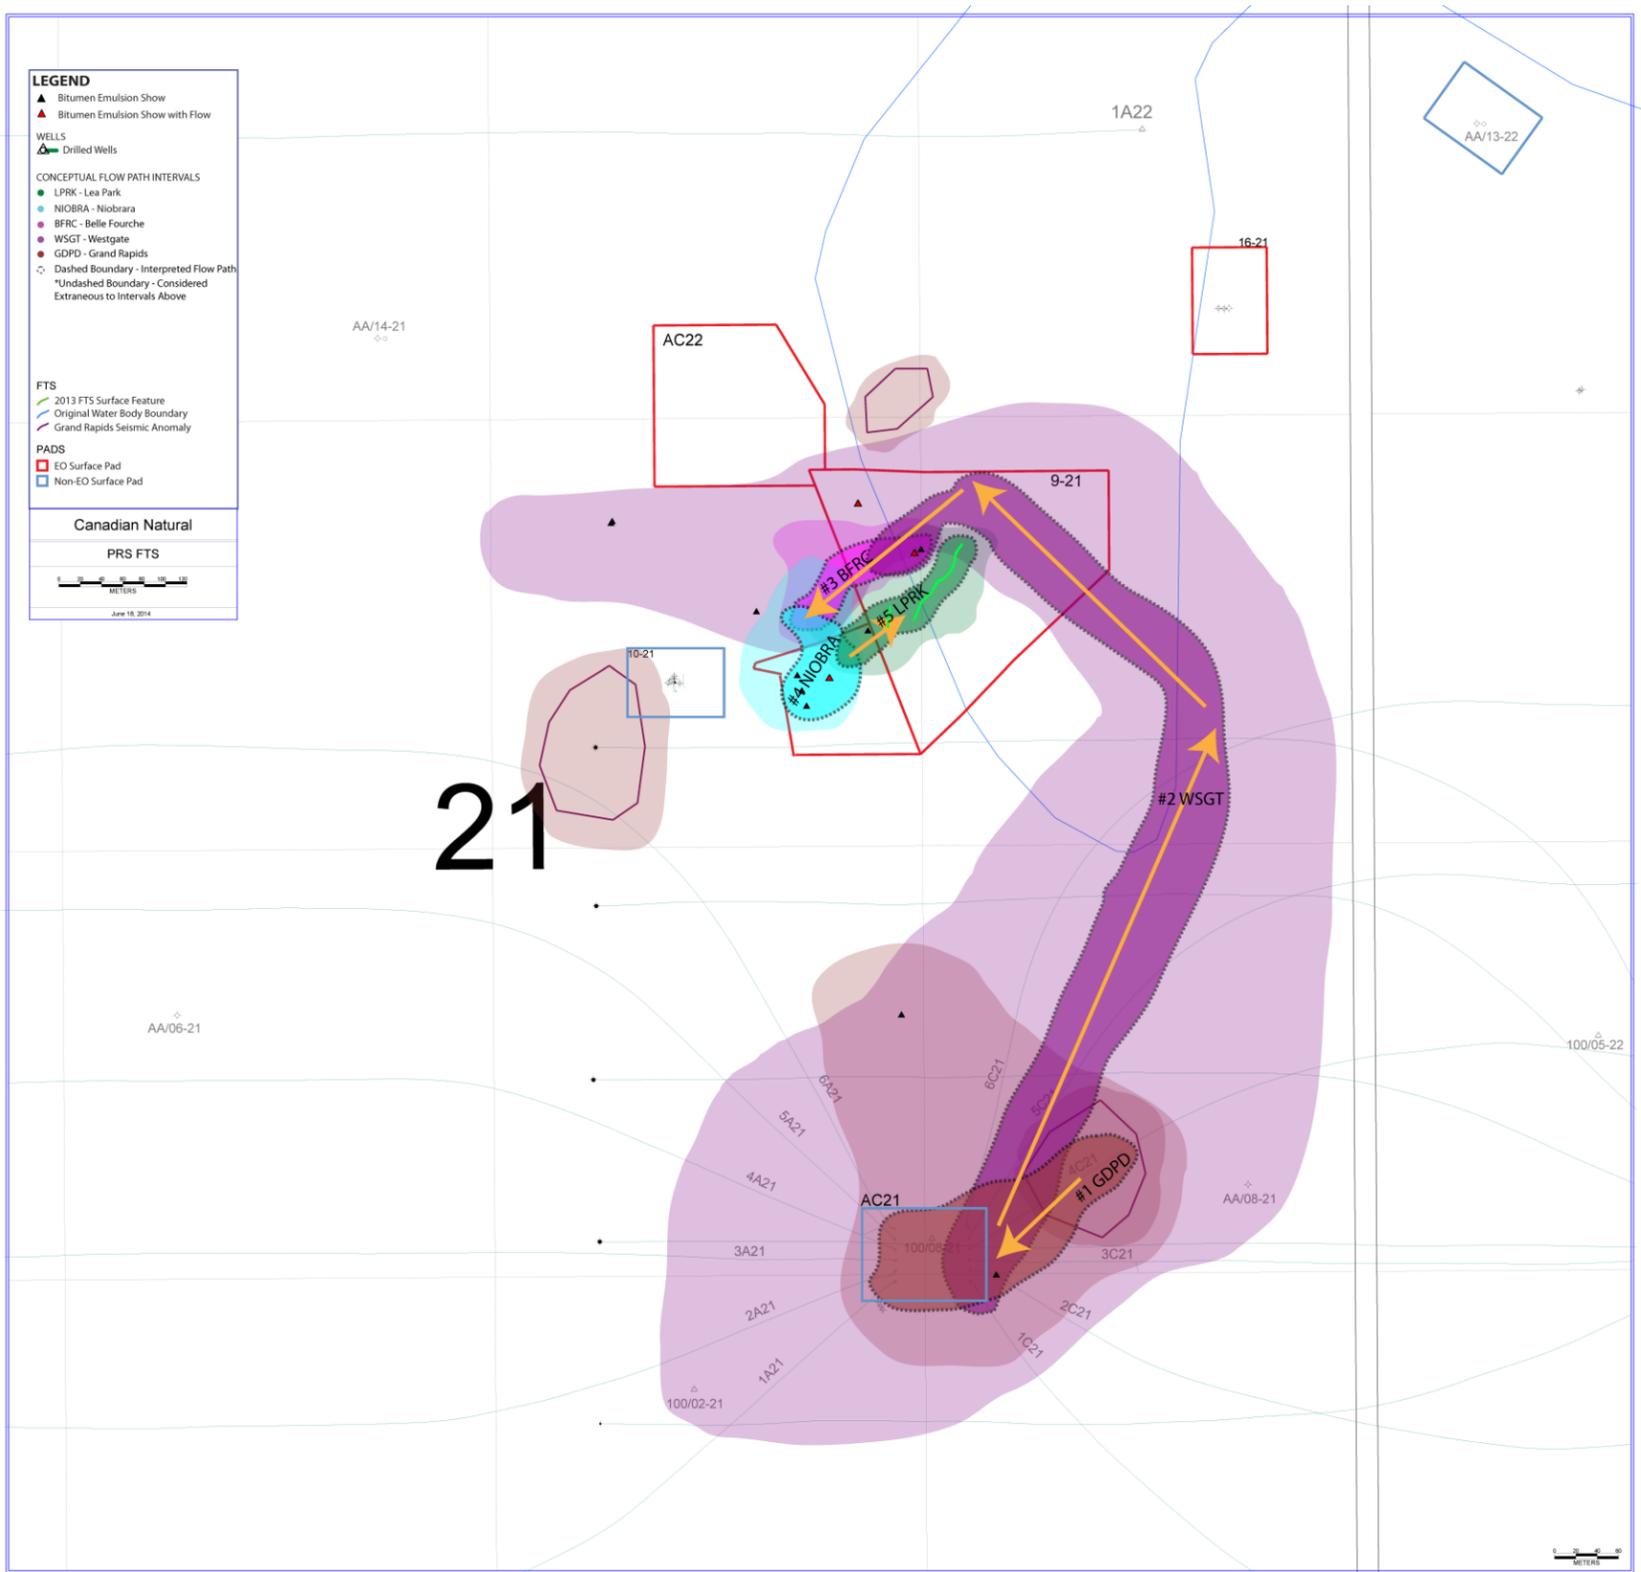
Figure 10-6 9-21 FTS – Conceptual Plan View of Bitumen Emulsion Shows

It is suspected that inadequate placement of primary cement of a well within the vicinity of Pad AC21 facilitated fluid migration from the Clearwater reservoir to the Westgate Formation several years ago. Steam injection and operation of Pad 22 during the most recent cycle in 2013 imposed uplift induced stresses on the Colorado Group and facilitated further fluid migration from the Westgate Formation. The mechanism for fluid flow through the remainder of the Colorado Group to surface has been determined using drilling, geological, geomechanical, and geochemical data collected throughout the study of FTS events.

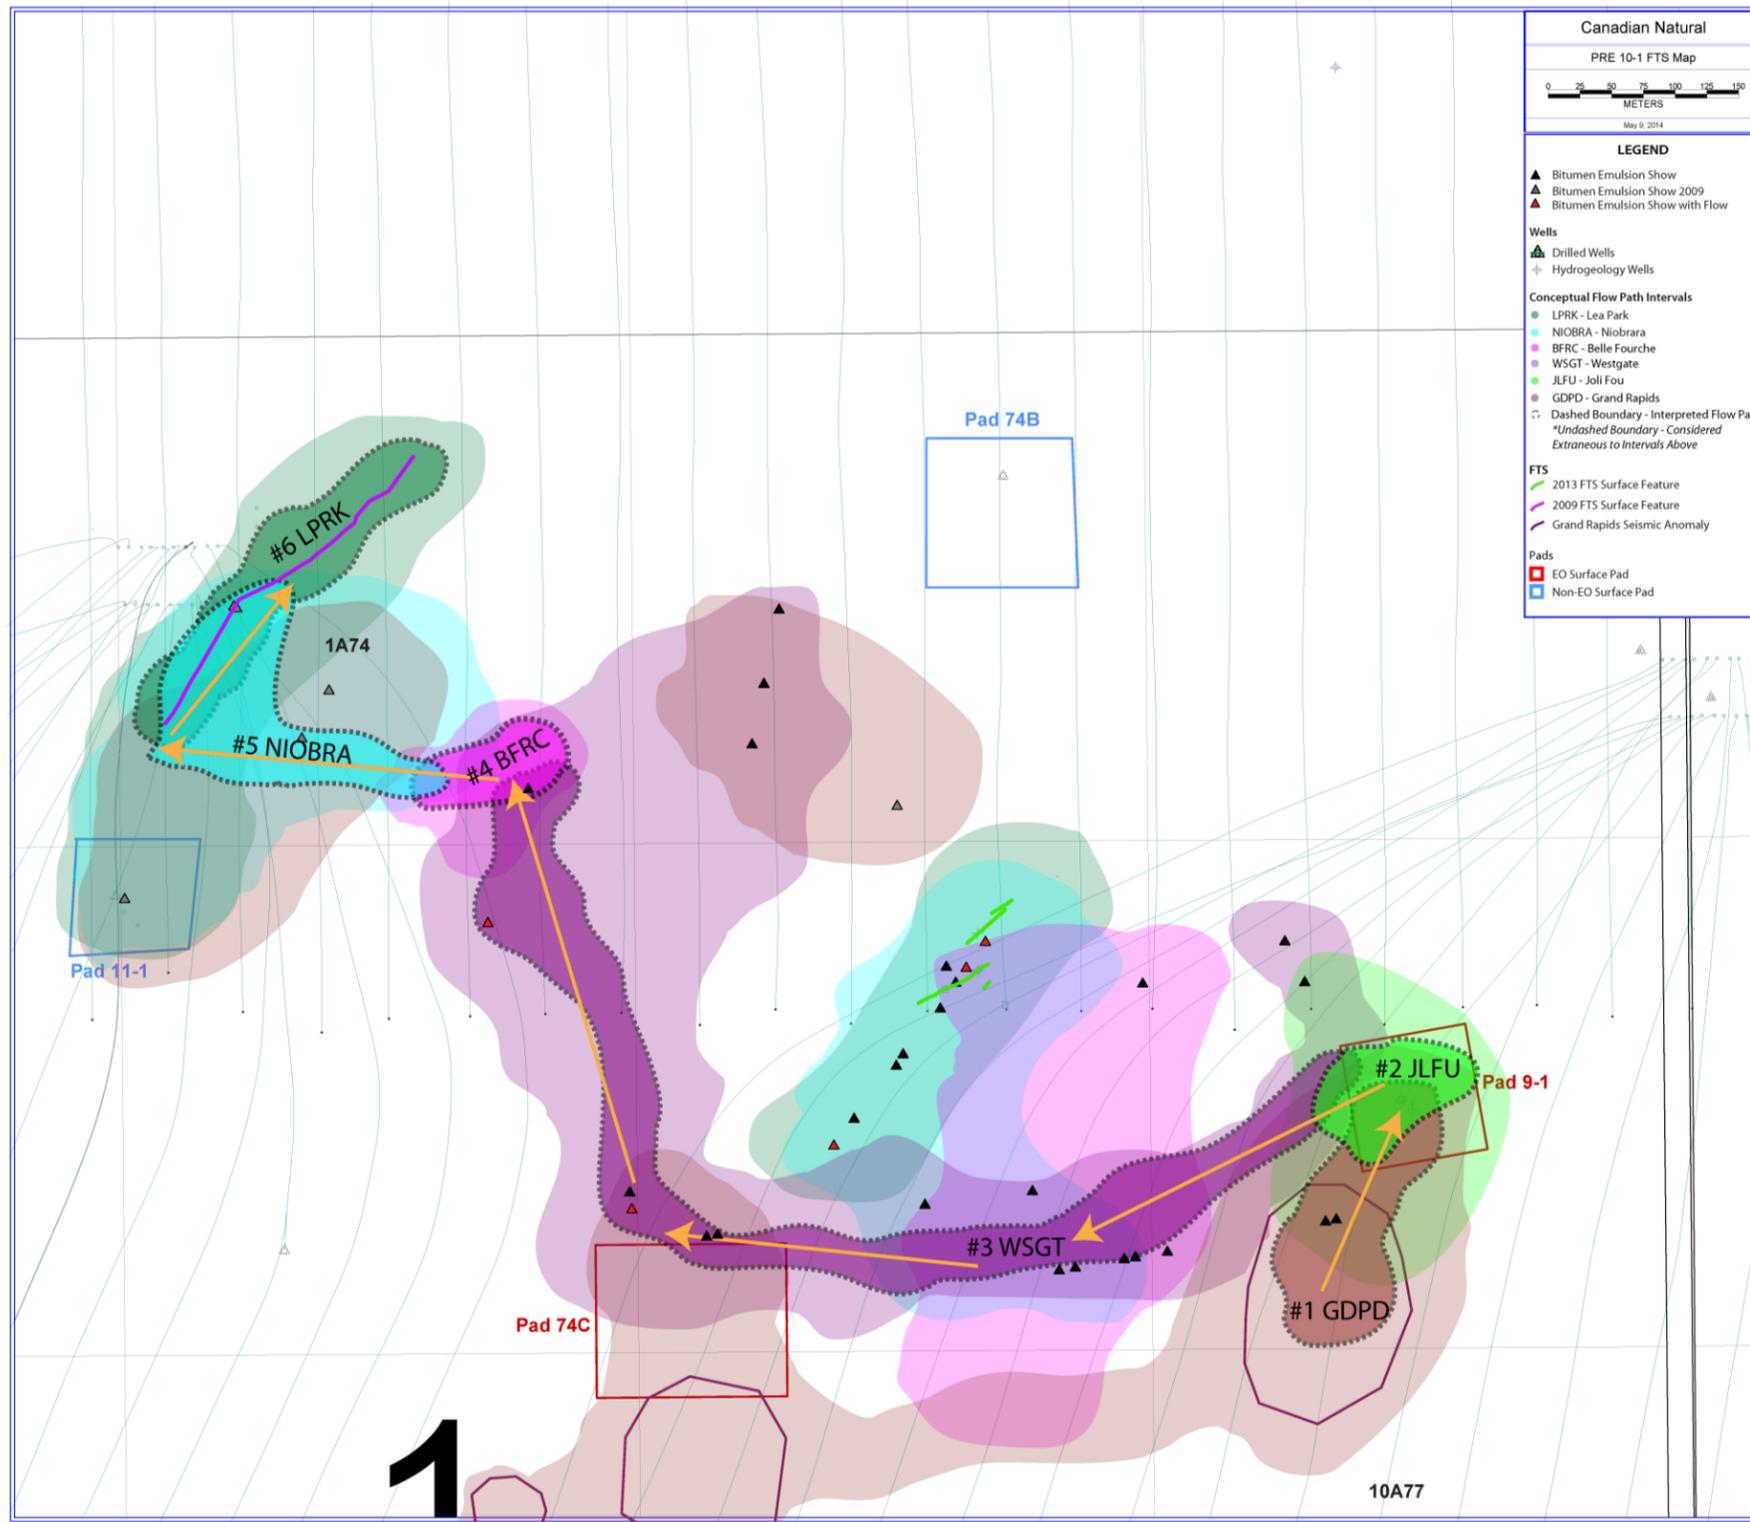
Figure 10-8 Pad 74 FTS – Conceptual Plan View of Bitumen Emulsion Shows

The 1AA/09-01-067-03W4 OSE wellbore most likely acted as a pathway for fluid migration to the top of the Joli Fou Formation. The mechanism for fluid flow through the remainder of the Colorado Group to surface has been determined using drilling, geological, geomechanical, and geochemical data collected throughout the study of FTS events.

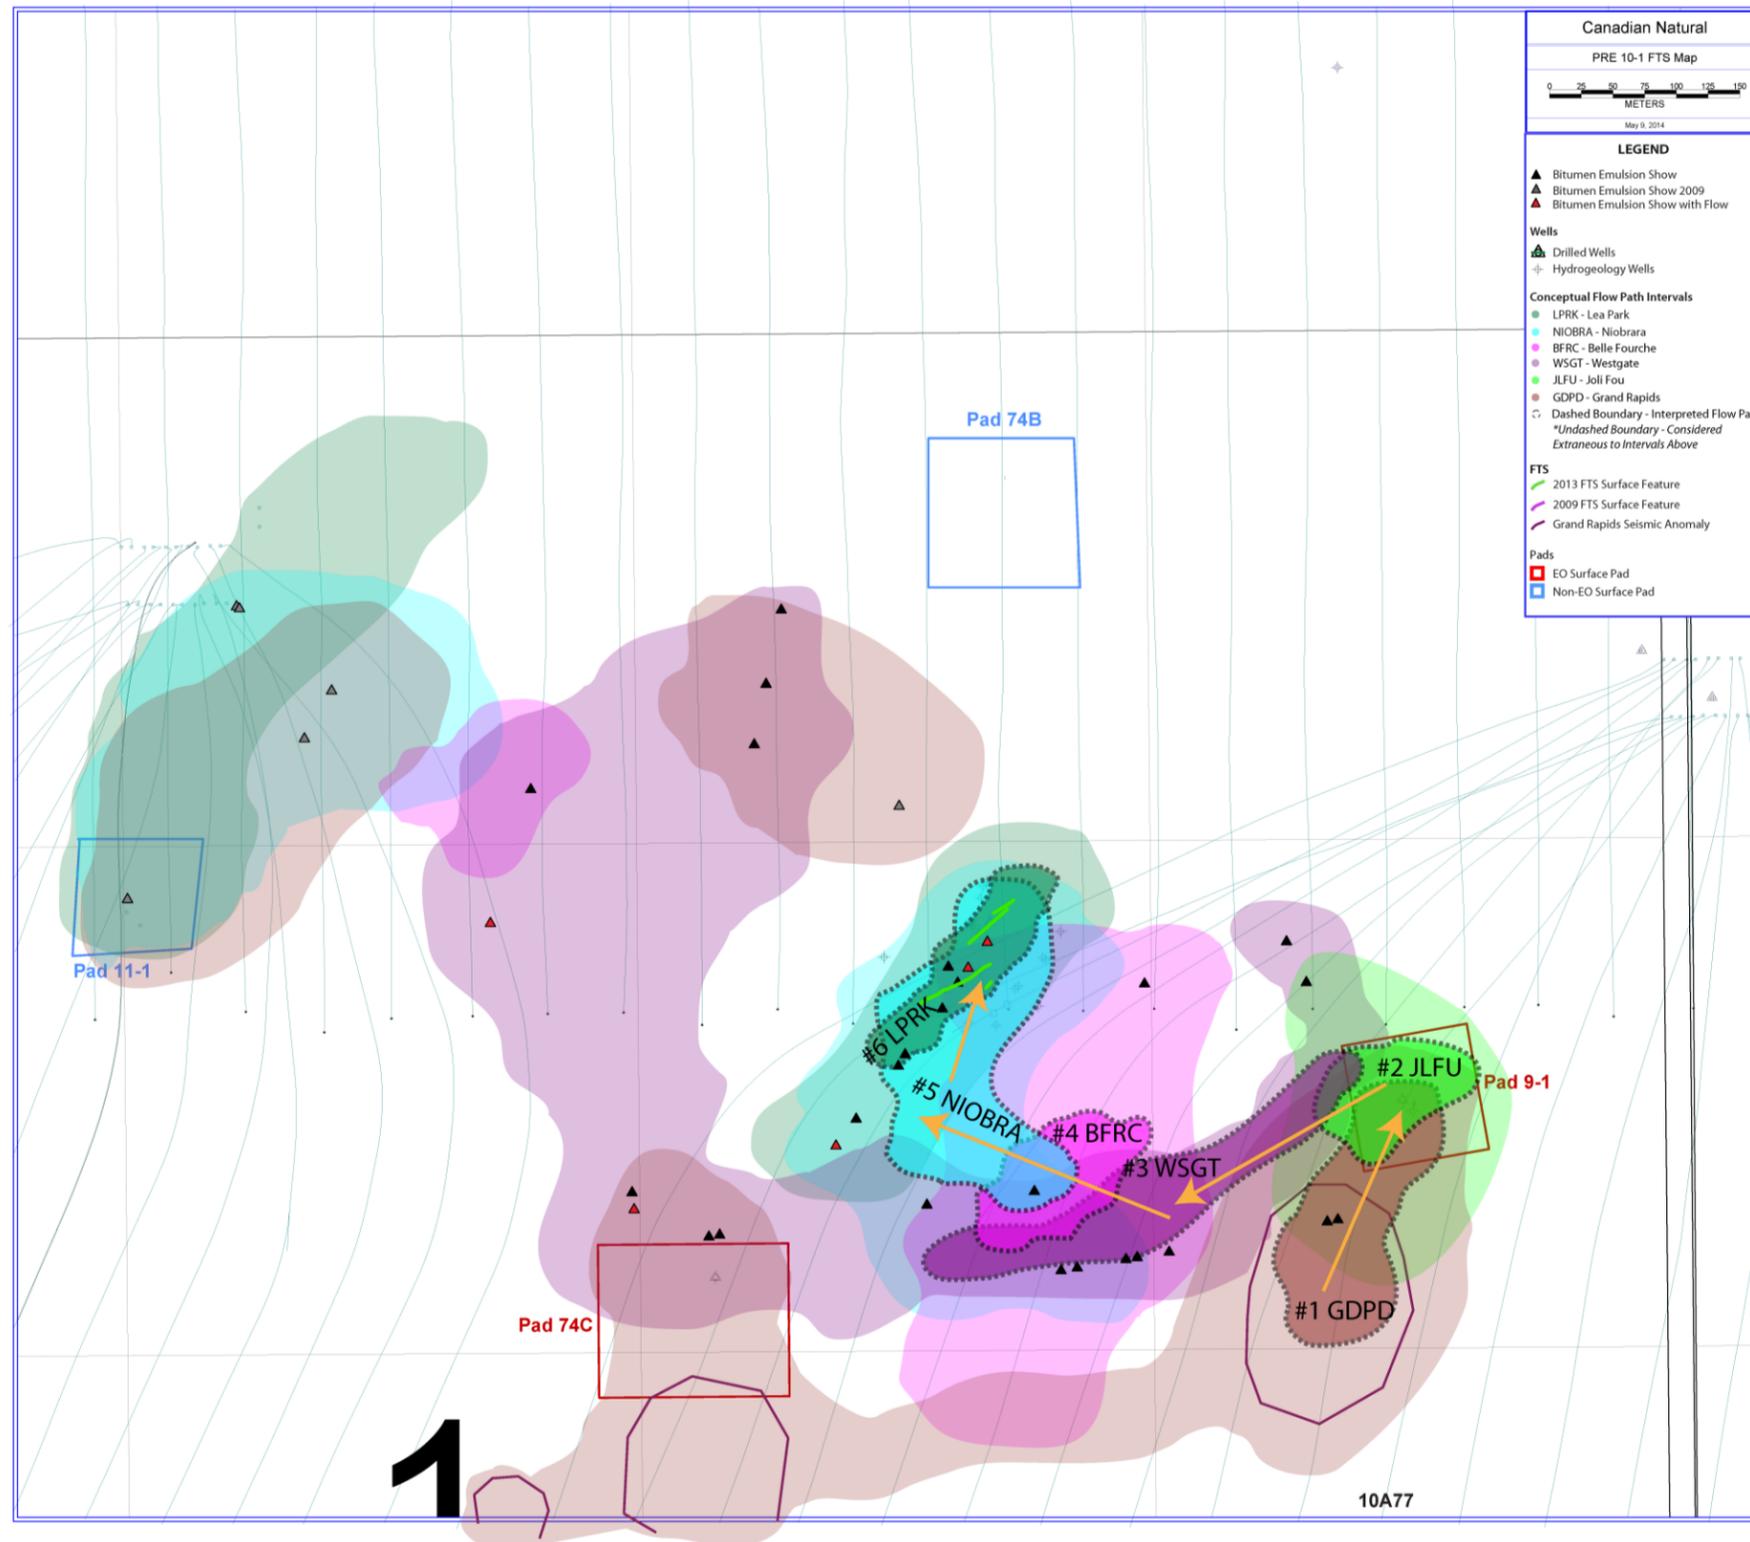
Figure 10-10 10-1 FTS – Conceptual Plan View of Bitumen Emulsion Shows

The 1AA/09-01-067-03W4 OSE wellbore most likely acted as a pathway for fluid migration to the top of the Joli Fou Formation. The mechanism for fluid flow through the remainder of the Colorado Group to surface has been determined using drilling, geological, geomechanical, and geochemical data collected throughout the study of FTS events.
