Swan Hills Synfuels Ltd Well Blowout October 10, 2011

AER Investigation Report

February 25, 2014

Alberta Energy Regulator

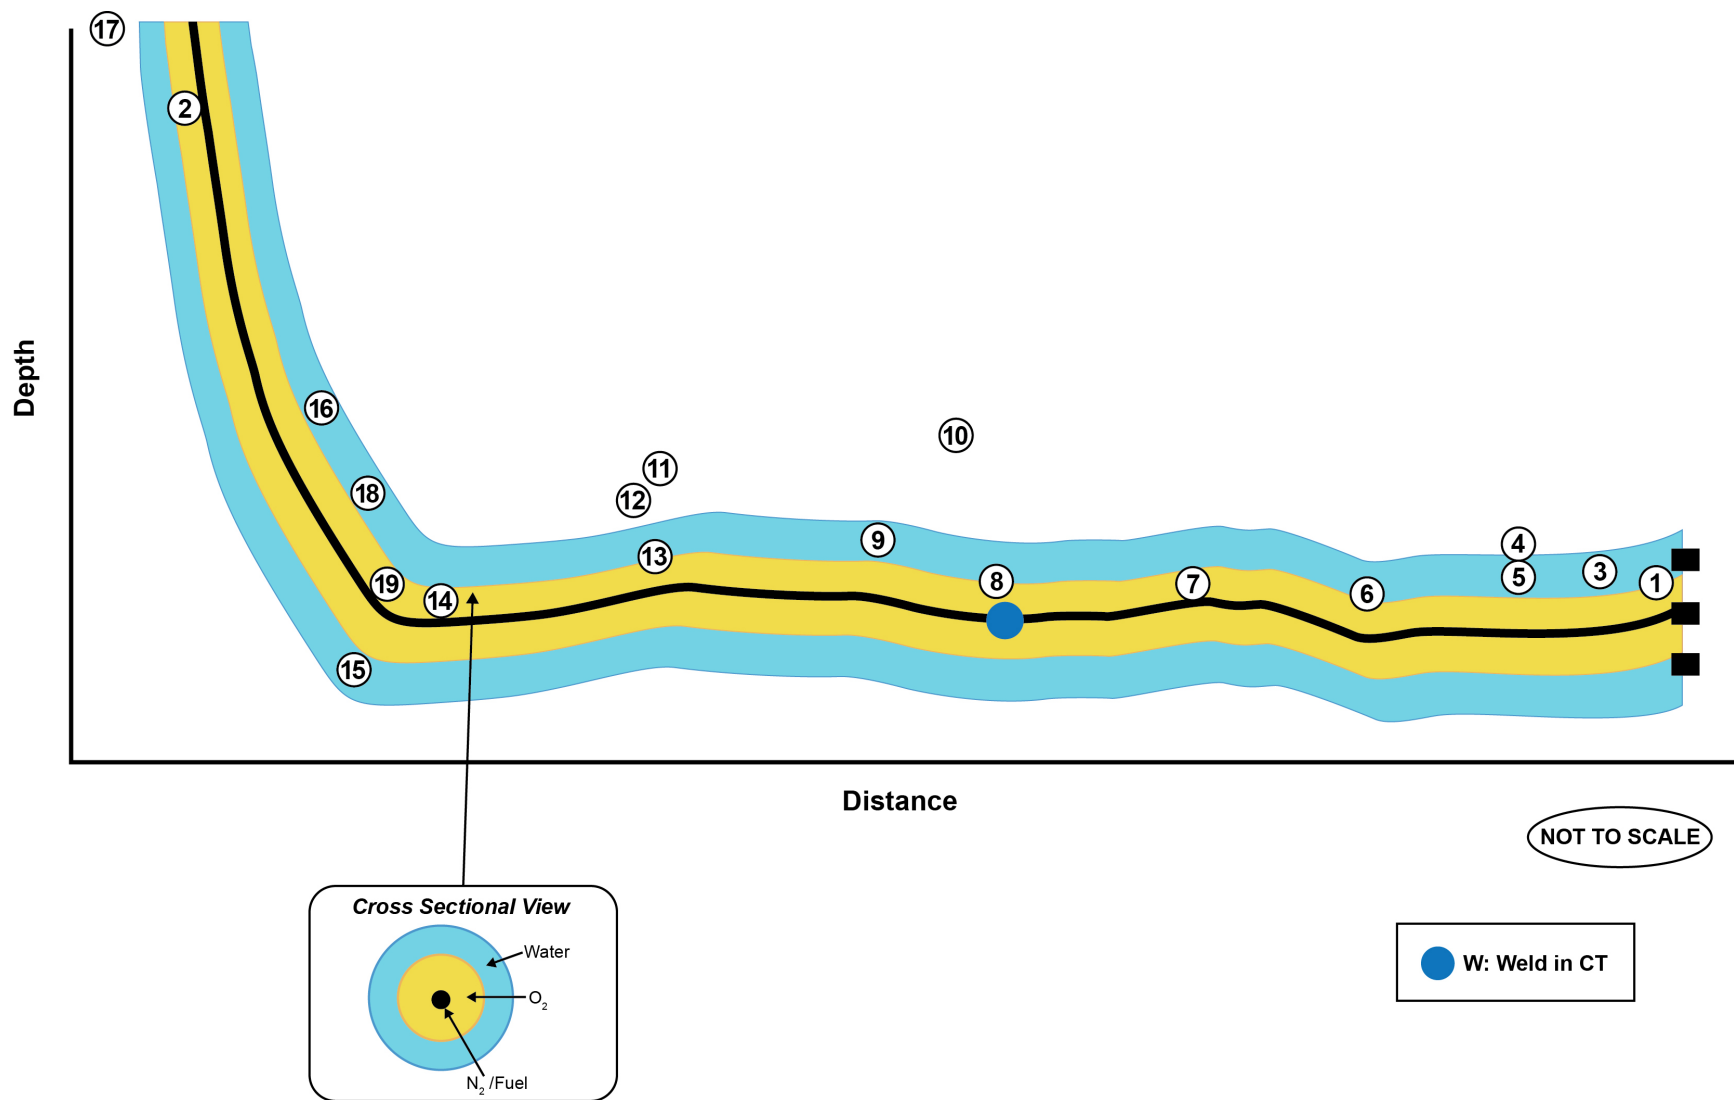
Figure 3. Visual representation of sequence of events.

Each root cause analysis had between 17 and 19 potential cause paths. From these cause paths, the SHS report concluded that the following was the most likely sequence of events (see also figure 3).

Date	Sequence	Event
February 20, 2011	1	<ul style="list-style-type: none"> • Ignition downstream of November 2010 ignition burner location • Casing thermally compromised • Coiled tubing stuck in injection well
July 21, 2011	2	<ul style="list-style-type: none"> • Coiled tubing filled with water during repairs • Coiled tubing insufficiently purged with nitrogen • Oxygen and water mixture caused coiled tubing to partially corrode, especially in low points along well trajectory
October 4, 2011	3	<ul style="list-style-type: none"> • Water injection rate decreased, causing laminar flow in water annulus • Oxygen and syngas migrated into water annulus • Oxygen and water mixture, as well as syngas, caused casing and coiled tubing to corrode
October 7, 2011

2:02 a.m.	4	<ul style="list-style-type: none"> • Casing breached due to corrosion and thermal impacts • Oxygen and syngas migrated farther into the water annulus

4:55 a.m.	5	<ul style="list-style-type: none"> • Syngas autoignited inside the water annulus and upstream of the burner
4:37 p.m.	6	<ul style="list-style-type: none"> • Coiled tubing collapsed due to ignition and corrosion

Date	Sequence	Event
6:14 p.m.	8	<ul style="list-style-type: none"> Coiled tubing breached at weld, located at about 2128 metres measured depth (m MD) and at a low point in well trajectory Oxygen migrated from oxygen annulus into water annulus Oxygen and water mixture caused casing and coiled tubing to corrode
October 7–8, 2011	9	<ul style="list-style-type: none"> Oxygen migrated from coiled tubing breach at weld (low point in well trajectory) to high point in well trajectory Oxygen and water mixture caused casing and coiled tubing between weld and high point to corrode Casing and coiled tubing breached due to corrosion Oxygen migrated from water annulus into formation
October 8, 2011
