**MEG Energy Corp.  
Steam Pipeline Failure  
Licence No. P 46441, Line No. 001  
May 5, 2007**

**ERCB Investigation Report**

**September 2, 2008**

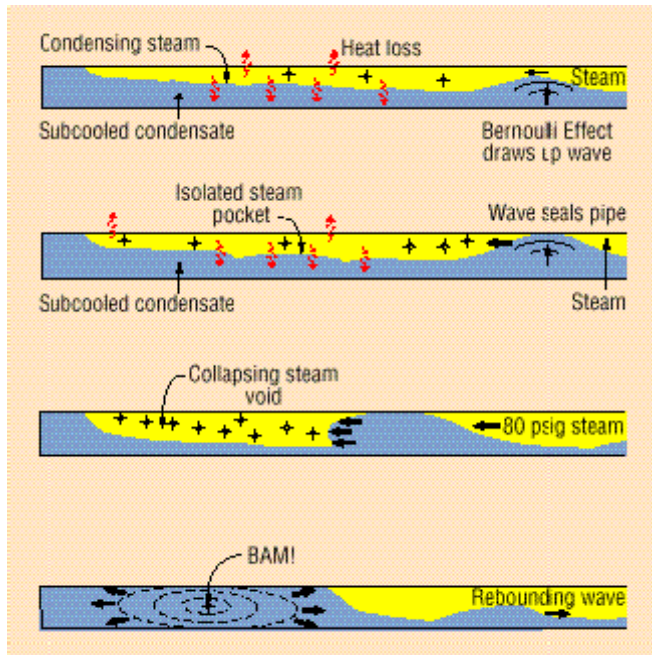
The investigation determined that the failure resulted from a condensation induced steam hammer that generated forces well in excess of the breaking strength of the pipe.

A condensation induced steam hammer is sometimes called a condensation induced water hammer or a steam bubble collapse and is a rapid condensation event. It occurs when a steam pocket becomes totally entrapped in subcooled condensate. As the steam gives up its heat to the subcooled condensate and pipe walls, the steam changes from a vapour to a liquid. The continued loss of steam by this phase transformation induces fresh steam to flow into the steam pocket in order to replace the lost steam. Steam flow over condensate will tend to draw up waves in the condensate via the Bernoulli Effect. If the rate of heat transfer is rapid enough for a given condensate level, the induced steam velocity will draw up a wave high enough to seal the pipe. This is critical because the wave seal effectively isolates the steam pocket from the upstream supply of steam. At that instant, ongoing condensation causes the vapour void to collapse because the volume of liquid is about 100 to 1000 times smaller than the precursor volume of steam. The associated drop in pressure within this void acts like a vacuum that causes the condensate waves to crash into each other. There are also rebounding shockwaves (see Figure 1).

Figure 1. Condensation induced water hammer
