Canadian Natural Resources Ltd. Primrose East Bitumen Emulsion Release January 3, 2009

ERCB Investigation Report

January 8, 2013

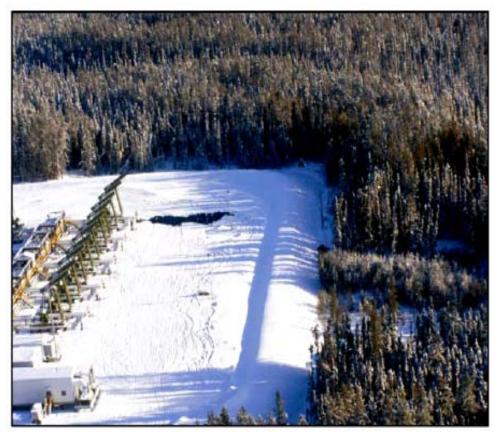
Figure 2. Photo of Pad 74

As shown in Figure 2 and Figure 3, accumulations of bitumen emulsion were observed south and east of the 1A74 wellhead near the southeast corner of Pad 74. The bitumen emulsion had flowed south across the top of the pad and had pooled in the ditch located along the inside of the pad's south berm. Bitumen emulsion was also observed near two thin (1 to 2 millimetres) surface fissures south and east of Pad 74. The composition of the bitumen emulsion indicated that it originated in the Clearwater Formation.

Since discovering the release, CRNL has removed approximately 11 380 tonnes of solids (including snow, organic material, soil, and bitumen) from the site for landfill disposal, and recovered 904 cubic metres (m^3) of bitumen from the surface of Pad 74 and transported it to CNRL's Wolf Lake plant.

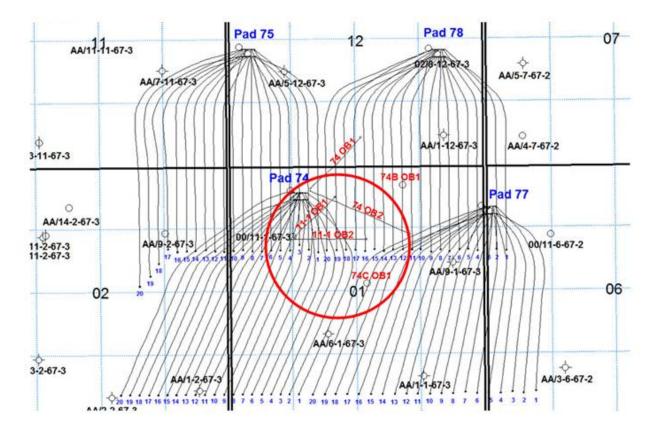
Figure 5. Bitumen delineation wells and subsurface area affected by the bitumen emulsion release

CNRL drilled six wells to delineate the subsurface areal extent of the bitumen emulsion release and to help identify the bitumen pathway to surface. Figure 5 shows the location of these six wells and an estimate of the subsurface area affected by the release.

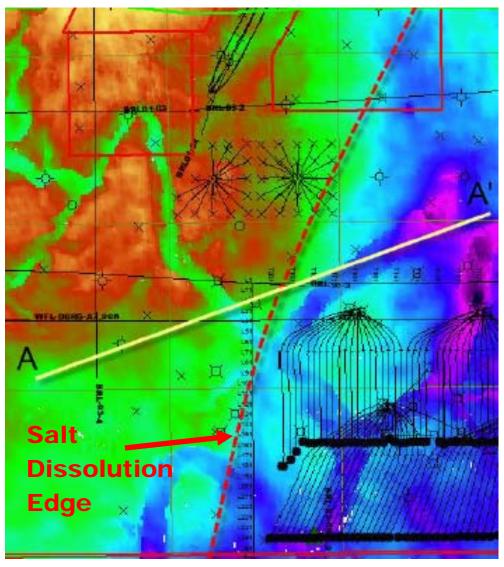
Figure 8. Time structure map of the Paleozoic unconformity

dissolution edge is visible on the time structure map on the Paleozoic unconformity shown in Figure 8. The average thickness of the Devonian strata is 600 m.

karsting along the sub-Cretaceous unconformity. The ERCB believes that these structural features provide a setting where fracturing and faulting of the Cretaceous strata is highly likely.

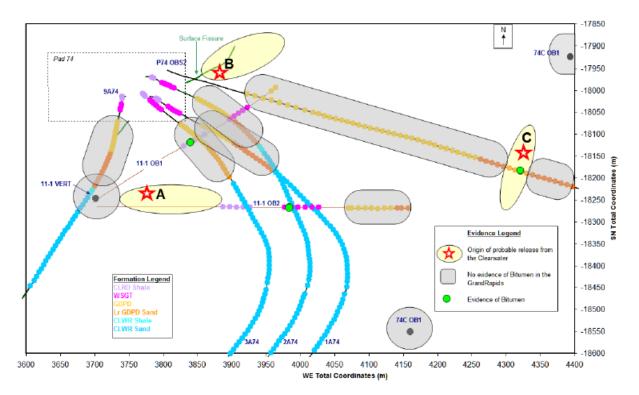
Figure 9. Probable Bitumen Emulsion release pathways

CNRL concluded that a general pattern of the bitumen emulsion flow path to surface could be inferred, but that a detailed flow path could not be determined with certainty. Figure 9 shows CNRL's three probable release pathway scenarios, of which CNRL claimed that scenarios A and B were the most likely.

- 1) Flow in Clearwater reservoir and breach through Clearwater shale about 300 m south of Pad 74. (Refer to Figure 9).
- 2) Steam-induced north-south-oriented vertical fracture to the top of the Grand Rapids formation.
- 3) Induced horizontal fracture at the base of the Joli Fou shale and intersection with the 2A74 wellbore.
- 4) Flow along the 2A74 wellbore within Colorado Group to an elevation of 315 true vertical depth (TVD—depth at which the temperature log on 1A74 shows constant temperature).
- 5) Induced horizontal fracture at 315 TVD and intersection with the 1A74 wellbore.
- 6) Flow along the 1A74 wellbore to the top of the Colorado Group (to Lea Park).

- 7) Vertical flow along an induced fracture to the top of Lea Park Formation.
- 8) Continued flow along an induced vertical fracture through Quaternary drift and its Bonnyville Aquifer to surface.

- 1) Flow in Clearwater reservoir and breach through Clearwater shale immediately east of Pad 74 (refer to Figure 9).
- 2) Induced vertical fracture in the Grand Rapids to top of formation.
- 3) Steps 3-8 are the same as in Scenario A.

- 1) Flow in Clearwater reservoir and breach through Clearwater shale directly below the bitumen show in the 74 OBS2 wellbore (refer to Figure 9).
- 2) Induced vertical fracture in Grand Rapids to top of formation.
- 3) Flow along a pre-existing fault or a series of interconnected minor pre-existing faults to the position of bitumen show in the Westgate Formation within the 11-1 OB2 wellbore.
- 4) Continued flow along a pre-existing fault or a series of interconnected minor pre-existing faults to the position of the bitumen show in the Colorado shale interval within the 11-1 OB1 wellbore.
- 5) Flow along an induced horizontal fracture at the top of the Colorado shale interval to intersect the 1A74 wellbore.
- 6) Flow along the 1A74 wellbore at the base of the Lea Park Formation.
- 7) Steps 7 and 8 are the same as Scenarios A and B.

In all three scenarios, the breach of the Clearwater shale was assumed to have occurred at a single location. In Scenario A, this location was assumed to be about 300 m south of Pad 74 based on the recorded temperature above the geothermal gradient in the nearby 11-1 observation well, which indicated the occurrence of convective flow at the top of the Clearwater bitumen reservoir. In Scenario B, this location was assumed to be about 100 m east of Pad 74 based on the slight temperature anomalies observed within the Grand Rapids

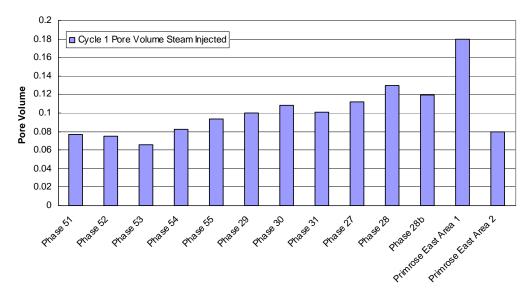
Figure 10. Cycle 1 pore volume steam injection at PAW shown chronologically

Cycle 1 injection volumes of about 80 000 m³ per well were used at Primrose East prior to the bitumen emulsion release. As shown in Figure 10, this was significantly greater on a reservoir pore volume basis than the volumes used elsewhere at PAW. The ERCB believes that the reduction of interwell spacing from 180 m used elsewhere at PAW down to 60 m at Primrose East, combined with the high individual well cycle injection volumes, likely contributed to the release. During the Area 2/Phase B diagnostic steaming, more traditional volumes were used without incident, which further supports this conclusion.

As a result of this incident the ERCB has put limits on the steam injection volumes that CNRL is allowed to inject per cycle. In addition, with the ERCB's concurrence, CNRL has undertaken a pressure monitoring program in the Grand Rapids Formation. When pressure changes are measured, particularly in conjunction with increases in steam injectivity, steam injection is reduced or suspended, as considered necessary.
