**Plains Midstream Canada ULC
NPS 20 Rainbow Pipeline Failure
Licence No. 5592, Line No. 1
April 28, 2011**

ERCB Investigation Report

February 26, 2013

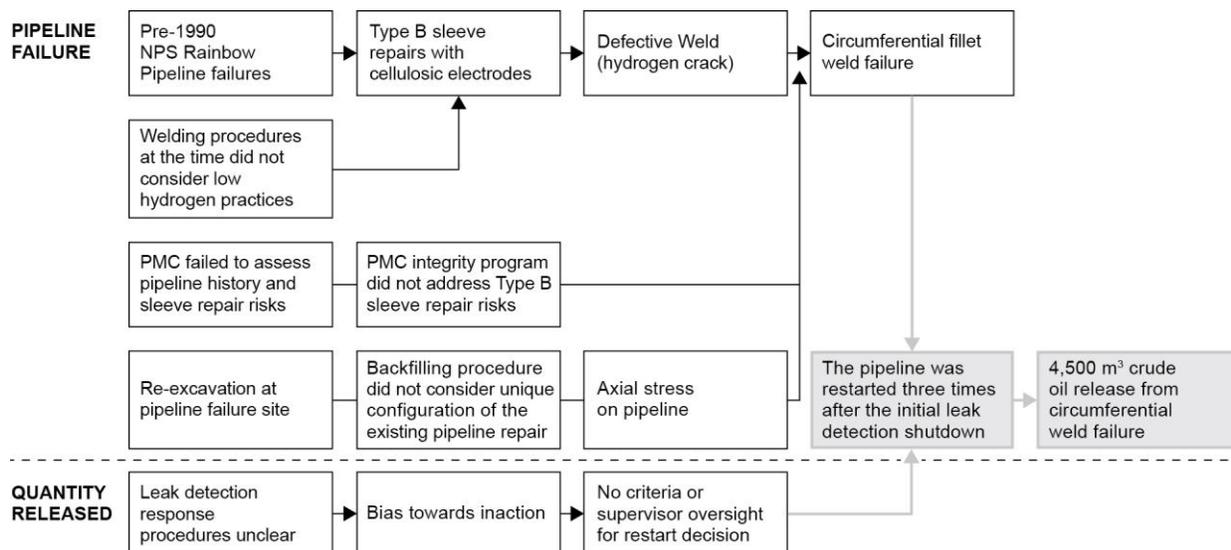
Figure 1. NPS 20 Rainbow Pipeline Failure Root Cause Analysis, 2011

The ERCB determined that Plains failed to fully assess the history of the pipeline, failed to

identify the risks posed by the application of Type B sleeves used for corrosion repair (referring to the NEB notification of cracking associated with Type B repair sleeves), and did not have measures in place to monitor and inspect the repairs. Had diligent inspection measures been in place for the sleeve repairs, the condition of the repair could have been assessed when the section of pipeline was excavated one year prior to the failure with the possibility that the defective weld may have been identified and repaired at that time.

The ERCB determined that Plains failed to have adequate practices in place for backfill placement and compaction for excavated pipeline sections where Type B sleeve repairs were present and for unique soils conditions such as muskeg. The ERCB viewed that inadequate backfill and compaction likely contributed to stresses on the circumferential fillet weld that failed.
