**Pace Oil and Gas Ltd.
Wellhead Piping Failure
Licence No. W0057420
May 19, 2012**

AER Investigation Report

March 3, 2014

Alberta Energy Regulator

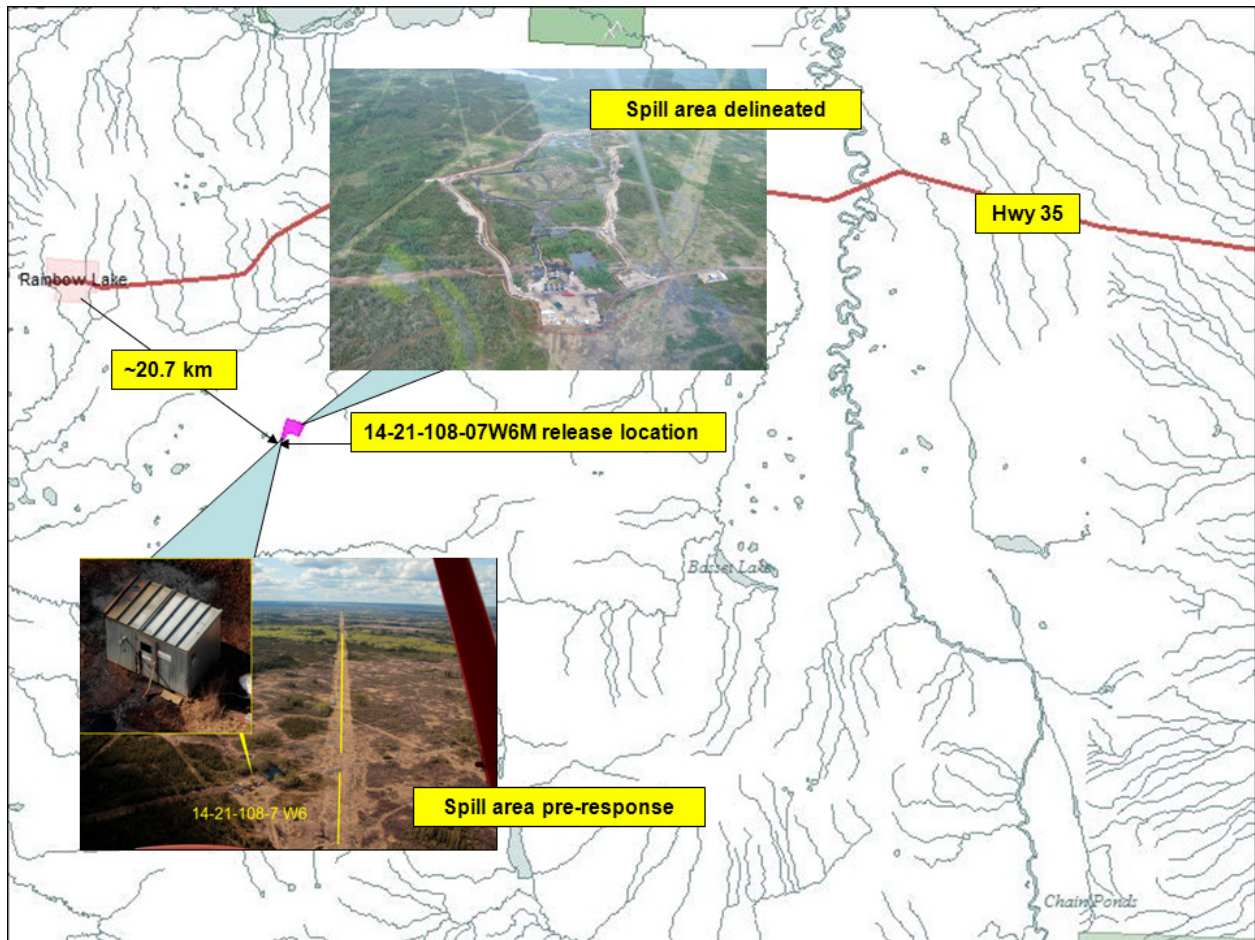
The spill, originating at the disposal well at LSD 14-21 (14-21 well), pooled in an unoccupied beaver dam about 40 metres (m) from the well and migrated almost 500 m downgradient from the source. The area visibly impacted by the spill extended about 475 m from the source and was about 185 m at its widest point. Pace, in consultation with the Alberta Energy Regulator (AER)³ and Alberta Environment and Sustainable Resource Development (ESRD), estimated the total spill area to be 4.5 hectares (11 acres).

Figure 1. Pace Rainbow Lake Field spill. (Source: AER)

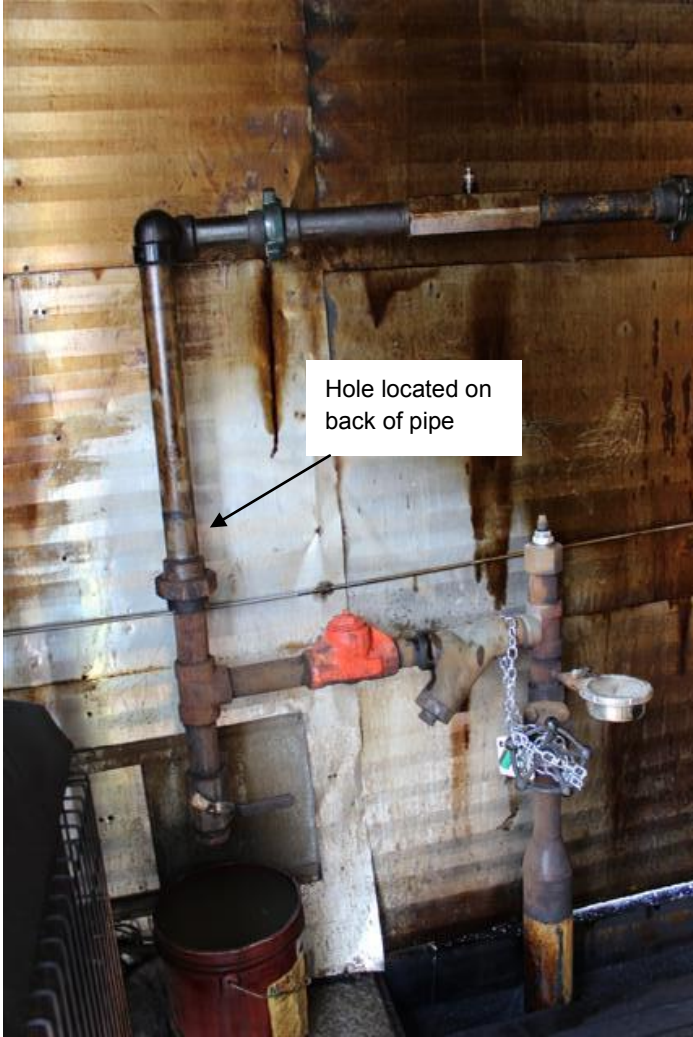
The 14-21 wellhead pipe failure occurred on a threaded, 58 centimetre (cm), vertically oriented segment of pipe (figure 2). The through-wall perforation (hole) was about 13 mm in diameter (figure 3) and about 15 cm downstream (towards the wellhead) of an electrical isolating union.¹² Documentation supplied by Pace indicated that there were no piping modifications to the wellhead until 2009 when Provident replaced the isolating union with a non-isolating hammer union. Provident made this replacement because of a recommendation from a CP adjustive survey.¹³ The failed pipe segment appears to have been originally installed in 1977 by Pacific when the well was approved for disposal operations. Produced water (about 14 000 to 18 000 ppm chlorides) is disposed of on an intermittent basis at a maximum pressure of 700 kilopascals (kPa) and a temperature of 38°C.

Figure 2. Lease piping prior to removal for analysis. (Source: AER)

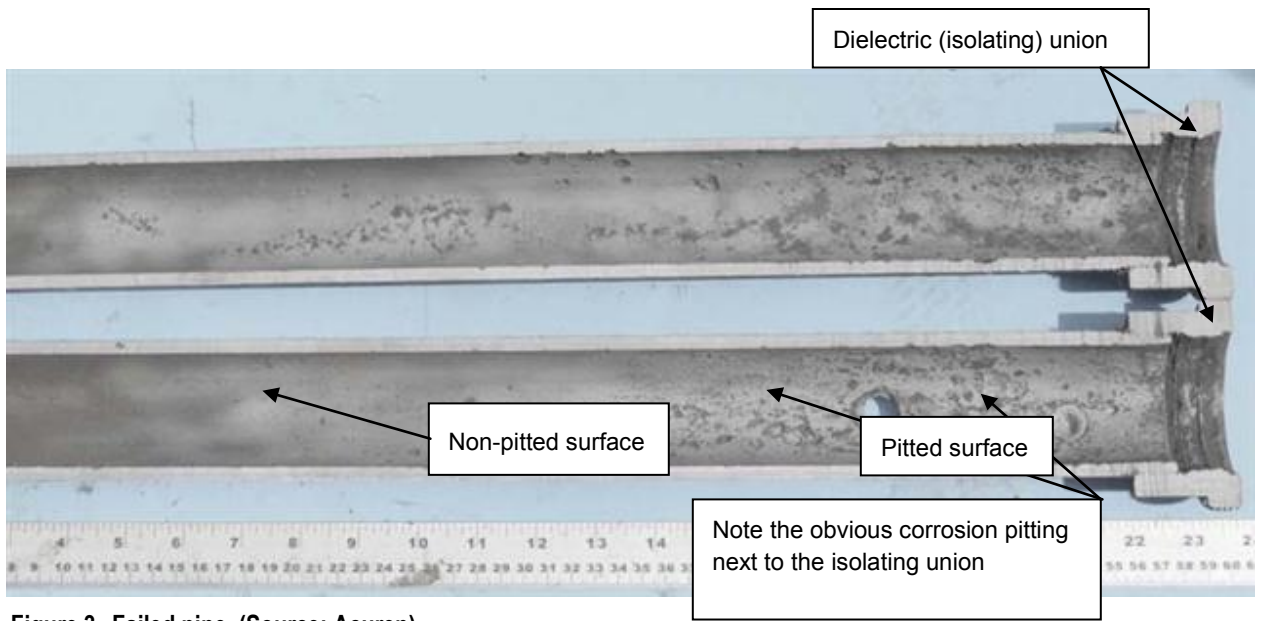
The AER has reviewed the metallurgical analysis and supporting documents submitted by Pace in the reports noted above relating to the failed wellhead piping on the 14-21 well. The AER concludes that the Schedule 80,¹⁸ 60.3 mm wellhead piping failed as a result of internal pitting corrosion initiated by stray current interference that could have been later influenced by one or a combination of the following:

The AER agrees with the analyses submitted by Pace and its consultants, which indicate that at some point during the operating history of the 14-21 well, stray current interference initiated the corrosion process, ultimately contributing to the wellhead pipe failure. This finding is supported by the obvious and abrupt internal corrosion pitting in the transition area immediately downstream of the CP isolating union.

Figure 3. Failed pipe. (Source: Acuren)
