Suncor ESEIEH Phase 2 Small Scale Pilot Project 2016 AER Performance Presentation Experimental Scheme Approval No. 12074

November 28, 2016; 2-3pm
Reporting Period September 1, 2015 – August 31, 2016

Effective Solvent Extraction Incorporating Electromagnetic Heating

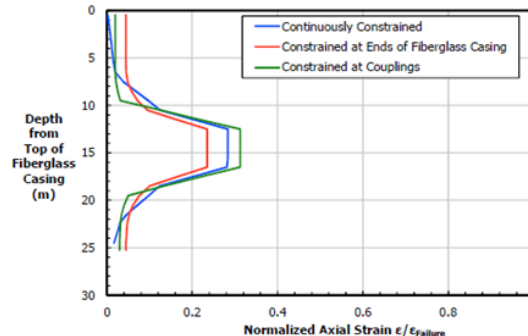
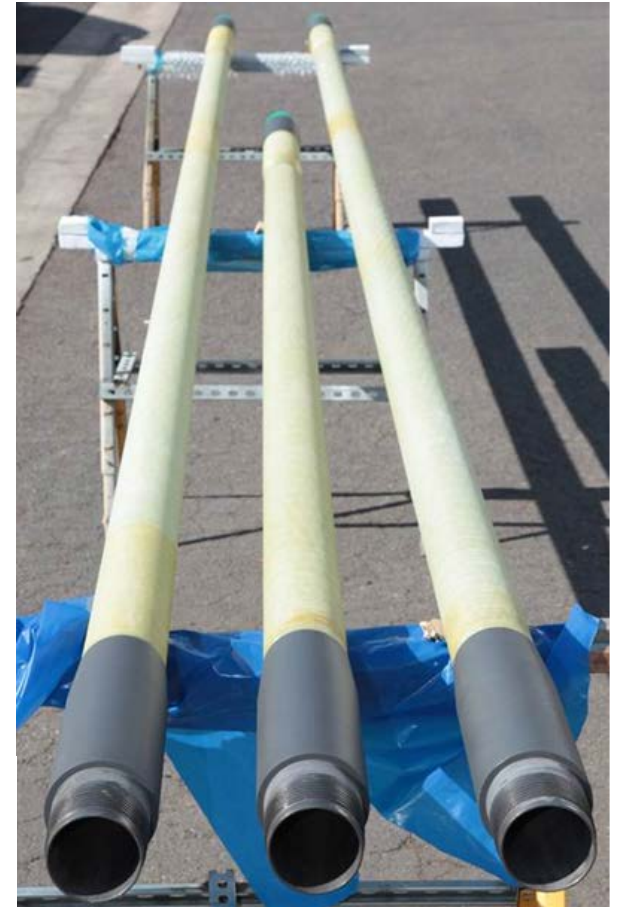
Composite Casing

- Model was originally used to estimate load rates
- Real data lab test was conducted after:
 - Composite casing tests showed reasonable correlation in tension and less accuracy in compression compared to model
 - Compression results do not fully represent tube behavior as boundary conditions of test significantly different from in situ conditions (small block cut from tube was used so there is loss of continuity of fiber winding around a whole cylinder)
- Refined model was done to predict system behavior:
 - Modeled temperature profile
 - Cement CTE obtained from vendor
 - Formation strain both from model and field measured
- 3 different constrain scenarios used and results show that in the worse case scenario composite casing would be able to withstand the loads

Figure 15. Normalized axial mechanical strains in reservoir heated to 190°C maximum and CTE = $23.1 \times 10^{-6} \text{ m/m/}^\circ\text{C}$.

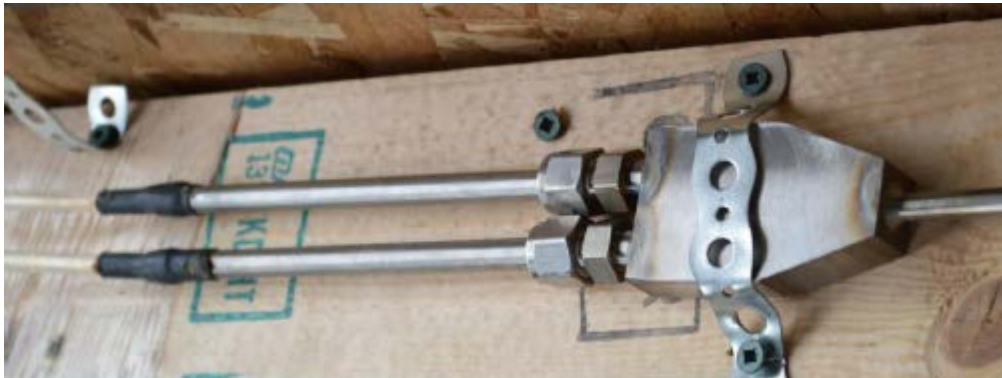
RF Instrumentation Design

- Instrumentation line and attachment to piezometer were specially developed for this project:
 - PFA jacket used instead of common stainless steel capillary line
 - Fiber developed by AFL in conjunction with Harris
 - Attachment to piezometer develop by Harris and final assembly develop by Opsens Solutions
- Final assembly successfully passed test in an environment chamber under expected In-Situ pressure and temperature
- Feed through connector on wellhead guarantee isolation of PFA jacket
