Suncor ESEIEH Phase 2 Small Scale Pilot Project 2017 AER Performance Presentation Experimental Scheme Approval No. 12074

Reporting Period September 1, 2016 – August 31, 2017

Effective Solvent Extraction Incorporating Electromagnetic Heating

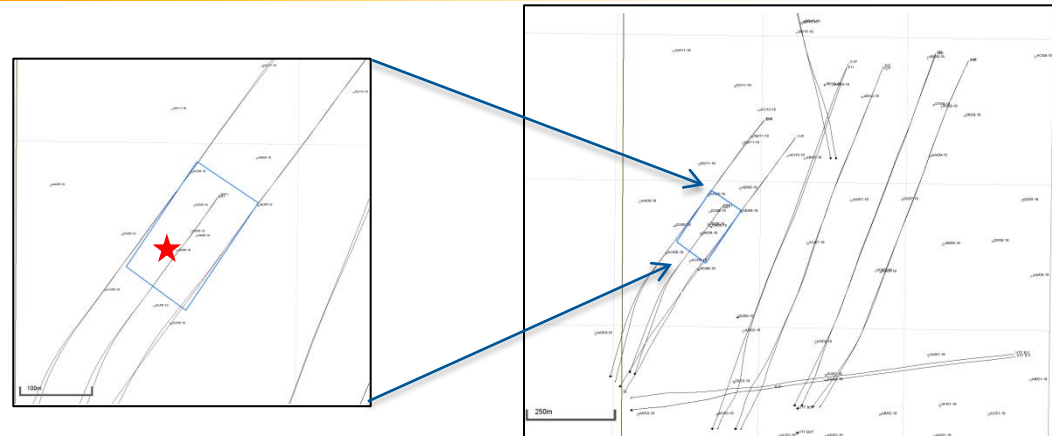
Stratigraphy

- Caprock in region is mappable, predictable, and laterally consistent (>36m thick)
- McMurray Formation Reservoir predominantly sand with minor breccia ranges 24m – 30m thick
- No top or base lean zones are observed within the reservoir

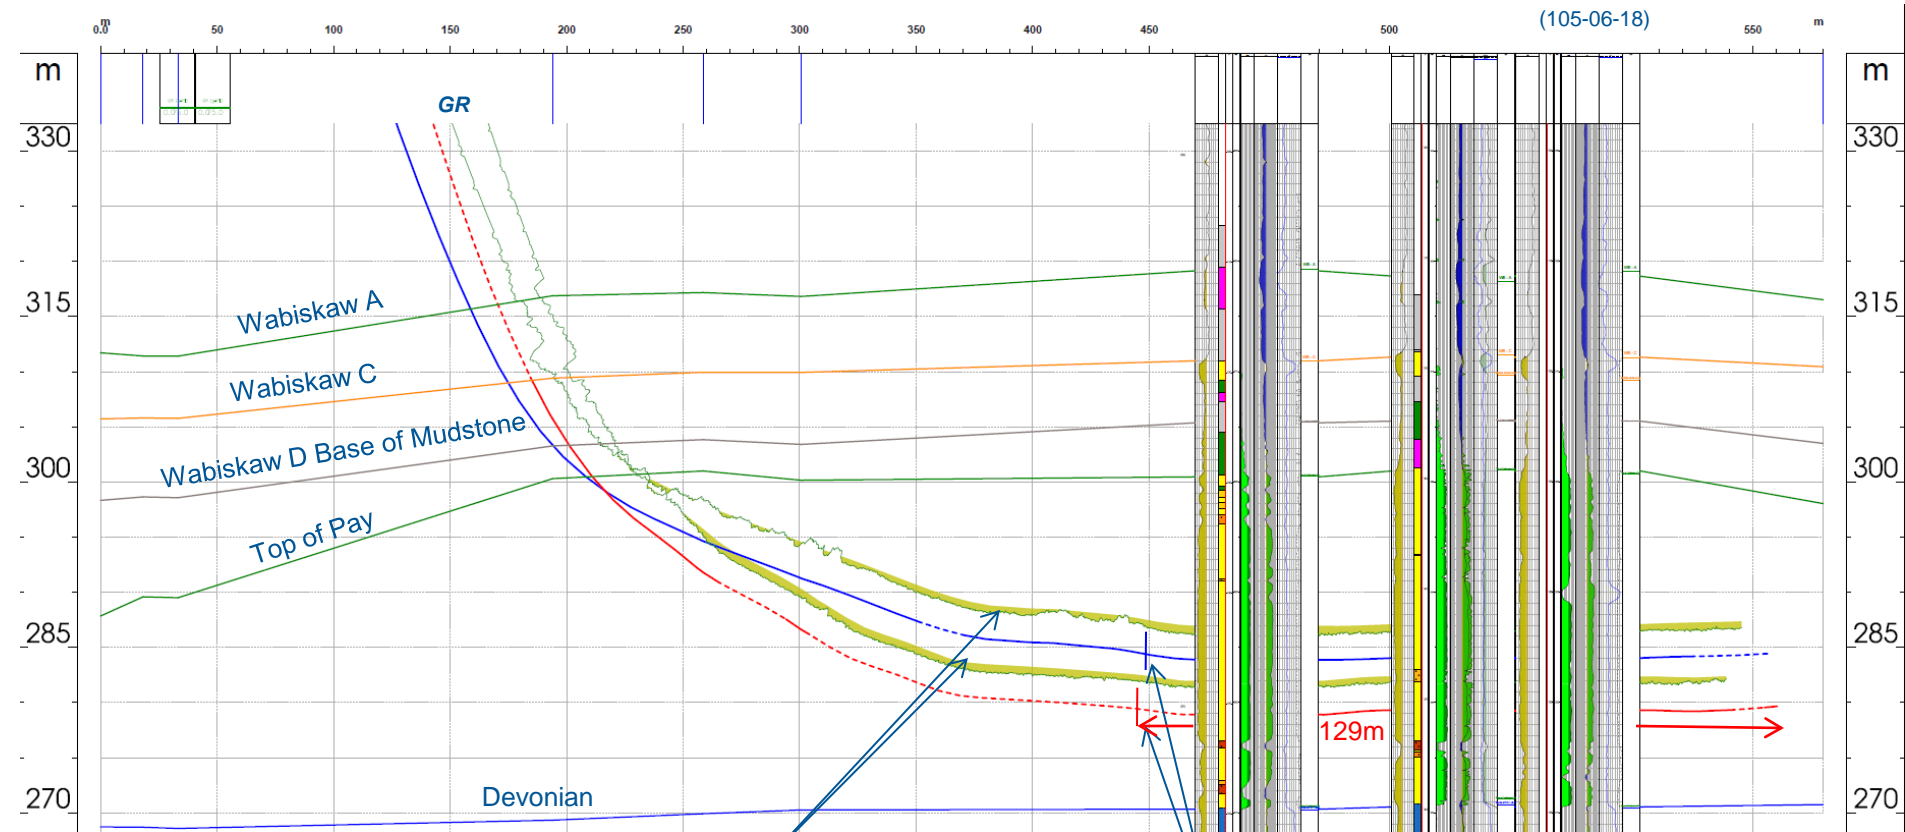
ESEIEH Horizontal Cross Section

— Antenna Well Path
— Producer Well Path

EZOB-2
(104-06-18)
EZOB-6
(108-06-18)
EZOB-1
(105-06-18)

Color fill on GR is at 35 API
cutoff (very clean sand)

Approximate position of ICP
ICP EZI1: 448m
ICP EZP1: 445m

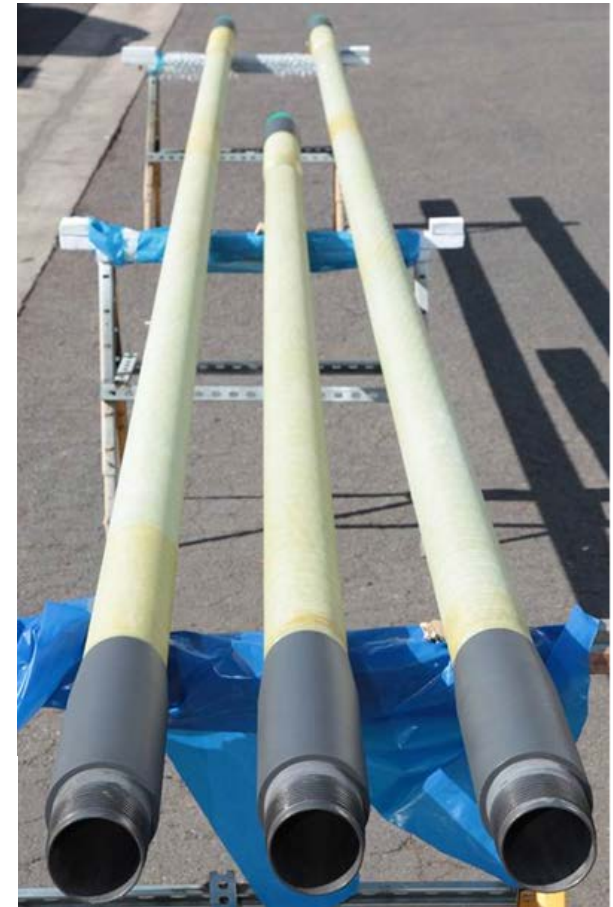
Composite Casing

- Model was originally used to estimate load rates
- Real data lab test was conducted after:
 - Composite casing tests showed reasonable correlation in tension and less accuracy in compression compared to model
 - Compression results do not fully represent tube behavior as boundary conditions of test significantly different from in situ conditions (small block cut from tube was used so there is loss of continuity of fiber winding around a whole cylinder)
- Refined model was done to predict system behavior:
 - Modeled temperature profile
 - Cement CTE obtained from vendor
 - Formation strain both from model and field measured
- 3 different scenarios used and results show that in the worse case scenario composite casing would be able to withstand the loads

Figure 15. Normalized axial mechanical strains in reservoir heated to 190°C maximum and CTE = $23.1 \times 10^{-6} \text{ m/m/}^\circ\text{C}$.

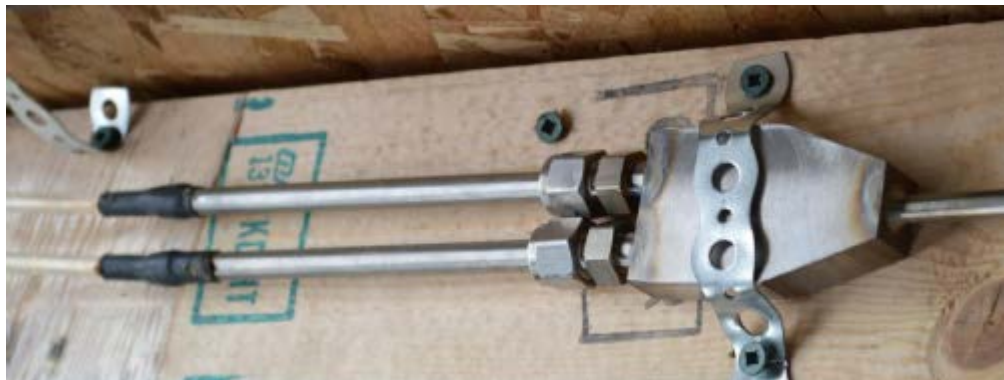
RF Instrumentation Design

- Instrumentation line and attachment to piezometer were specially developed for this project:
 - PFA jacket used instead of common stainless steel capillary line
 - Fiber developed by AFL in conjunction with Harris
 - Attachment to piezometer develop by Harris and final assembly develop by Opsens Solutions
- Final assembly successfully passed test in an environment chamber under expected In-Situ pressure and temperature
- Feed through connector on wellhead guarantee isolation of PFA jacket
