Scheme No. 11461 Performance Report

2021

- McKay River Project was previously owned and operated by Southern Pacific Resource Corp.
 - November 2010 Receives project approval:
 - EPEA Approval No. 255245-00-00
 - Oil Sands Conservation Act Approval No. 11461
 - Approved Capacity 12,000 bbl/d oil treating
 - In January 2015, Southern Pacific Resources, previous owner of STP McKay, was granted protection under the CCAA and subsequently entered Receivership in June 2015
 - Due to the depressed commodity price environment and high operating costs at the time, production was shut-in, and the Receiver initiated and completed a warm-hibernation program by August 2015
- Project was officially transferred to Everest Canadian Resources on February 2019

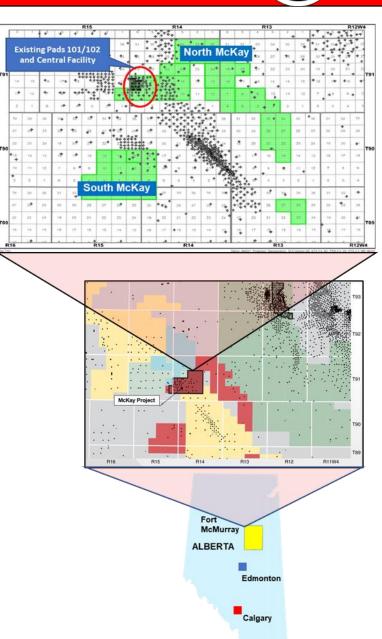
- Current approved development includes four well pads (101 to 104)
- The initial development is west of the MacKay River and includes well pads 101 & 102
- Process Facility existing capacity of 12,000 bbld oil and 37,400 bbld steam

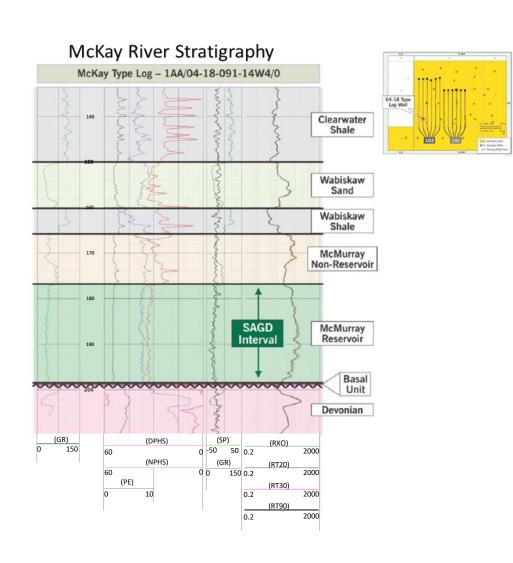
APPROVAL AREA RESERVOIR PROPERTIES

Average Reservoir Properties

Depth (m TVD)	190
Pay Zone Thickness (m)	17 - 27
Lateral Well Pair Spacing (m)	100
Horizontal Well Length (m)	800 - 1100
Porosity (%)	32
Oil Saturation (%)	74
Original Reservoir Pressure (kPa)	650
Original Reservoir Temperature (°C)	8.5
·

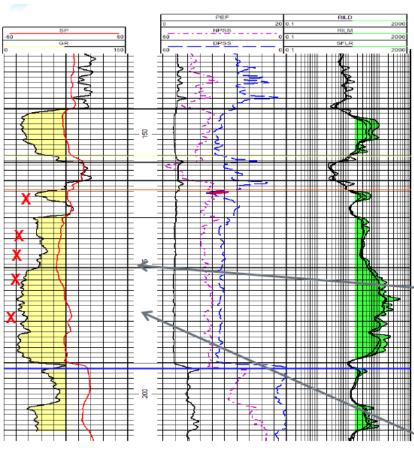
AA/04-17-91-14w4

Upper Reservoir (Bioturbated)

- Very Fine to Fine grained (<180 um)
- · Moderately sorted, Subangular with elongate grains
- Framework consists of quartz, common chert, siltstones with some feldspars
- Clays are within the microporosity of the chert, but also exist within the pore spaces. Pore space has 10% clay in the pore space.
- XRD: Analysis shows 86% qtz, 4% K-feldspar, 2% Plagioclase, 1% dolomite, 1% pyrite and 6% total clay.

Main Reservoir

- Fine to Medium grained (180-250 um)
- Moderately sorted, Subrounded with elongate and spherical grains
- Framework consists of quartz, chert, siltstones with some feldsnars
- Similar clays with less interstitial clay found in the rock matrix.
- \bullet XRD: Analysis shows 93% qtz, 2% K-feldspar, 1% pyrite and 4% total clay.

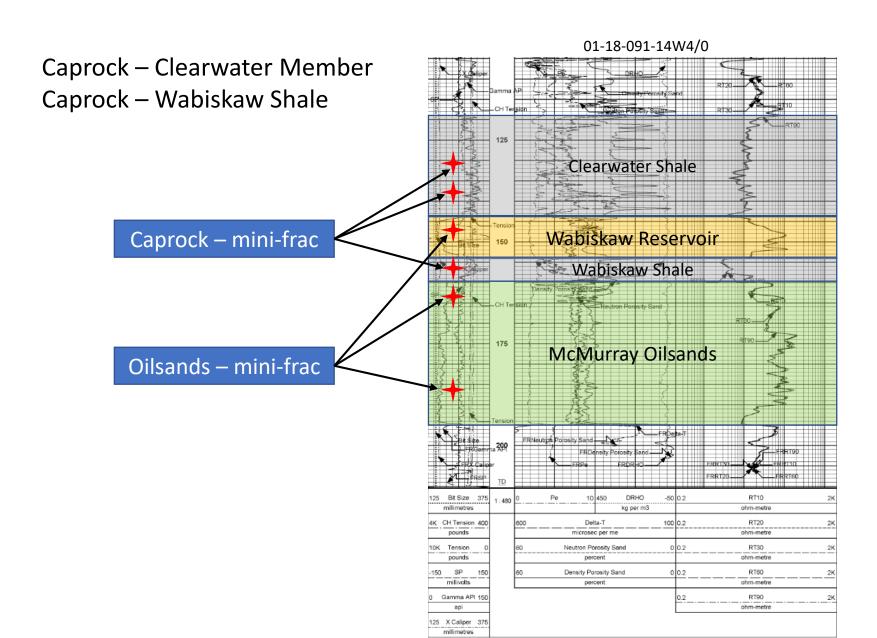
MINI-FRAC TESTS AND FRACTURE PRESSURE

- Fracture Pressure
 - Assessment of minimum fracture pressure (Smin) at the base of the Clearwater Formation using mini-frac test results.
 - Smin from both wells 5-16 and 1-18 were consistent.
 - Smin fracture pressure at the base of the Clearwater Formation caprock was between ~2,860 kPa and ~ 3,020 kPa.

- Mini-Frac Tests
 - Mini-frac tests completed at wells 5-16 and 1-18
 - Stress gradient results are consistent and similar to those expected in the Athabasca Oil Sands.
 - Vertical stress gradient is ~21.5 kPa/m.

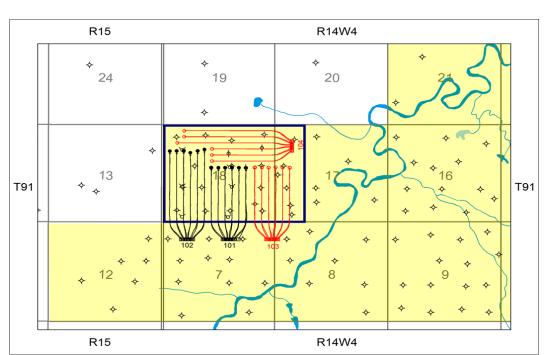
WELL LAYOUT

- Approved Development area outlined in blue
- Drilled to date (black):
 - Pad 101 (6 pairs) → 800 m Hz
 - Pad 102 (6 pairs) → ~ 1,000 m Hz
 - Wabiskaw observation well (lies above 1P1)
- Approved Pads (red):
 - Pad 103 (6 pairs)
 - Pad 104 (6 pairs)

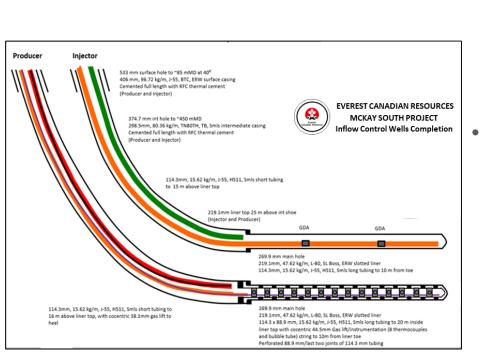
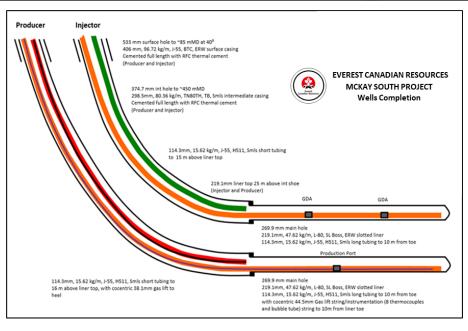
WELLS COMPLETION SCHEMATICS

- Initial Wells completion design
 - Six installations in production wells
 - All production wells are equipped for gas lift
 - Coil tubing with temperature instrumentation is run to toe.

- ICD Installation Producer (Gas Lift)
 - Six installations in production wells
 - All production wells are equipped for gas lift
 - Coil tubing with temperature instrumentation is run to toe.

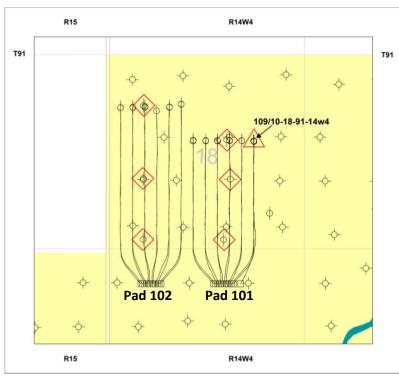
OBSERVATION WELLS

- 6 Vertical, Nested Observation Wells:
 - Pressure and temperature measurements extending from McMurray to Clearwater Formations
 - 10-18 and 12-18 wells have experienced 1 TC failure each. 5-18 has experienced 4 TC failures.
- Horizontal Observation Well:
 - Wabiskaw Member
 - Temperature/Pressure measurements

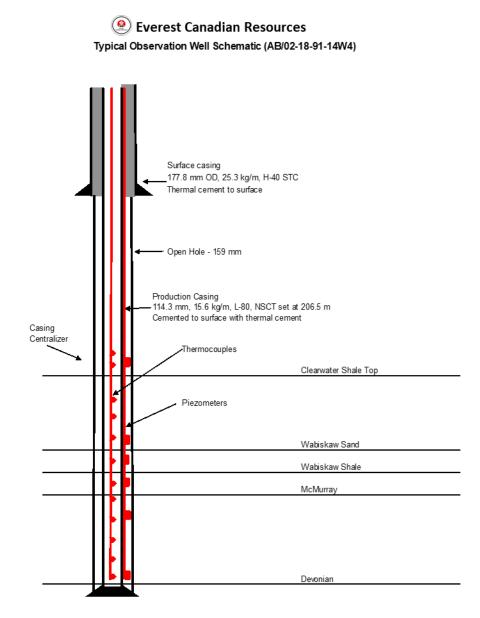
TYPICAL VERTICAL WELL

- 12 thermocouples spaced between the Base of McMurray to Clearwater
- 6 piezometers spaced between Base of McMurray to Clearwater
- Instrumentation strapped to outside of casing string

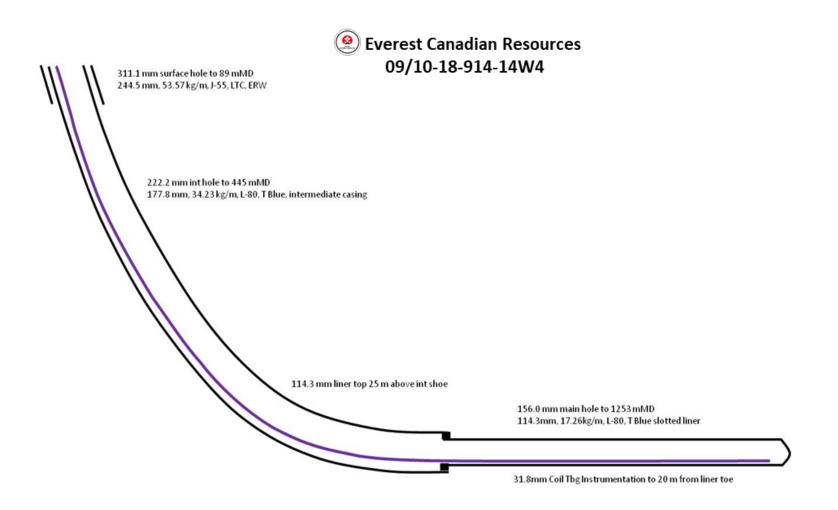
HORIZONTAL WABISKAW OBSERVATION WELL

Horizontal observation well designed and drilled in Wabiskaw formation for potential future production from zone

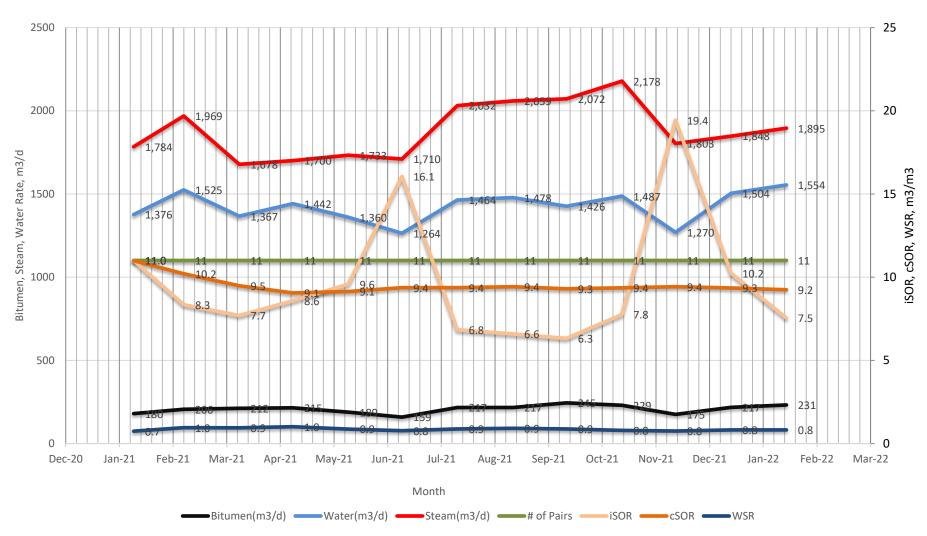
4.3.8.c Annual Operational Bitumen and Steam Rates

ECR-McKay	Actual Operational	Facility Design
Bitumen	230 m3/cd	1905 m3/sd
Steam	1781 m3/cd	5937 m3/sd
