Canadian Natural

**PRIMROSE FLOW TO SURFACE
CAUSATION REPORT**

**ALBERTA ENERGY REGULATOR AND ALBERTA ENVIRONMENT AND SUSTAINABLE RESOURCE
DEVELOPMENT**

June 27, 2014
Calgary, Alberta

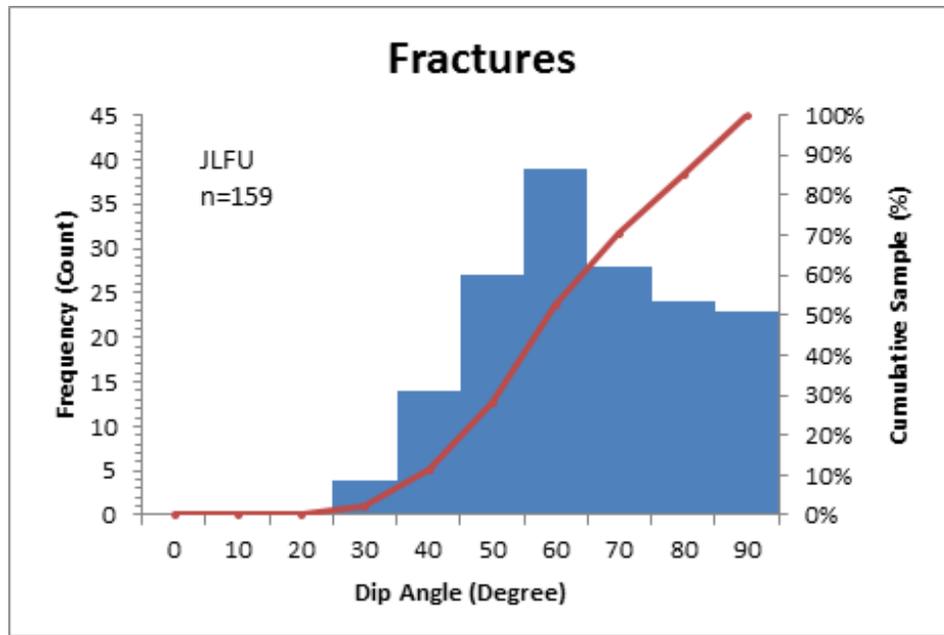
Figure 4-1 Number and Dip Angle of Fractures Observed in the Joli Fou Formation

The Joli Fou Formation is a thick mudstone which exhibits evidence of dewatering-induced soft sediment deformation. Natural fractures with high dip angles in the range of 30 to 90 degrees are observed on micro image logs (Figure 4-1). On Figure 4-1, Figure 4-2, Figure 4-3, Figure 4-4 and Figure 4-5, n represents the fracture count from micro image logs on the 50 Cretaceous wells drilled to date as part of this study.

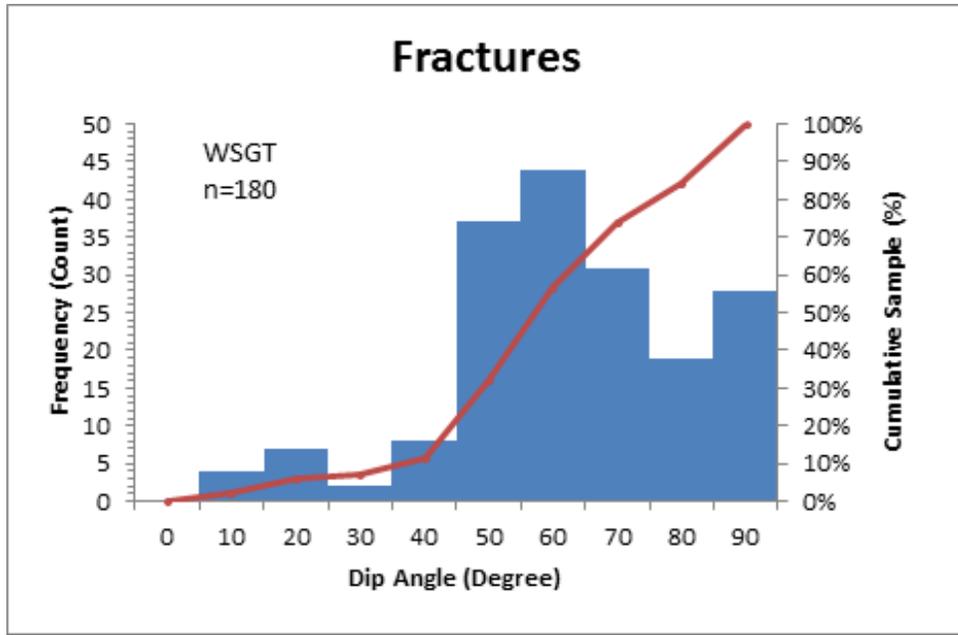
Figure 4-2 Number and Dip Angle of Fractures Observed in the Westgate Formation

In the upper cycles of the Westgate Formation, the shales become more quartz-rich, sedimentary layering becomes more visible in core, and the number of fractures observed in core and on micro image logs tend to increase compared to the underlying Viking and Joli Fou formations. Over 90 percent of the natural fractures observed on micro image logs dip in the 40 to 90 degree range (Figure 4-2).

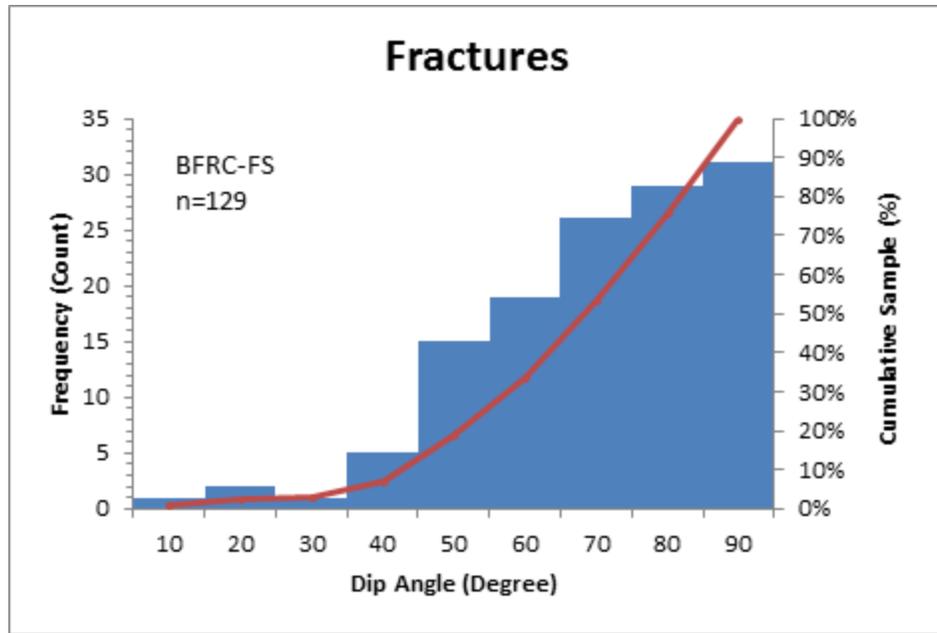
Figure 4-3 Number and Dip Angle of Fractures Observed in the Fish Scales and Belle Fourche Formations

The 3 – 12 m thick Fish Scales Formation often contains a basal bio-clastic lag. It is comprised of medium grey mudstone. The Belle Fourche Formation is 15 – 30 m thick and consists of two distinct units. The basal unit does not have an observable base and is a similar lithology to the underlying Fish Scales unit. The upper Belle Fourche Formation has an erosional lag and consists of interlaminated mudstone and low permeability sandstone. The 30 – 40 cm “X-bentonite” occurs near the base of the upper unit and cm-scale bentonites are common above it. Fractures observed in core and on micro image logs in these formations are relatively uncommon, but do occasionally occur.

Figure 4-3 indicates the number and associated dip angles of all natural fractures observed on micro image logs from the base of the Fish Scales and Belle Fourche Formations.

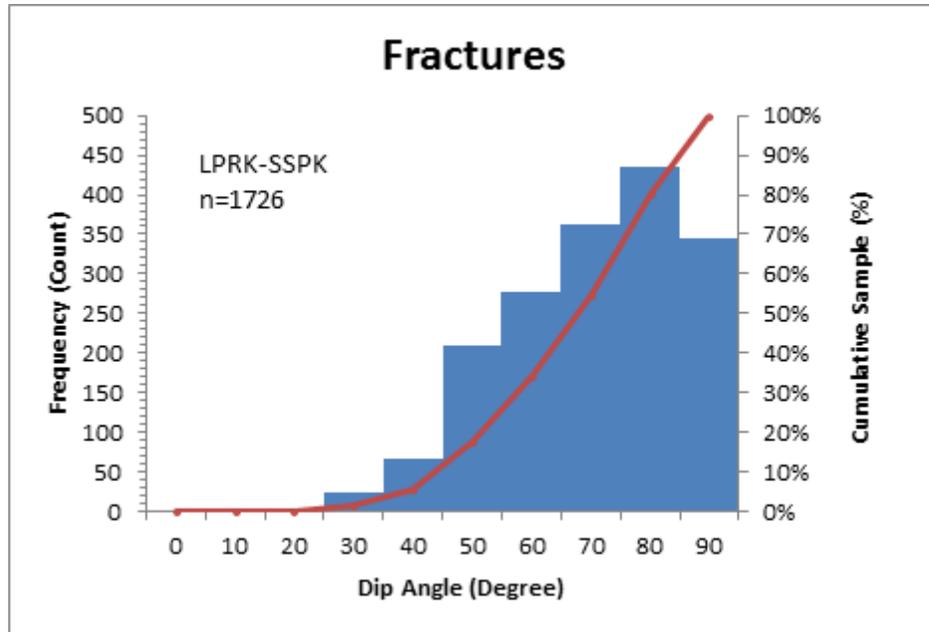
Figure 4-4 Number and Dip Angle of Fractures Observed in the Second White Specks, Niobrara and Lea Park Formations

The Lea Park Formation is light brown mudstone with common lenses of rippled sandstone and abundant siderite nodules. Depending on the amount of Quaternary erosion, it varies from 0 – 120 m thick. Curved, intermediate angled mud-lined (healed) fractures are common as are an apparently unrelated set of near vertical fractures.

Figure 4-4 indicates the number and associated dip angles of all natural fractures observed on micro image logs from the base of the Second White Speckled Shale Formation to the top of the Lea Park Formation.

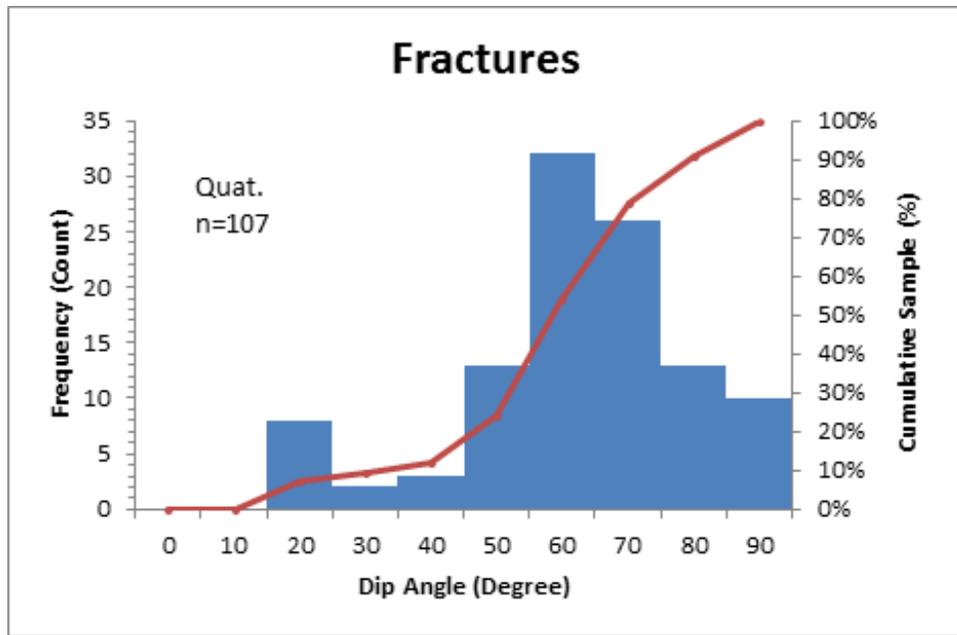
Figure 4-5 Number and Dip Angle of Fractures Observed in the Quaternary Formations

FTS locations occur on relative bedrock highs near the confluence of the regionally mapped Sinclair and Helina Valley Systems. The Quaternary deposits consist predominantly of regionally extensive till sheets with sand aquifers hanging from the tops of the units. Two features are present in the vicinity of the FTS locations. The first is the Burnt Lake Channel, which cuts to near the base of the Lea Park Formation. The second is a small subglacial tunnel channel, which cuts midway into the Lea Park Formation. Neither has affected the Colorado Group shale. High angle to vertical fractures are present in till units (Figure 4-5).

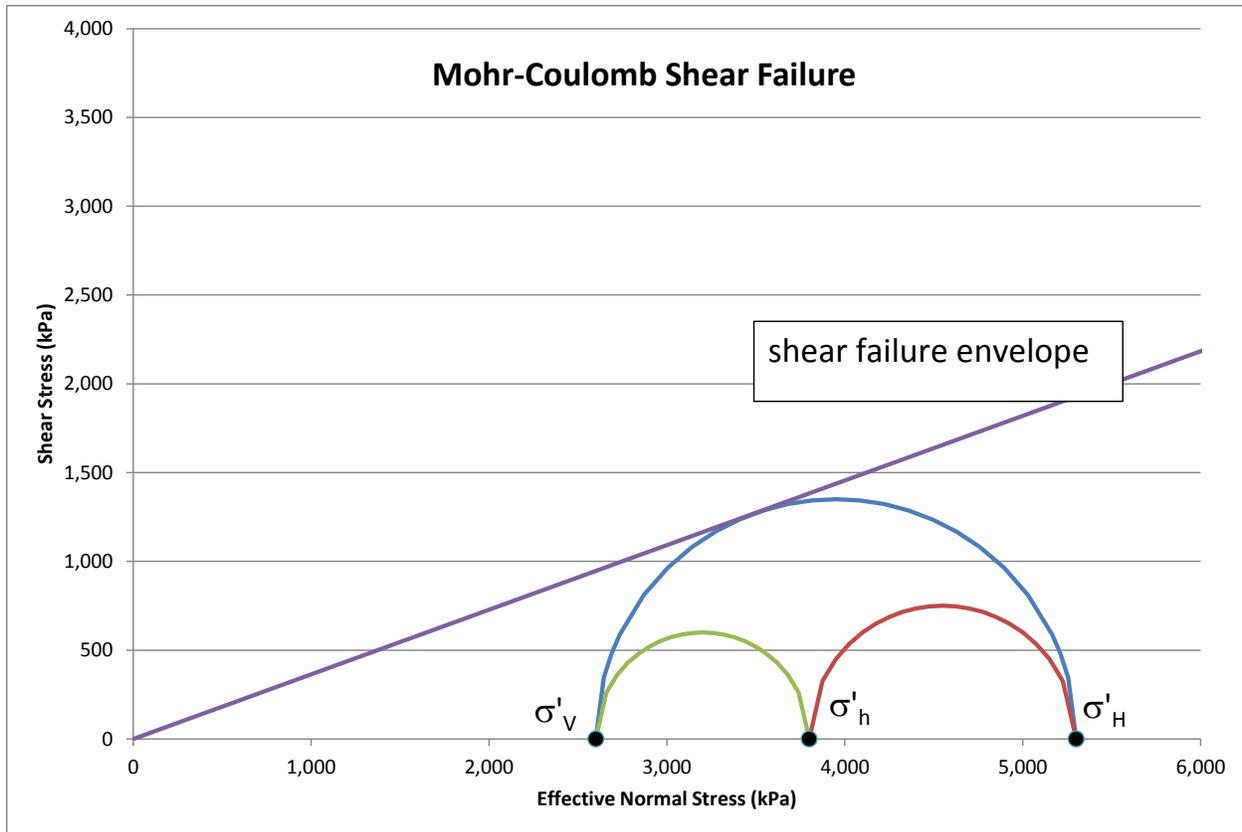
Figure 6-3 A simplified example of shear failure of a natural fracture at a fluid pressure less than the hydraulic fracture pressure

An example of a natural fracture shear failure at a pressure below the hydraulic fracture pressure is illustrated in Figure 6-3. In this example, the following assumptions are used:

The near horizontal geometry of the bitumen emulsion in the above example indicates that shear failure of natural fractures and faults intersected did not appreciably change the direction of the bitumen emulsion movement. This is interpreted that the permeability enhancement was insufficient to divert material bitumen emulsion flow from the horizontal fracture. This also indicates that the shear strain associated with intersected faults does not appear to have resulted in significantly different hydraulic conductivity behavior between faults and natural fractures. These results indicate that the flow capacity of natural fractures and faults can be overwhelmed by the rate of injection creating a horizontal hydraulically induced fracture.

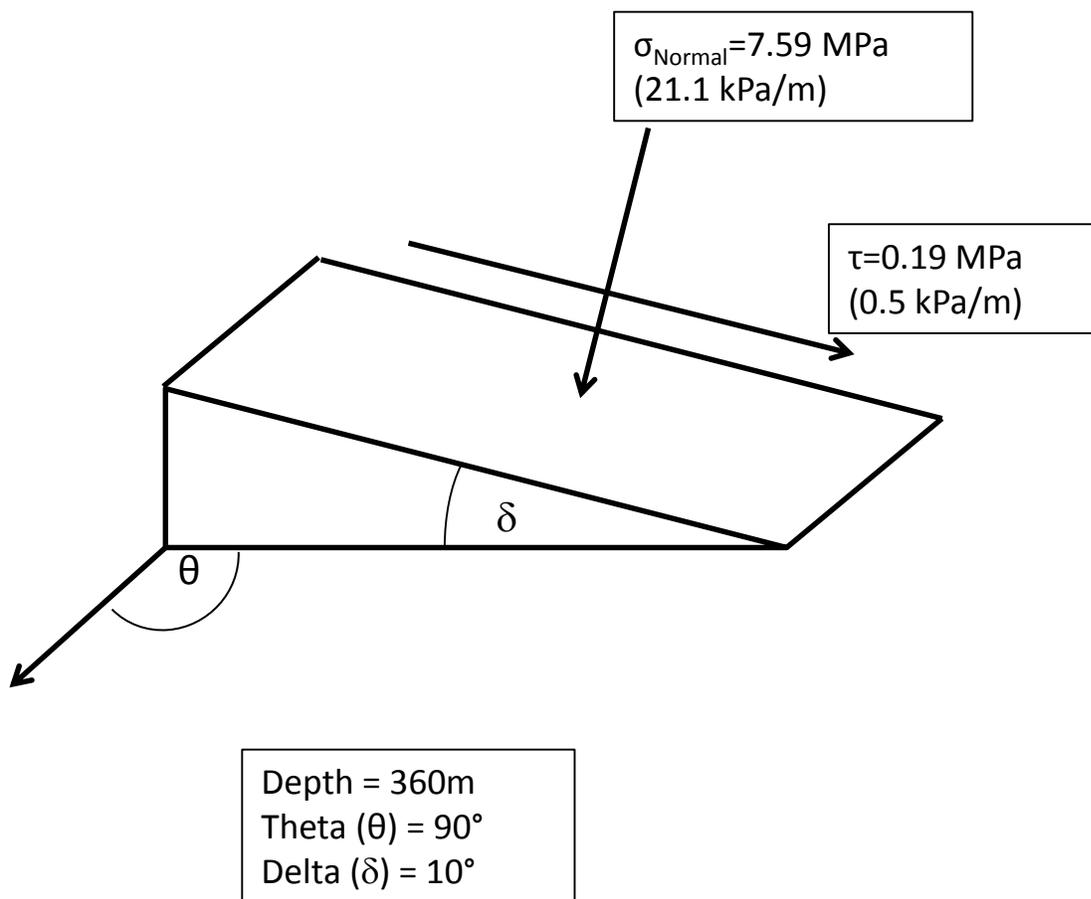
Figure 6-4 Example of stresses acting on a natural fracture with a 10 degree dip at a depth of 360 m

This hydraulically induced tensile failure of a natural fracture or fault can be illustrated in Figure 6-4 with an example of an element of rock from the Joli Fou Formation at a depth of 360 m using typical in-situ stresses from the data acquisition. In this example, a natural fracture is illustrated with a dip angle of 10 degrees and a strike parallel to the orientation of the maximum horizontal principal stress.

Brazilian tests of Joli Fou Formation samples have found tensile strengths of 160 – 200 kPa (TerraTek 2014, BitCan 2013). In the above example, the difference between the normal stress and the vertical stress is less than the tensile strength. As such, an induced horizontal hydraulic fracture may turn into this natural fracture due to tensile strength of the matrix providing greater resistance than the

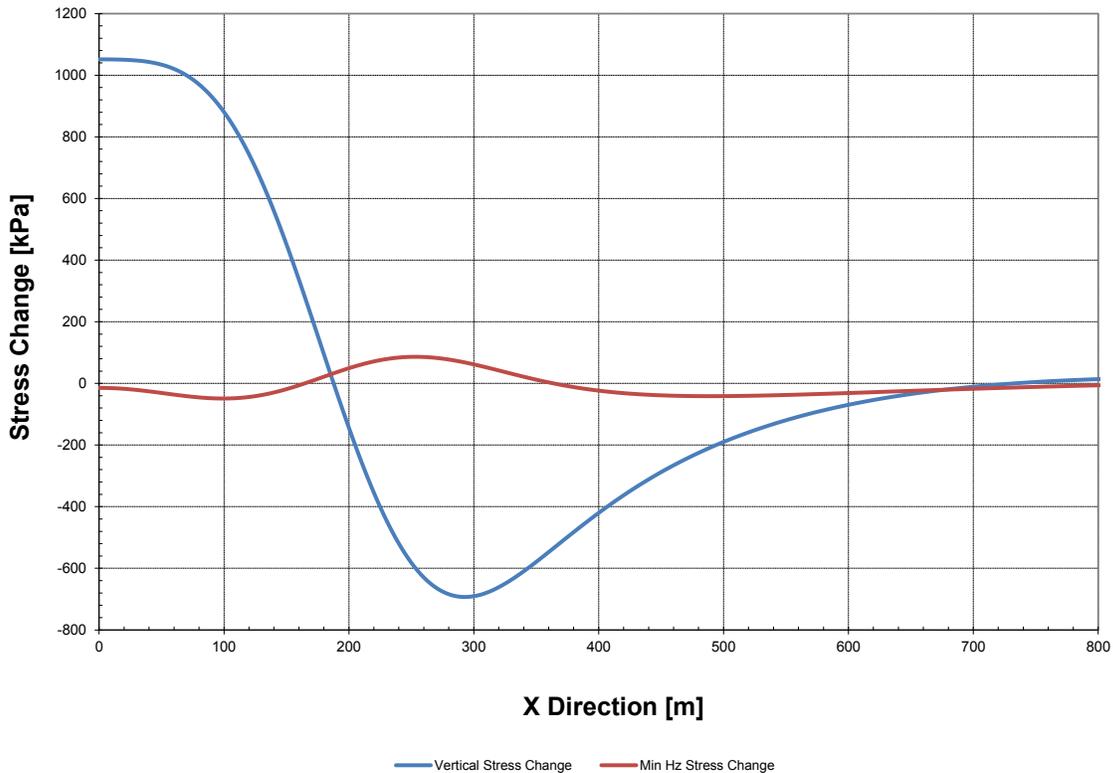
Figure 6-5 Example of total stress changes with distance away from the center of the Clearwater uplift profile at a depth of 360 m

At the depth of the base of the Joli-Fou (~360 m) and with the stresses assumed to be as in Figure 6-2, induced stress changes above a region of uplift were capable of making the vertical and minimum horizontal stresses converge if the Clearwater capping shale uplift was 0.6 m. Figure 6-5 illustrates the change in stress at the base of the Joli Fou Formation (360 m depth) under these conditions. One caveat is that more work needs to be done to confirm the relationship between uplift and the absolute magnitude increase in stress. The assumptions used are:

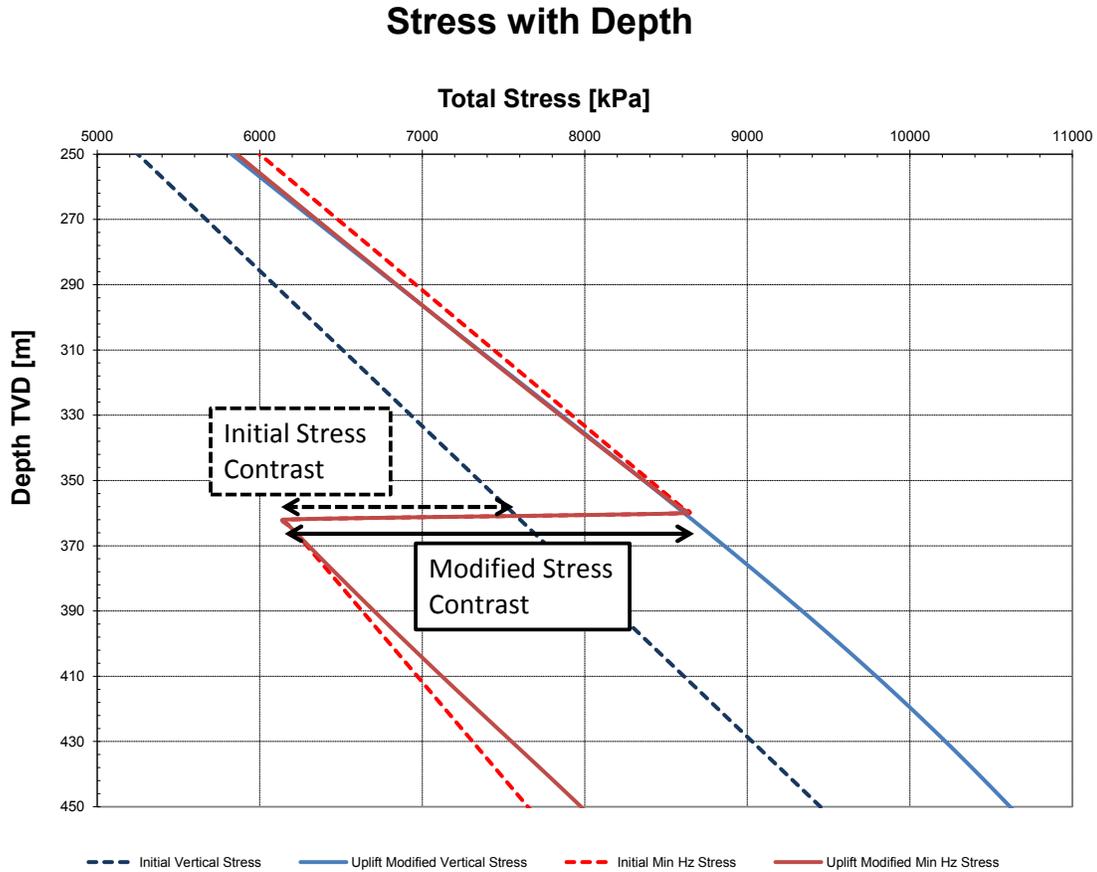
Figure 6-6 Example of calculated total stress changes with depth and effects of vertical stress approaching the minimum horizontal stress

Applying the results in Figure 6-5 on the stresses in Figure 6-2, the results are illustrated in Figure 6-6 where at a depth of 360 m, the initial vertical principal stress was 7.6 MPa and increased to 8.7 MPa (~24 kPa/m). The initial minimum horizontal principal stress was 8.7 MPa (~24 kPa/m) and decreased by 30 kPa. It is important to note that this convergence is dominated by the vertical stress increase and the horizontal stress change tends to be one order of magnitude lower within the Joli Fou Formation. Directly over the Clearwater reservoir uplift, the increased vertical stress at the base of the Joli Fou Formation results in a substantially increased minimum stress contrast between the Grand Rapids and Joli Fou Formations. In order to initiate hydraulically induced fracturing within the Joli Fou Formation in this example, the pressure requirement has increased by 1.1 MPa as shown in Figure 6-5.

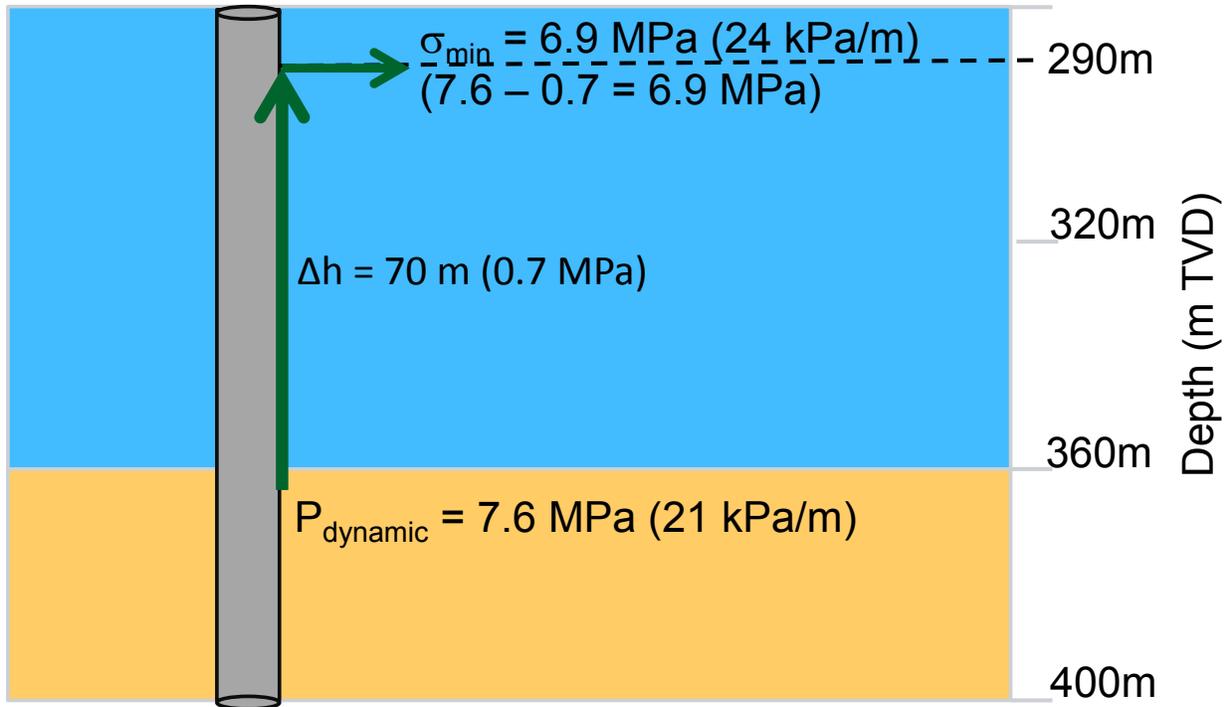
Figure 6-7 Example of pressures required for initiation of hydraulically induced fracturing in the Lower Colorado

The uplift induced stress changes increase the likelihood of a wellbore being involved due to the increased fracture pressure within the Joli Fou Formation above the Clearwater reservoir uplift. One example is shown in Figure 6-7 of a wellbore with inadequate hydraulic isolation illustrating a relatively low pressure to initiate and propagate hydraulic fracturing within the Colorado Group. A fluid gradient of 10 kPa/m and no frictional effects was assumed for the example below.

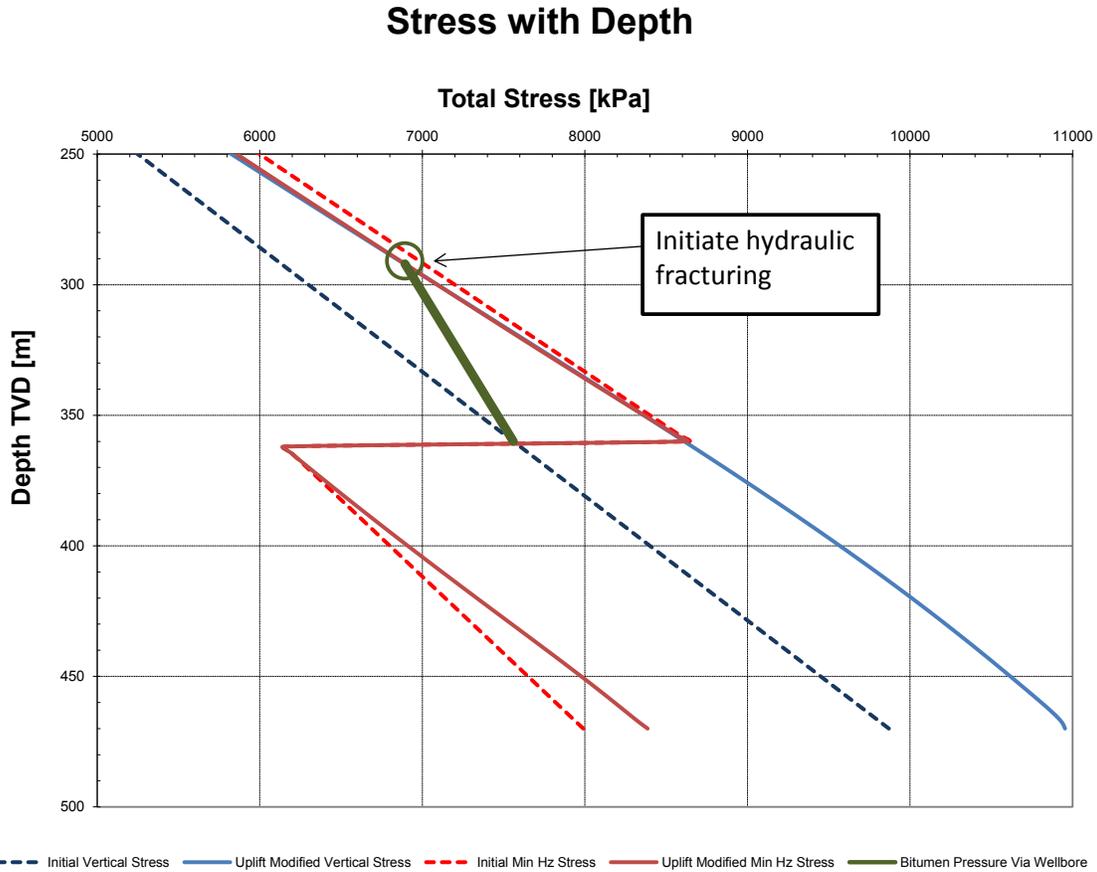
Figure 6-8 **Example of stress change with depth and pressure profile along a wellbore path intersecting the minimum stress**

Building upon Figure 6-6 an example pressure profile of bitumen emulsion flowing up a wellbore pathway is illustrated in Figure 6-8.

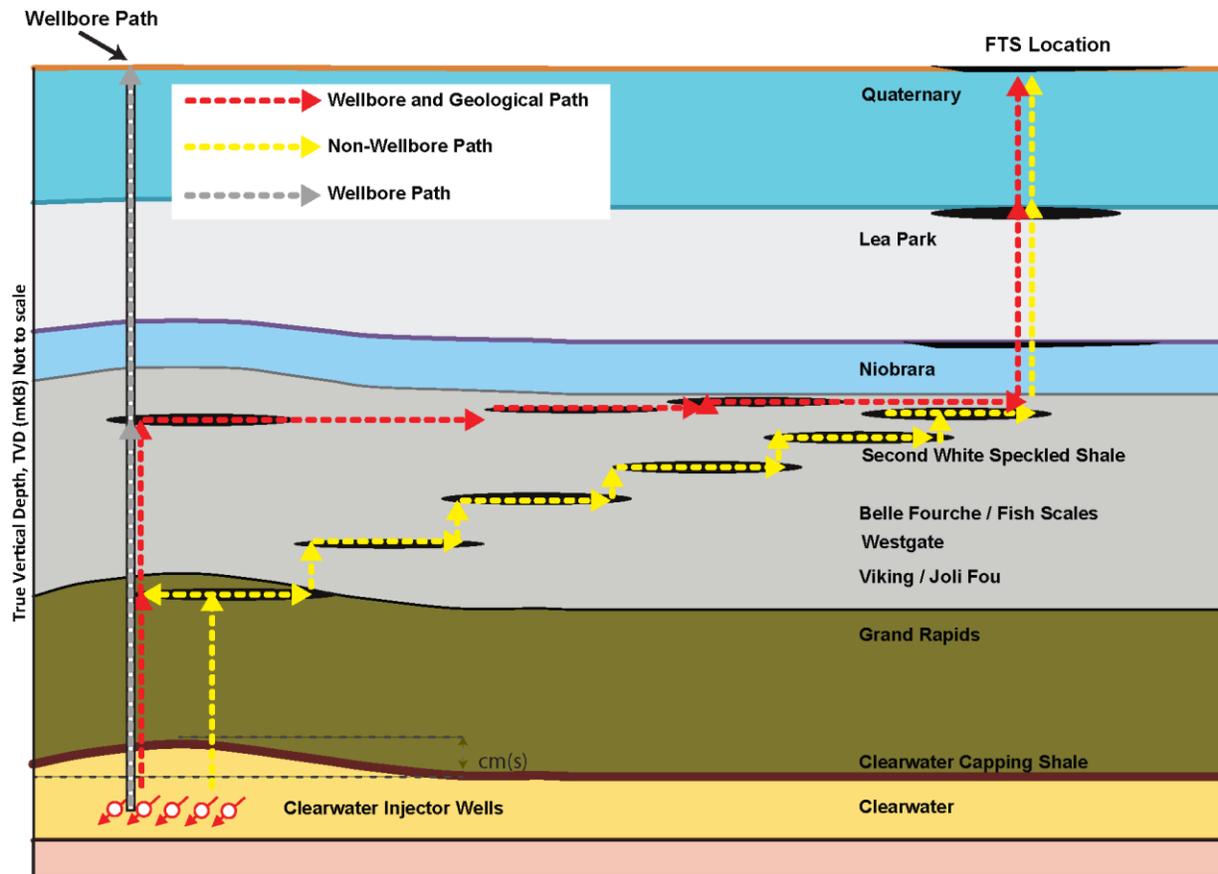
Figure 9-1 Conceptual Flow Path for FTS

As shown in Figure 9-1, the three potential paths to surface are:

Possible geomechanical enhanced conduits are induced features such as:

- Hydraulically induced fractures
- Hydraulically induced opening of natural fractures
- Hydraulically induced opening of faults
- Hydraulically induced opening of bedding plane

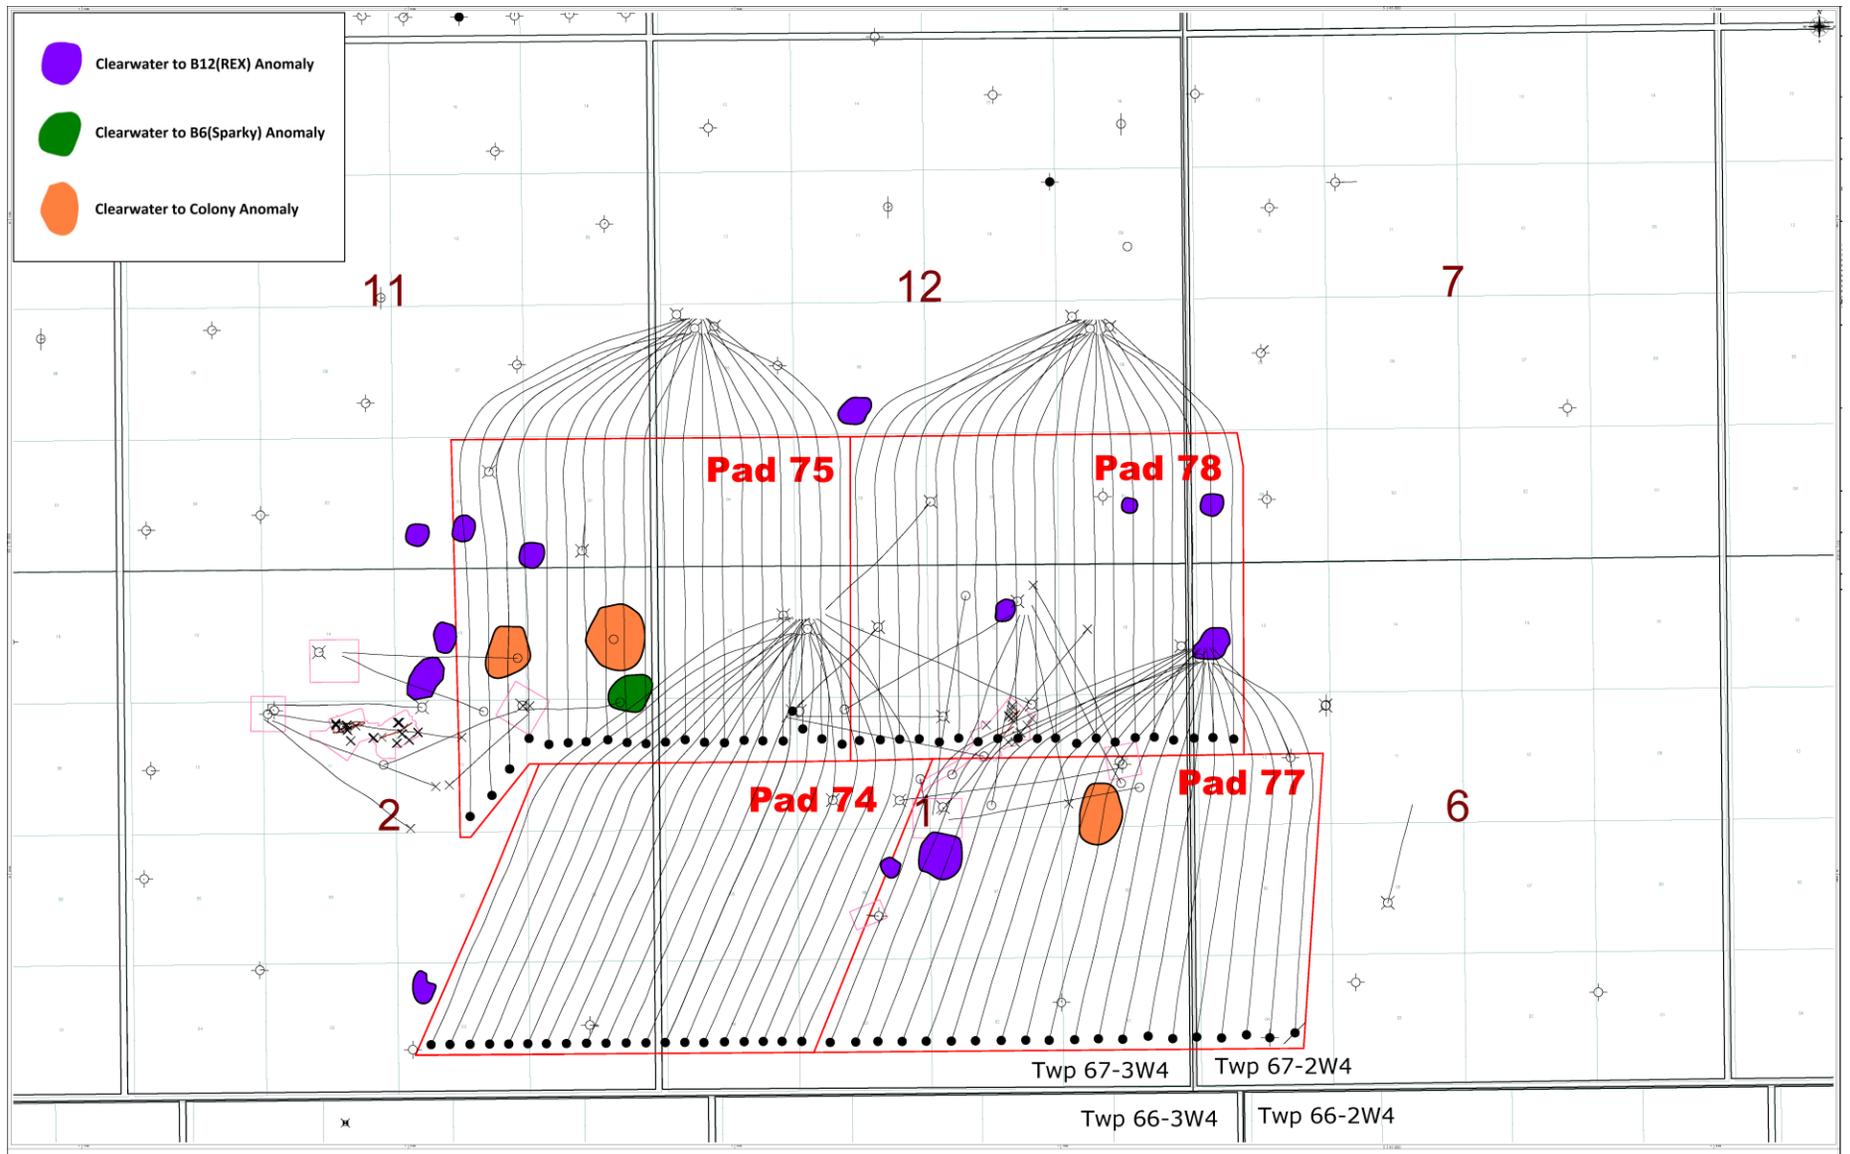
Figure 9-2 Simplified Grand Rapids Formation Post Steam Seismic Anomaly Location Map for PRE Area 1

Analysis of post-steam seismic anomalies within the Grand Rapids Formation, illustrates that flows of sufficient volume and duration, to reach the top of the Grand Rapids Formation are relatively uncommon. The Grand Rapids Formation post-steam seismic anomalies are shown in Figure 9-2 and Figure 9-3.

These seismic anomalies are characterized by highly localized often circular amplitude changes and push down effects observed in post steam seismic volumes. Modelling and drilling data suggests the seismic features are observed because of the presence of liberated solution gas from the bitumen, but pressure and temperature effects may also play a role. Mapping of these anomalies shows that most do not extend to the top of the Grand Rapids Formation.

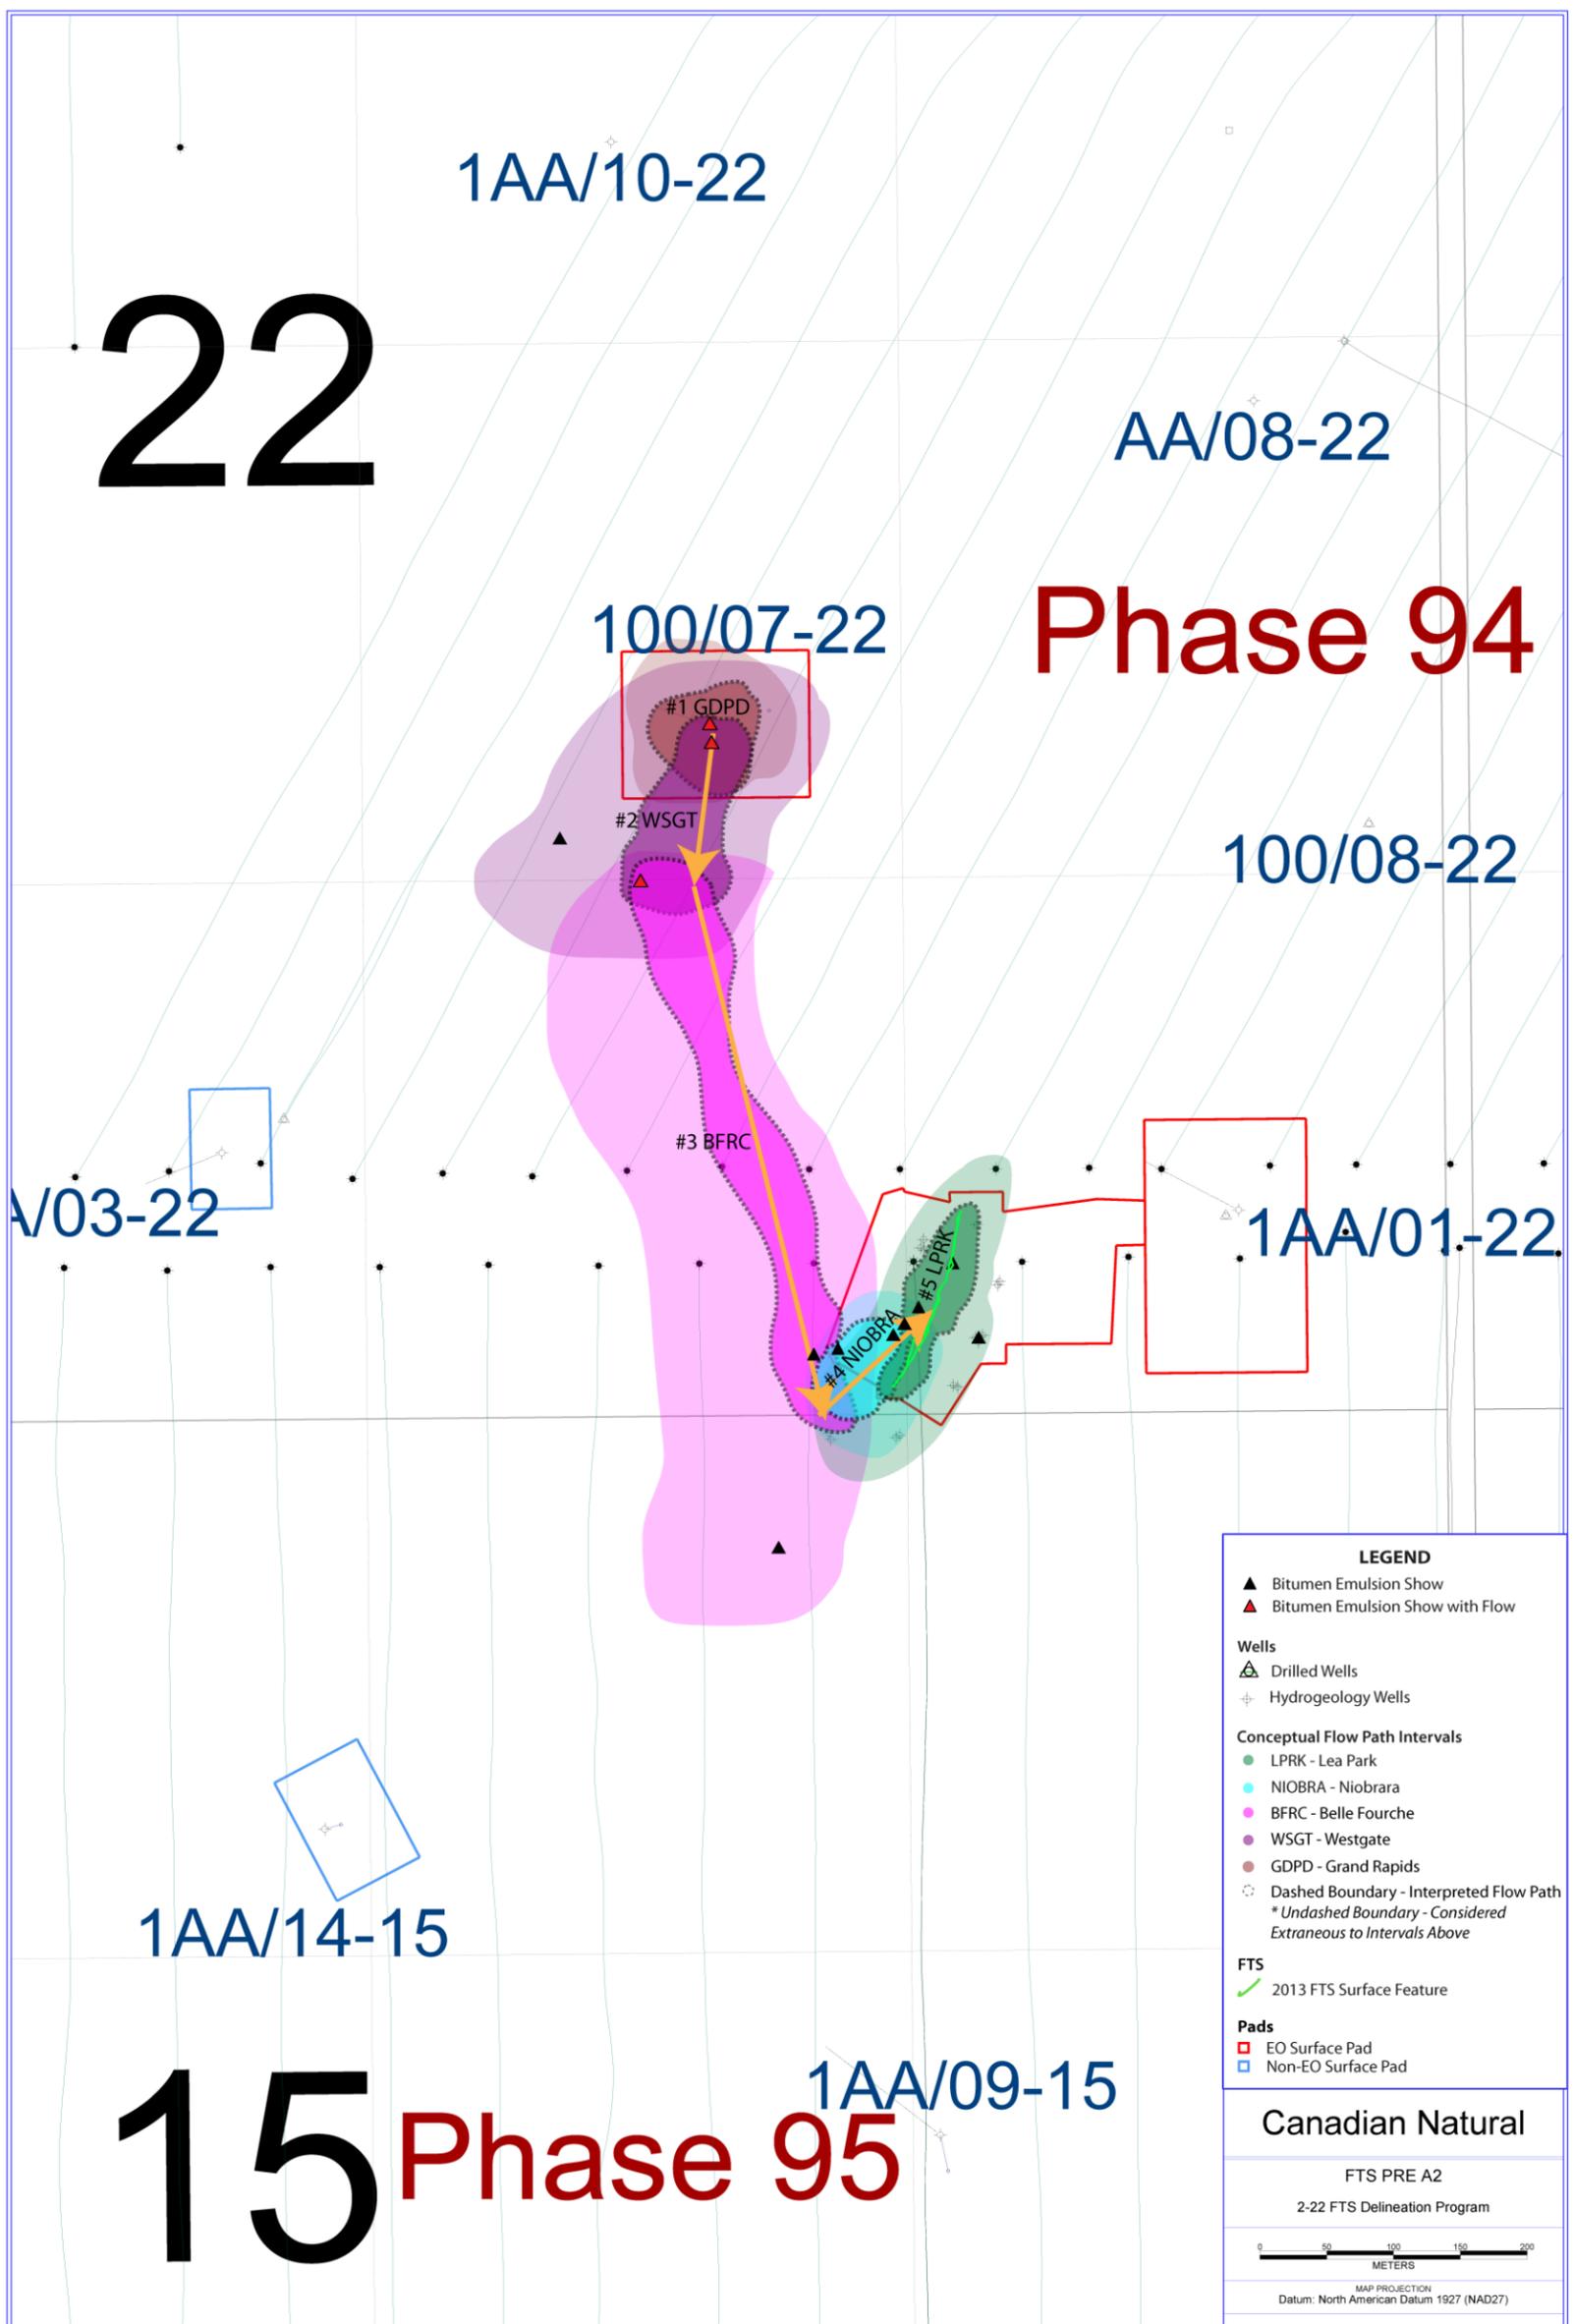
Figure 10-2 2-22 FTS – Conceptual Plan View of Bitumen Emulsion Shows

The study into the cause of bitumen emulsion being released from the Clearwater reservoir and flowing to surface at 2-22 in PRE A2 has generated the following pathway description (Figure 10-1 and Figure 10-2):

- An injectivity event was noted at the CNRL 16A94 PRIMROSE 2-22-67-3 and subsequent wells which are in close proximity to the DOME AEC 100/07-22-067-03W4 OSE wellbore

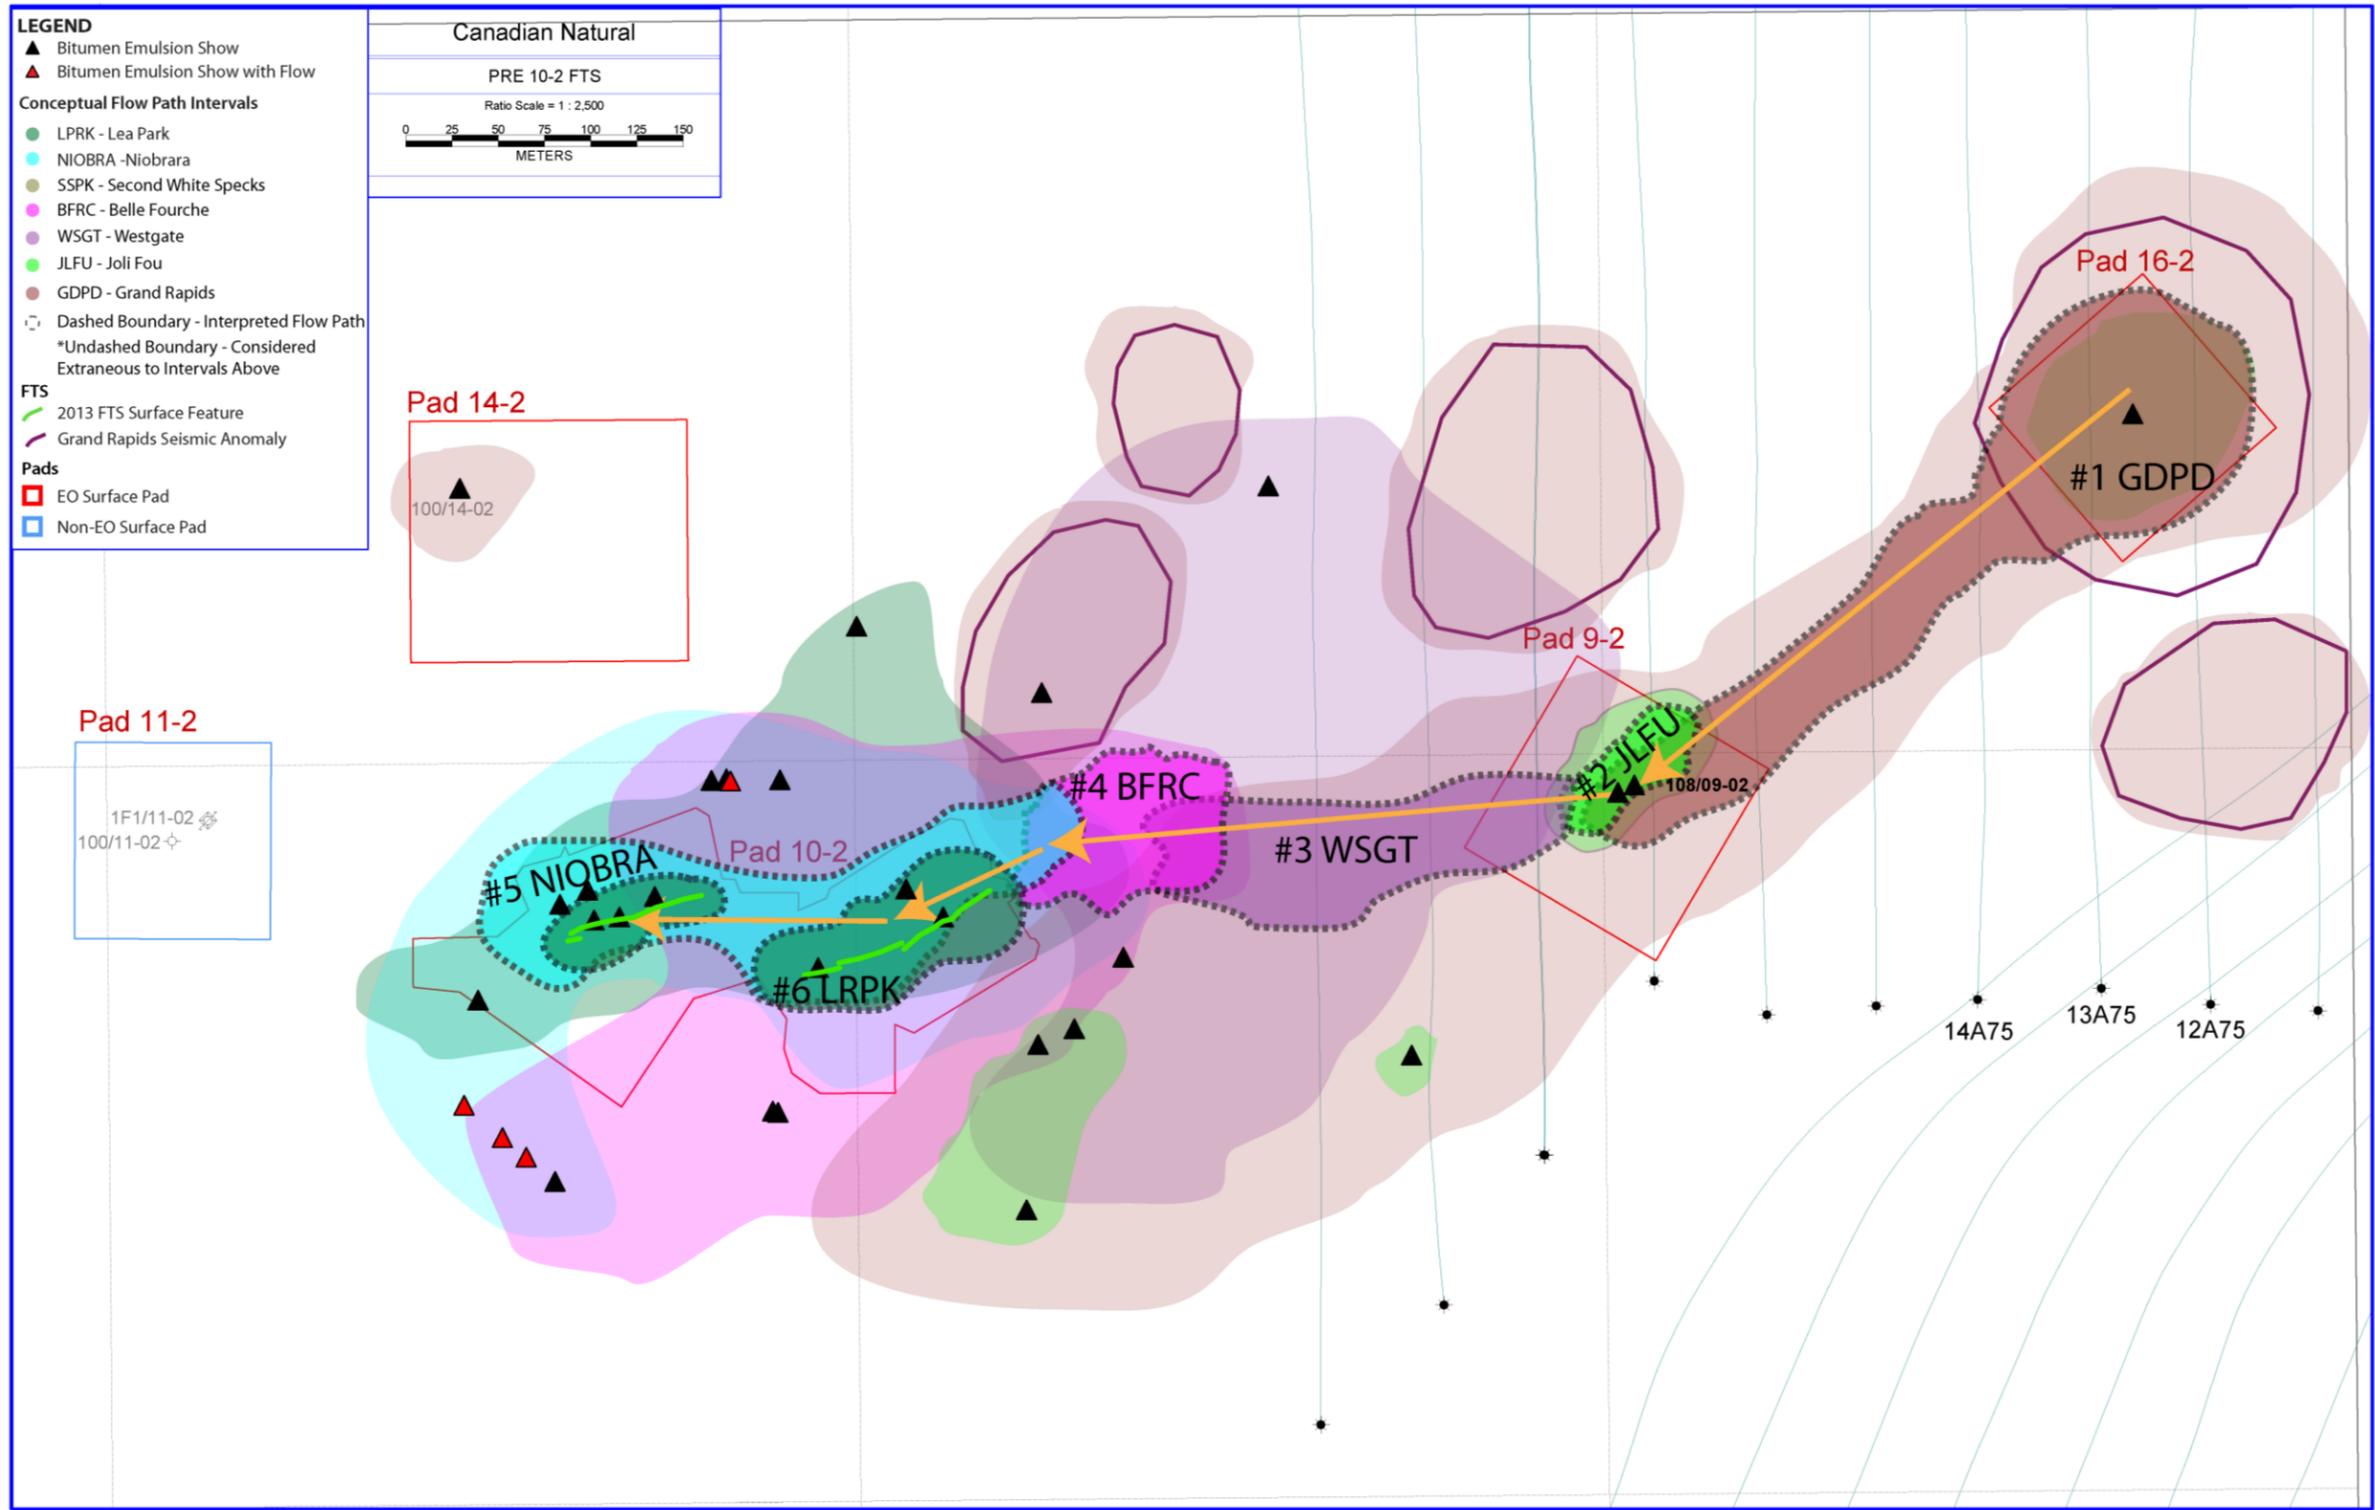
Figure 10-4 10-2 FTS – Conceptual Plan View of Bitumen Emulsion Shows

The study into the cause of bitumen emulsion being released from the Clearwater reservoir and flowing to surface at 10-2 in PRE A1 has generated the following pathway description (Figure 10-3 and Figure 10-4):
