Canadian Natural Resources Ltd. Primrose East Bitumen Emulsion Release January 3, 2009

ERCB Investigation Report

January 8, 2013

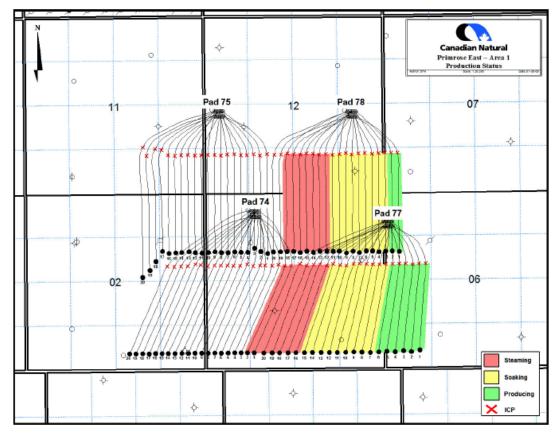
Figure 4. Primrose East well operation status on January 2, 2009

Primrose East began Cycle 1 steam injection at Pad 77 on August 29, 2008, and on September 25, 2008, steam injection began on Pad 78. By October 1, 2008, a seven-row steam wave had been established, and Cycle 1 production began on October 17, 2008. At the time of the bitumen emulsion release, 26 wells at Primrose East had completed their first steam injection cycle. The Primrose East well operation status on January 2, 2009, is shown in Figure 4.

At the time of the incident, Primrose East had passive seismic and thermal fibre monitoring wells on each pad to detect horizontal movement of fluid in the shales of the Colorado Group. Each HPCSS well was also monitored using a differential pressure alarm to detect well failures. While these systems were determined to be working correctly at the time of the failure, none detected the loss of containment.

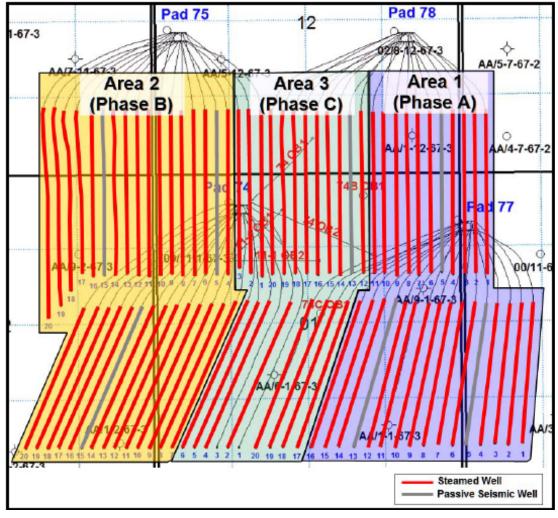
Figure 6. Primrose East diagnostic steam injection phases and areas

Diagnostic steam injection occurred between August 2009 and March 2010 in three phases and areas as shown in Figure 6.

During Phase A, the wells were steamed for about 30 days at an injection rate of $2000 \text{ m}^3/\text{day/well}$. The steam wave started at the 1A77 well and moved westward to the 15A77 and 11A78 wells. Due to the close interwell spacing (60 m), there was significant communication between wells, and leak-off made it difficult to reach fracture pressure.

The objective of Phase B was to acquire baseline heave response data, determine whether the vertical fractures would be contained within the Clearwater Formation, and change the minimum stress regime of the reservoir. Phase B involved two cycles of steam injection on those wells that had previously only been preconditioned with about 1000 m³ of steam per well.

In Phase C, steam injection occurred in four stages, beginning at 1000 m³/d in the first stage and increasing to 2000 m³/d by the fourth stage. During the first three stages, only two wells were steamed at any one time, increasing to six wells during the fourth stage. In the first three stages the wells were operated below fracture pressure. The fourth stage was operated at fracture pressure. The combined volume of steam injected during all four stages was less than that for other PAW wells.
