2019 Annual Summary Report on Casing Integrity

Submitted: March 11, 2020

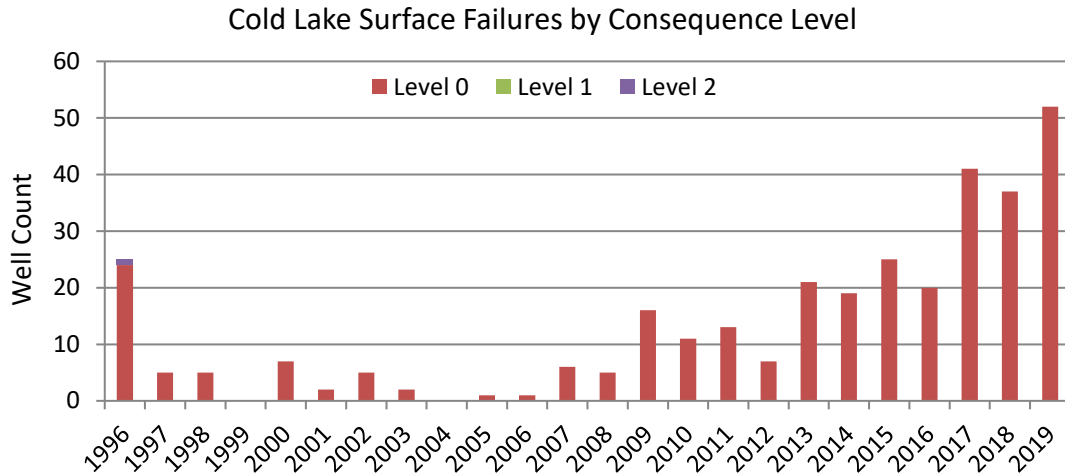
Historic consequence levels associated with near surface casing failures since 1996 are displayed in Figure 1. All near surface failures, except H01-03 in 1996, were assessed at a level 0 environmental consequence, including all 2019 failures.

Figure 1: Cold Lake Surface Failures by Consequence Level

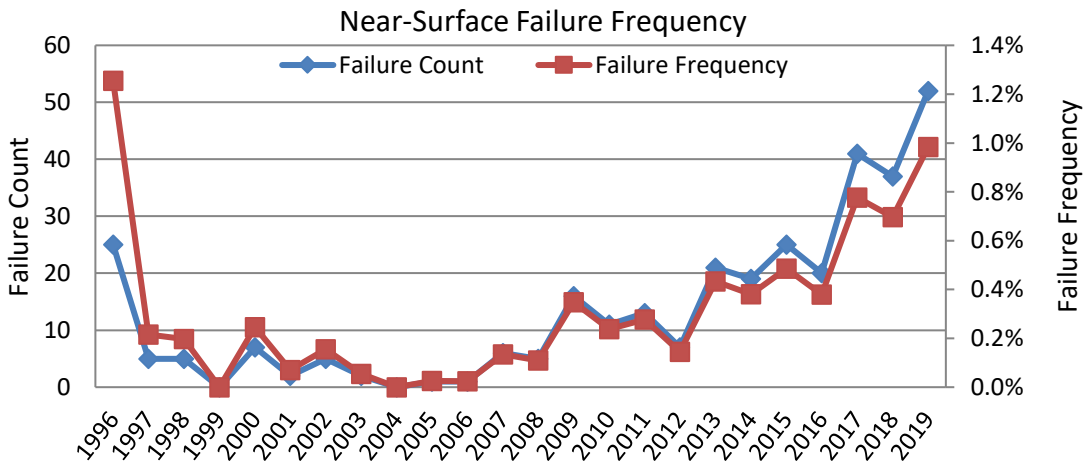
The number and frequency of near surface external corrosion related casing failures for the commercial casing design in Cold Lake are summarized below in Figure 2. The 2019 near surface casing failure frequency was 1.0%. Failure frequency is the number of failures divided by the total number of wells operating. The peak failure frequency of 1.26% (red line) observed in 1996 marks the inception of Imperial’s casing integrity operating practices. At that time, the bentonite top-up program was developed to reduce corrosion and subsequent improvement was observed with reduction of corrosion at the primary cement top depths. Failure frequency has increased in the 2013-2019 period. This increase is a result of the aging well population, with many low pressure operating wells now at 25+ years-of-service. With a decrease of corrosion at the original primary cement top, the corrosion cell has moved very close to surface (within 1 meter of final grade).

Figure 2: Commercial Near-Surface Failures and Failure Frequency

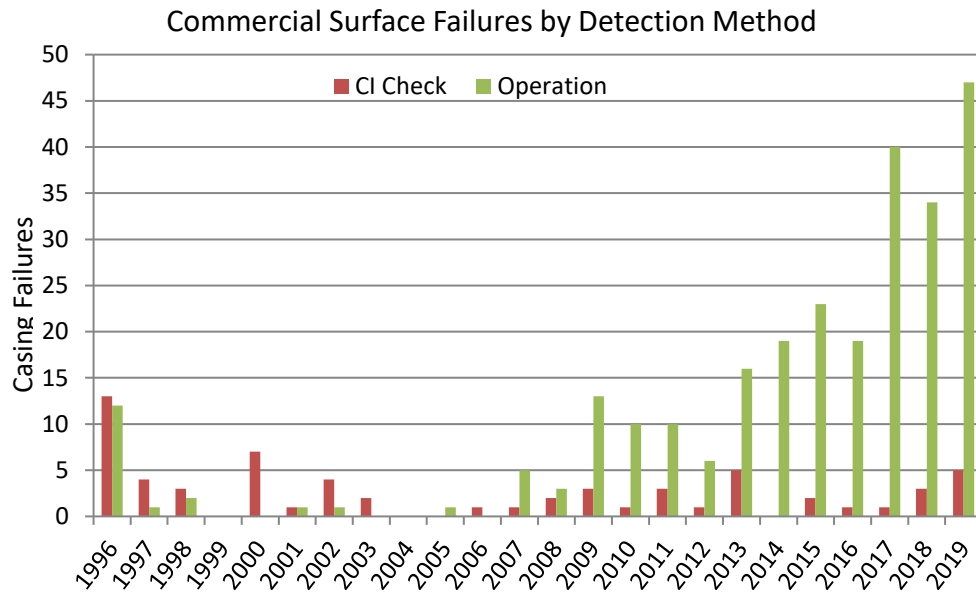
In 2019, 47 of the near-surface casing failure events were found operationally via visual inspection. The remaining 5 were detected during rig work on isolated wellbores; 2 failures were identified during regulatory pressure testing, 1 failure was detected during a routine zonal abandonment and 2 failures were detected during casing integrity checks. The historical detection trends are shown in Figure 3 below.

Figure 3: Commercial Surface Failures by Detection Method

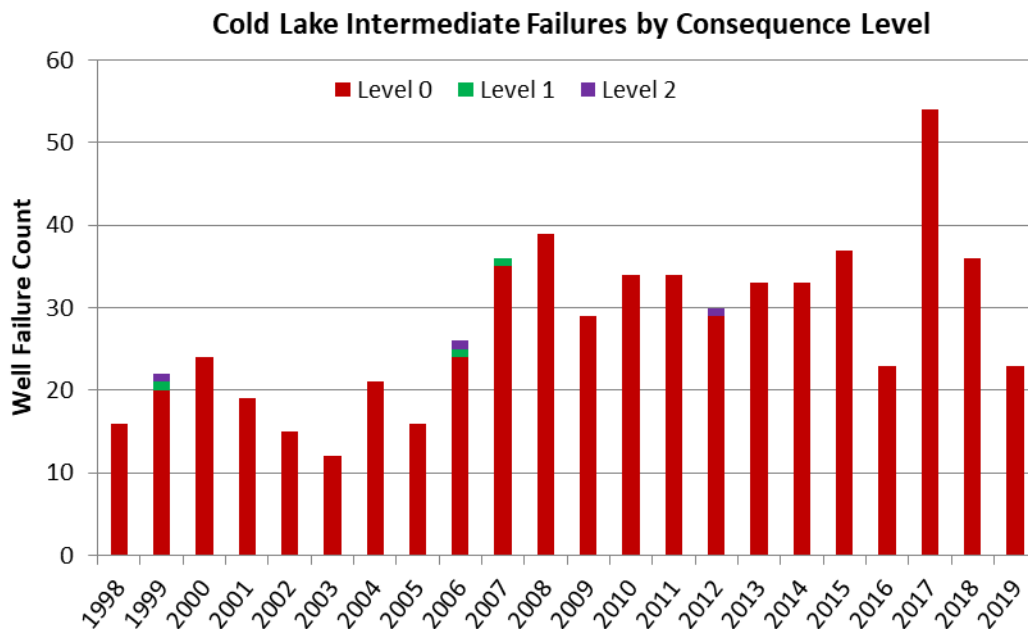
Historic environmental consequence levels associated with intermediate casing failures since 1998 are displayed in Figure 4. In 2019, there were no intermediate casing failure events that were classified higher than a Level 0 Environmental Consequence event (no events resulted in adverse environmental consequences). Three historical intermediate failures have required aquifer remediation (H15-10 in 1999, H39-H04 in 2006, and V13-31 in 2012).

Figure 4: Cold Lake Intermediate Failures by Consequence Level

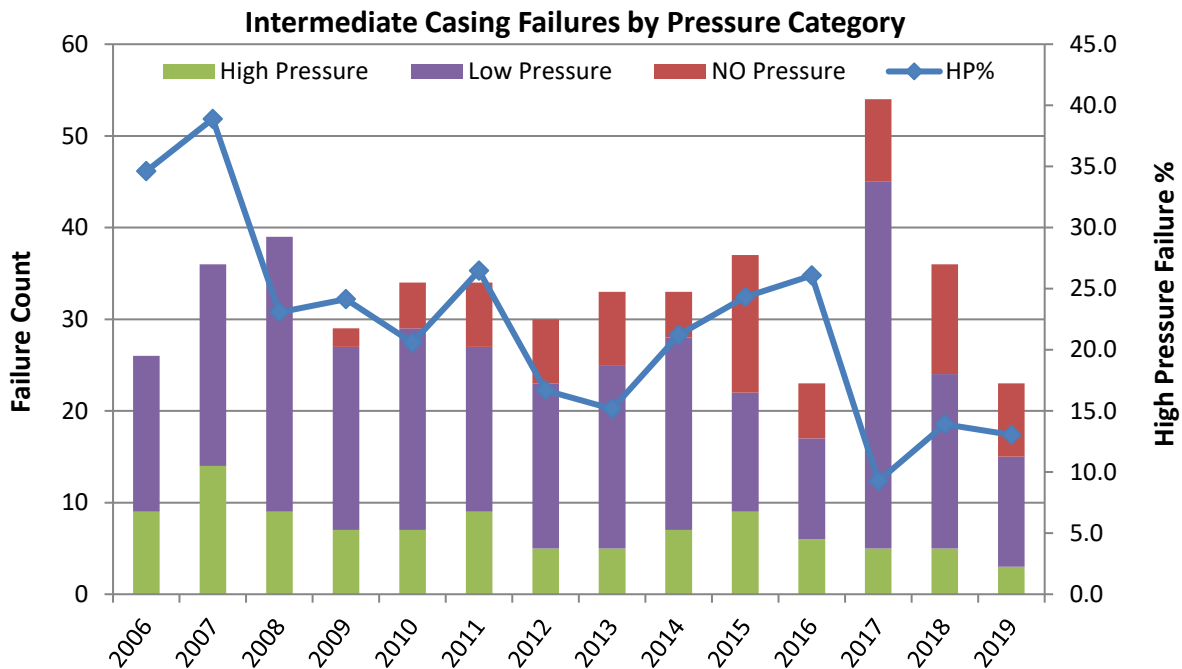
Many enhancements to Imperial’s casing integrity processes and detection systems, as discussed in section 3.0, have led to a reduction in the rate of higher potential consequence events since 2007, as shown in Figure 5. In 2019 there were 3 high pressure failures, or 13% of the total intermediate failures.

In 2019, there were 8 wells with intermediate failures located on already suspended/zonally abandoned wells or on 'No Pressure' (e.g. well suspended, or during pressure tests while rig on well) with no potential for liquid loss (34.7% of total). If these 'No Pressure' failures are excluded, there were a total of 15 wells with failures on 'Low Pressure' and 'High Pressure' active wells. The green bars show that this is the historic low for high pressure failures over the last 14 years.

Figure 5: Intermediate Casing Failures by Pressure Category

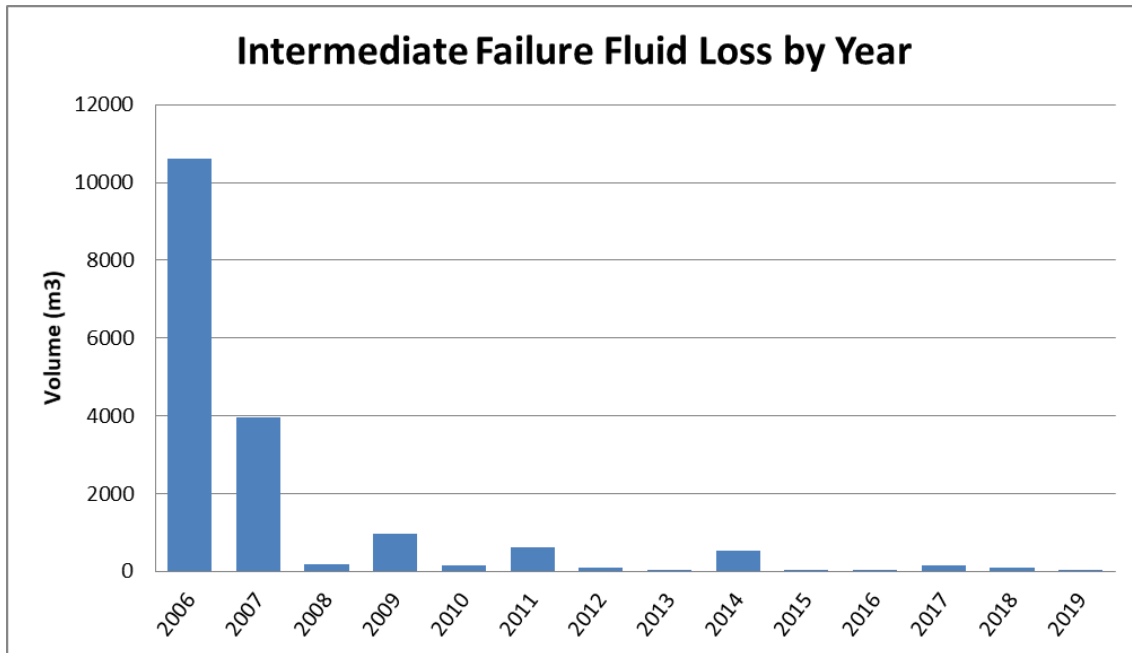
In 2019, there were no casing failures with subsurface liquid losses that could have had an adverse impact on the integrity of adjacent wellbores, and there were no adverse environmental impacts. The total volume of subsurface liquid loss in 2019 was 2.0 m3, as shown in Figure 6.

Figure 6: Intermediate Depth (Subsurface) Failure Liquid Loss by Year

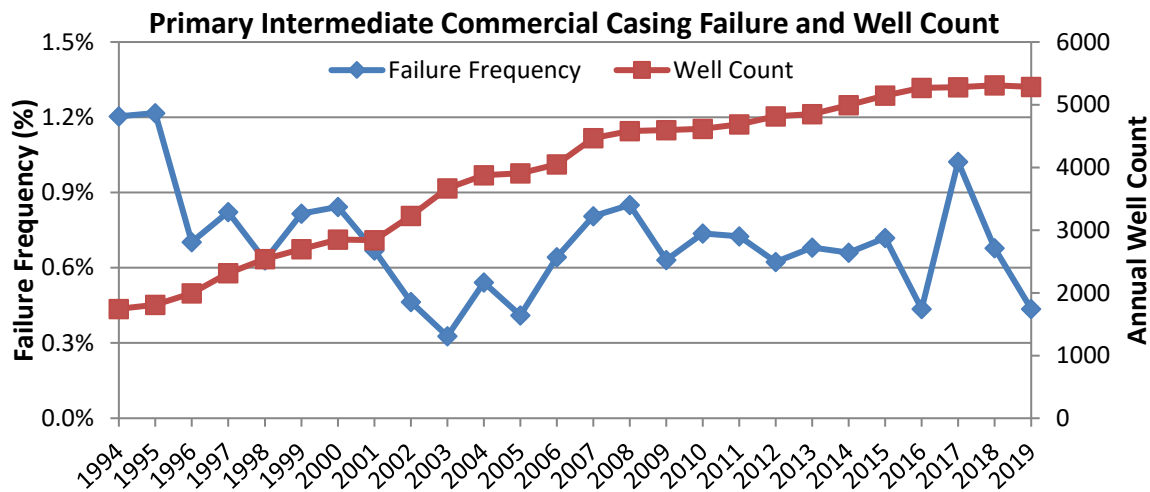
The primary intermediate casing failure frequency for commercial casing design and total Cold Lake district well count are presented in Figure 7. Intermediate casing failure frequency for 2019 was 0.4%. Variations from year to year can be attributed to aging wellbores and is also driven by the steam schedule, which can increase/decrease failure rates based on the number of pre-steam checks required each year and numbers of wells steaming.

Figure 7: Intermediate Casing Failure and Well Count

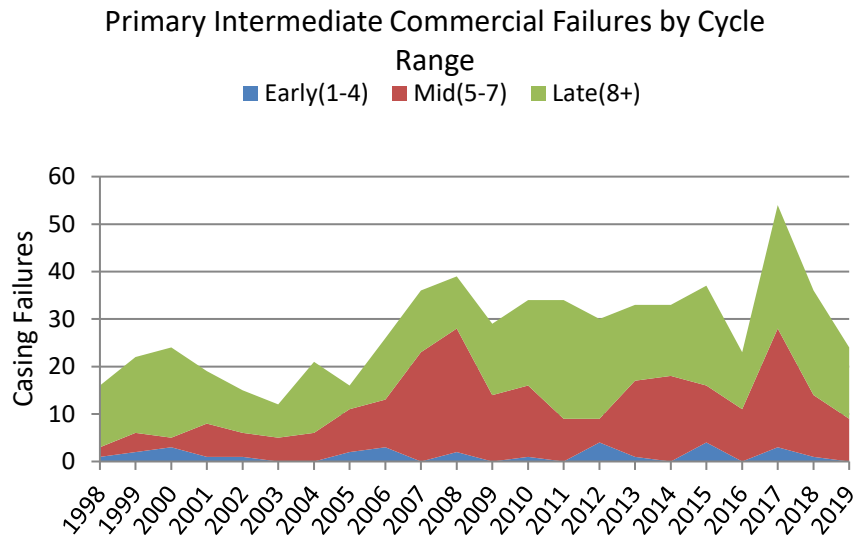
In Figure 8, the number of primary intermediate casing failures for Cold Lake commercial casing design wells are stacked by early (1-4), mid (5-7), and late (8+) cycle periods. Early cycle failures continue to be lower than mid and late cycle failures.

For mid-cycle failures, 62.5% were found through Passive Seismic (5/8), 37.5% were found through Casing Integrity Checks (3/8)

For late-cycle failures, 20% were identified through Passive Seismic (3/15), 67% were found through Casing Integrity Checks (10/15), and 13% were found through regulatory pressure testing (2/15).

Figure 8: Intermediate Failures by Cycle Range

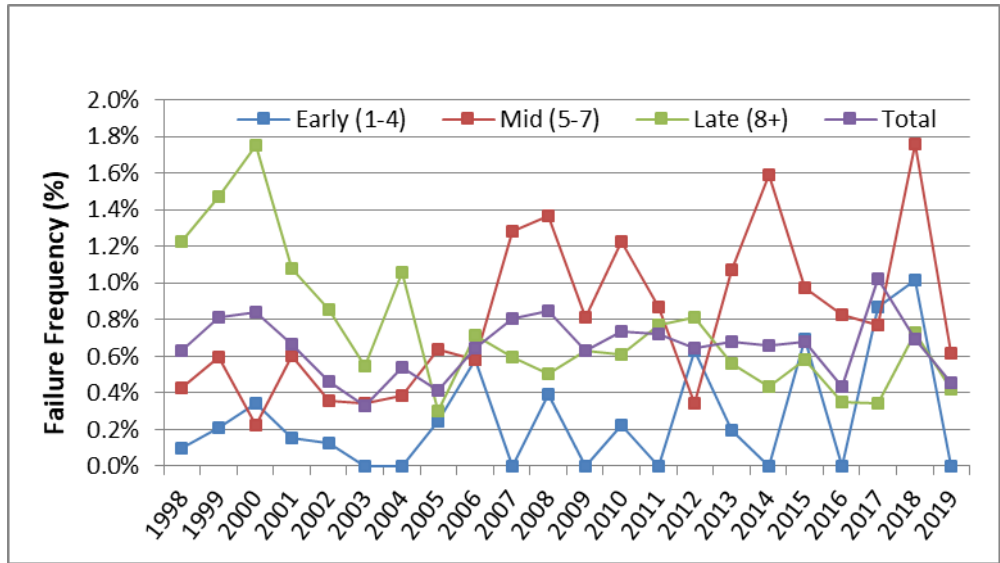
Figure 9 shows intermediate failure frequencies for commercial casing design wells, which are again divided into early (1-4), mid (5-7), and late (8+) cycle classifications. The failure frequency is calculated by dividing the number of failures in a cycle classification by the total number of wells in that classification. Early cycle failure frequency is typically driven by unique wells or rare events. Mid cycle failure frequency steadily increased between 2004 and 2008, due primarily to failures at Mahkeses. Similar increases have occurred from 2012-2018 as Mahihkan North pads have become mid cycle. The number of mid cycle failures has fluctuated annually, dependent on how many pads are moving through this period when casing failures generally start to be observed. The late cycle failure frequency trend has stayed fairly consistent for the past several years. The total number of wells in each of the three cycle classifications is distributed as follows:

- Early (1-4) – 276 wells
- Mid (5-7) – 1452 wells
- Late (8+) – 3557 wells
- Total – 5285 wells

Figure 9: Intermediate Failure Frequency by Cycle Range

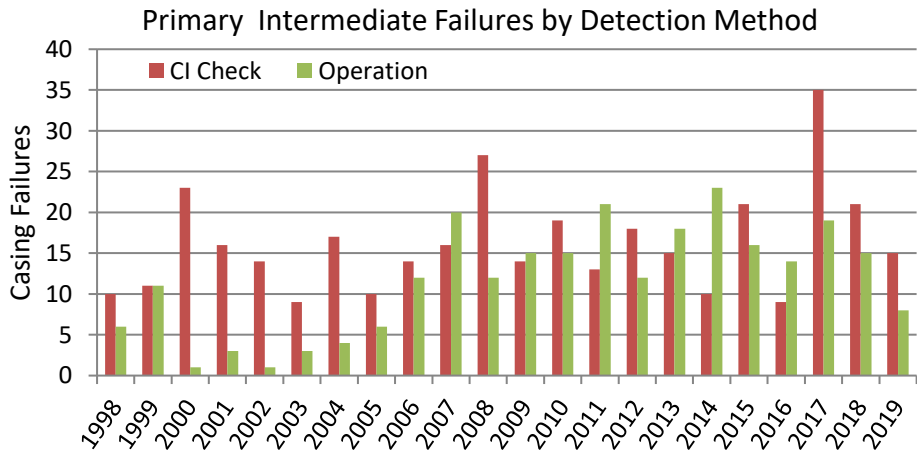
The intermediate failure detection method is displayed in Figure 10. Approximately 58% of intermediate casing failures are identified during rig based casing integrity checks since 1998. The percentage of operationally identified casing failures has generally increased since 2002, mainly due to increased detection capabilities and enhancements through the passive seismic and nitrogen soak monitoring programs. 8 failures were detected by operational monitoring systems in 2019.

15 failures were detected by casing integrity checks in 2019. 5 occurred on wells that were already isolated from the Clearwater reservoir (i.e. rig based D013 5-year pressure tests on suspended wells or during other wellwork activities on prior suspended/abandoned wells).

Figure 10: Primary Intermediate Failures by Detection Method

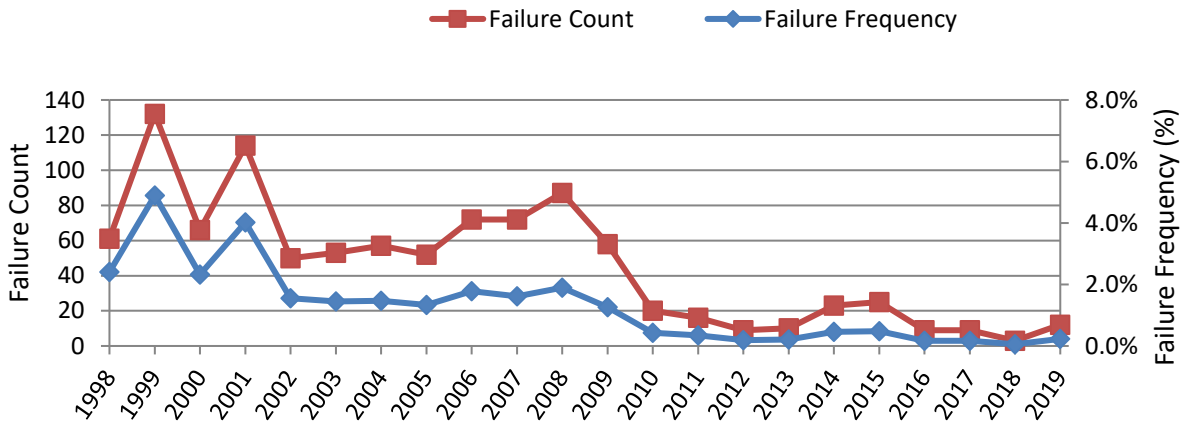
The number and frequency of Clearwater casing failures for the commercial casing design in Cold Lake since 1998 are presented in Figure 11. Clearwater failure performance has stayed in a similar range since 2010, which represents a step change reduction from earlier Clearwater failure rates. The reduced failure frequency is likely attributed to a larger portion of the field moving to low pressure operations, an increase in horizontal well development, and enhanced intermediate depth shear stress management having a collective effect on Clearwater top formation movement.

Figure 11: Clearwater Failures and Failure Frequency

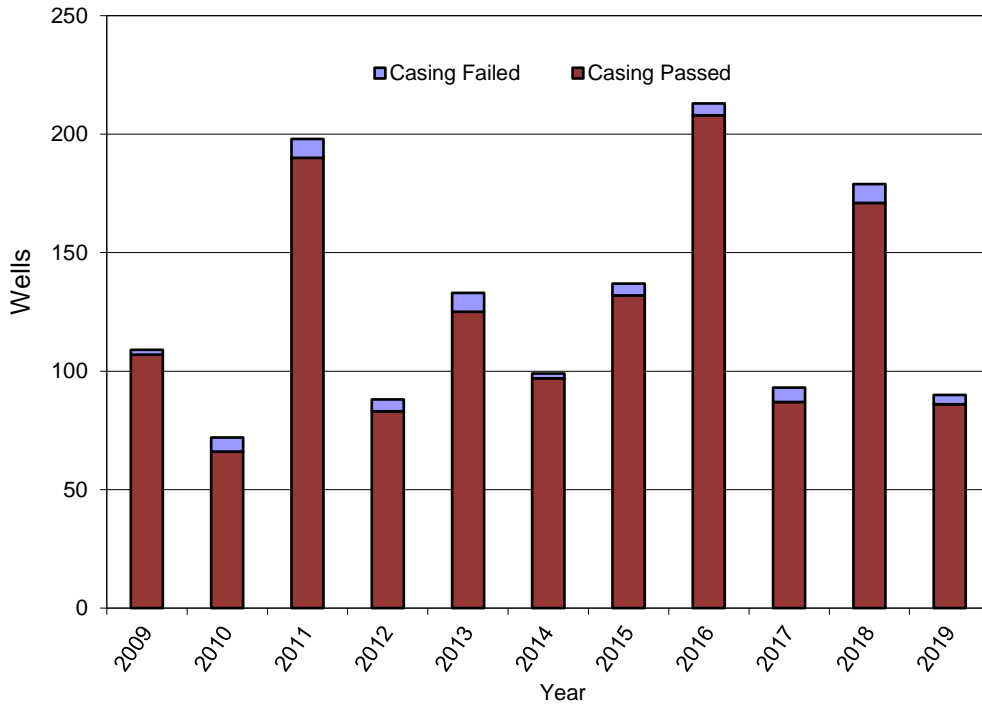
The table in Figure 12 displays the results of regulatory D013 5-Year pressure tests on suspended wells. In 2019, 91 wells required pressure tests and integrity of the suspension plug was confirmed on 90 wells. One well (E07-18) had a small pressure bleed off thru the suspension plug and required remedial work on the isolation. An additional nine wellbores on E07 pad had unsuccessful pressure tests and are undergoing additional diagnostics and remediation to ensure isolation in early 2020.

New intermediate and surface depth failures found during the 5-Year pressure test are noted in the columns in Figure 12. These are called 'No Pressure' failures since the suspension plugs were isolating the Clearwater perforations from the upper wellbore, and therefore there are no consequences. These failures are also included in the report sections above.

Figure 12: Suspended Well Five Year Pressure Test Performance

In three wells (D09-08, H04-06 and H68-22) new intermediate casing failures were discovered above the top of the isolation plug. In an additional well (A03-10), a near surface casing failure was discovered.

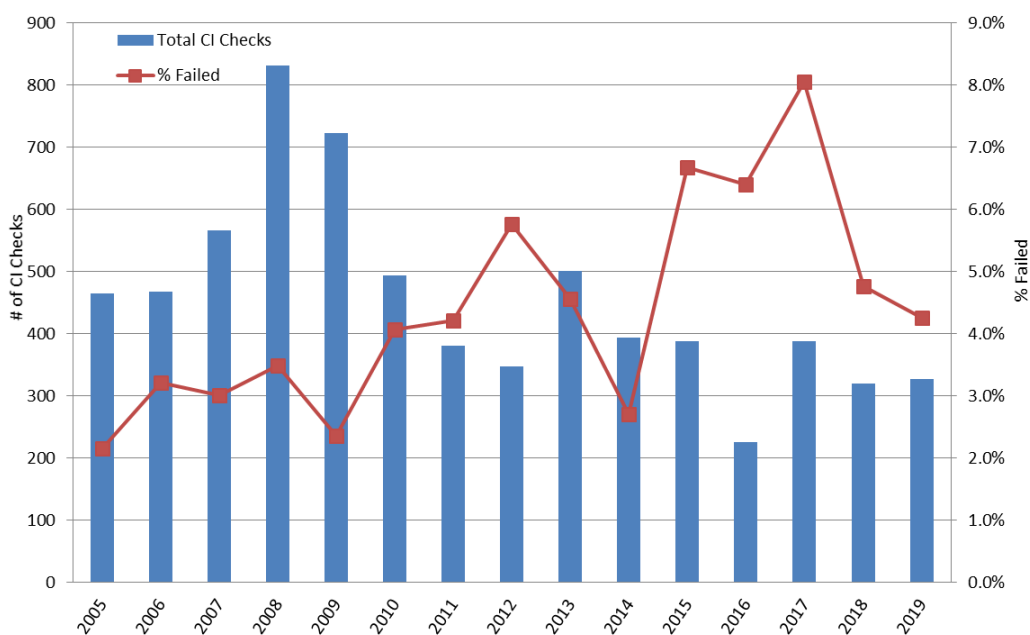
The total well count in Cold Lake has increased over time and the frequency of casing integrity checks increases over time with a given pad's cycle number. However, the continuously changing mix of early, mid, and late cycle wells and the variety of depletion methods (e.g. high pressure CSS, low pressure CSS, steamflood) will cause fluctuations in the total number of casing integrity checks each year. Figure 13 shows the number of casing integrity checks performed each year since 2005. The numbers from 2013 forward include Schlumberger wireline EM scan log checks. The percentage of casing integrity checks that initially found near surface or intermediate depth failures is also plotted in Figure 13. The peak number of integrity checks from 2007 to 2009 were primarily due to numerous Mahkeses wells reaching their first round of casing integrity checks and the 2007 increase in casing integrity check frequency. Since those peak years the total number of casing integrity checks have generally been decreasing due to a higher number of early cycle wells being steamed, an increasing percentage of multi-bottom hole location horizontal wells per pad, an increase of injector-only infill wells, and an increase in low pressure steam flood operations. In 2019 there were a total of 327 CI checks completed (282 rig based and 45 EM Scan checks), with 12 intermediate depth failures identified during these casing integrity checks (not including regulatory pressure testing). The percentage of CI checks which identify a casing failure has generally increased over time, since the targeted selection practice identifies wells with a higher probability of a failure. The increase is also attributed to aging wellbores.

Figure 13: Casing Integrity Check History
