# 阳光油砂 SUNSHINE OILSANDS LTD.

# WEST ELLS SAGD

#### Scheme No. 11764G 2022 In Situ Performance Presentation June 30, 2023

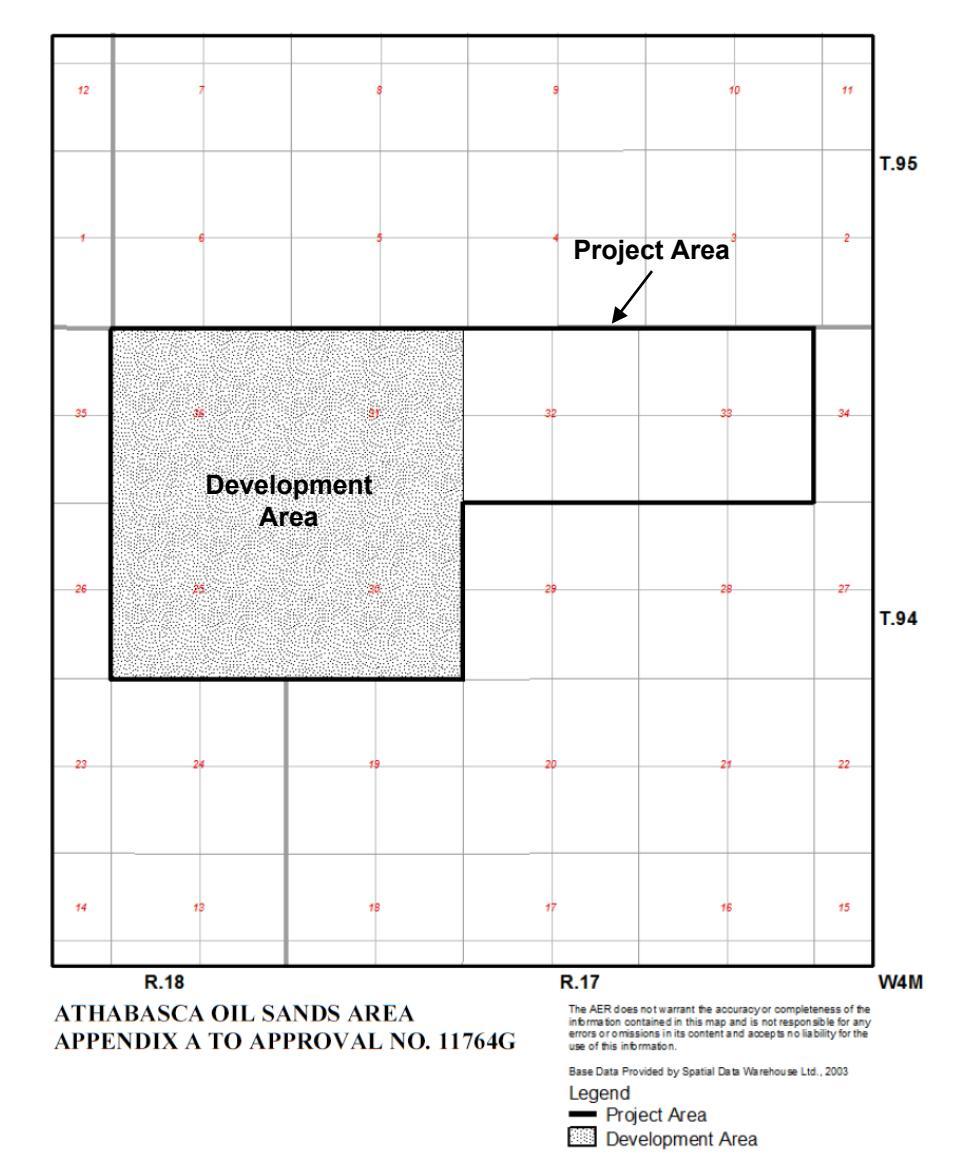
## **Development and Project Area**

Area	Land Description
Development Area (4 sections)	T94 R17W4; Sec 30, 31 T94 R18W4; Sec 25, 36
Project Area (6 sections)	T94 R17W4; Sec 30, 31, 32, 33 T94 R18W4; Sec 25, 36

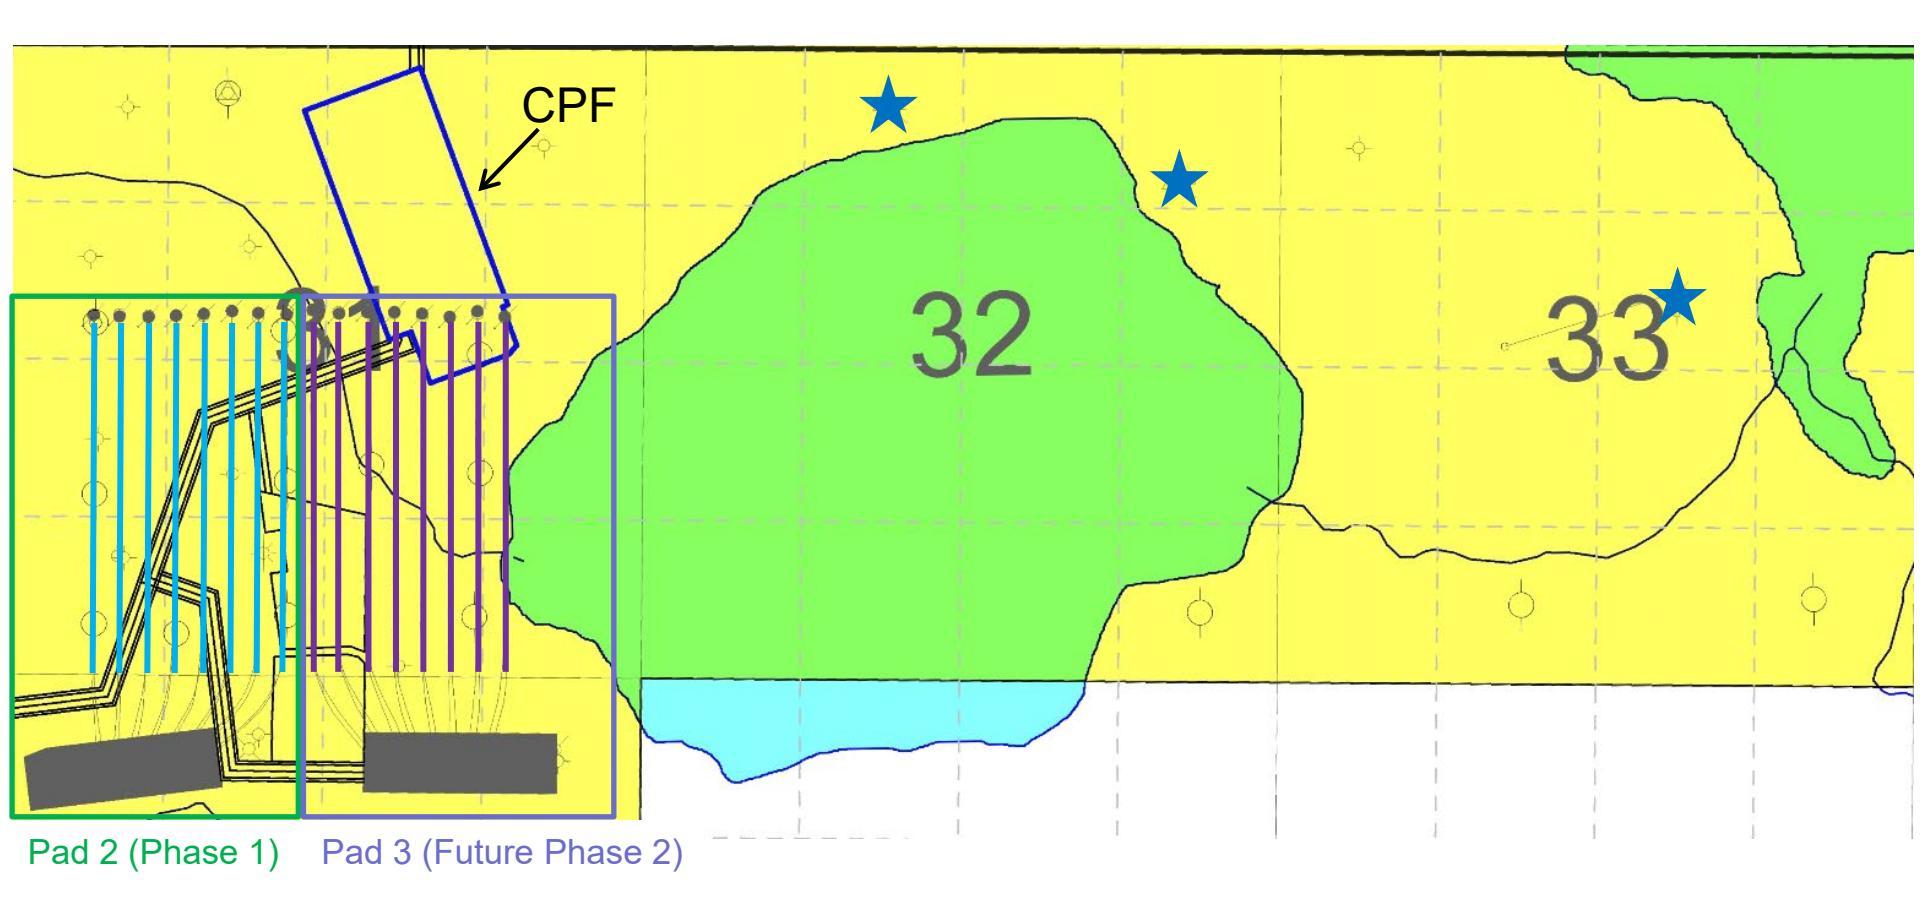
SAGD Well Pair – Drilled & Completed

SAGD Well Pair – Drilled, liners installed, pump and instrumentation install not complete.

Source Water Well – Drilled & Completed

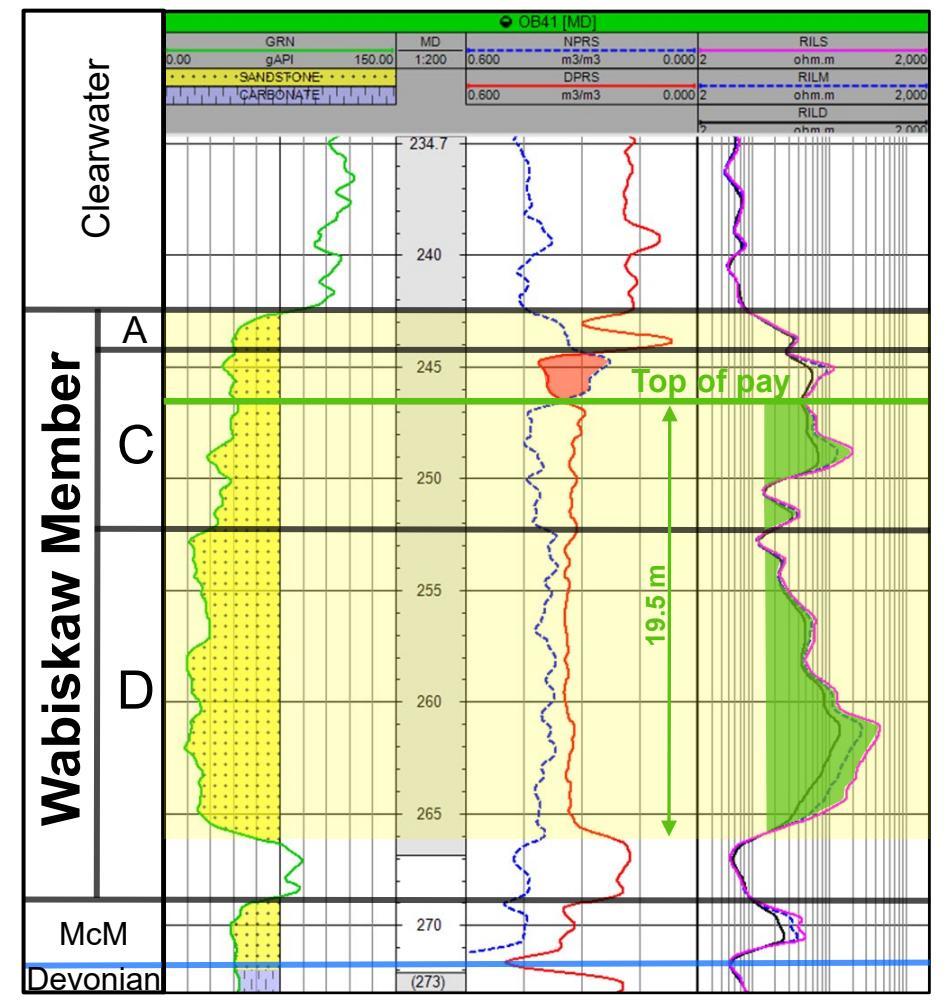
#### Type Well – OB41 (102/06-31-094-17W4)

The SAGD wells are located at the base of the Wabiskaw D sand unit

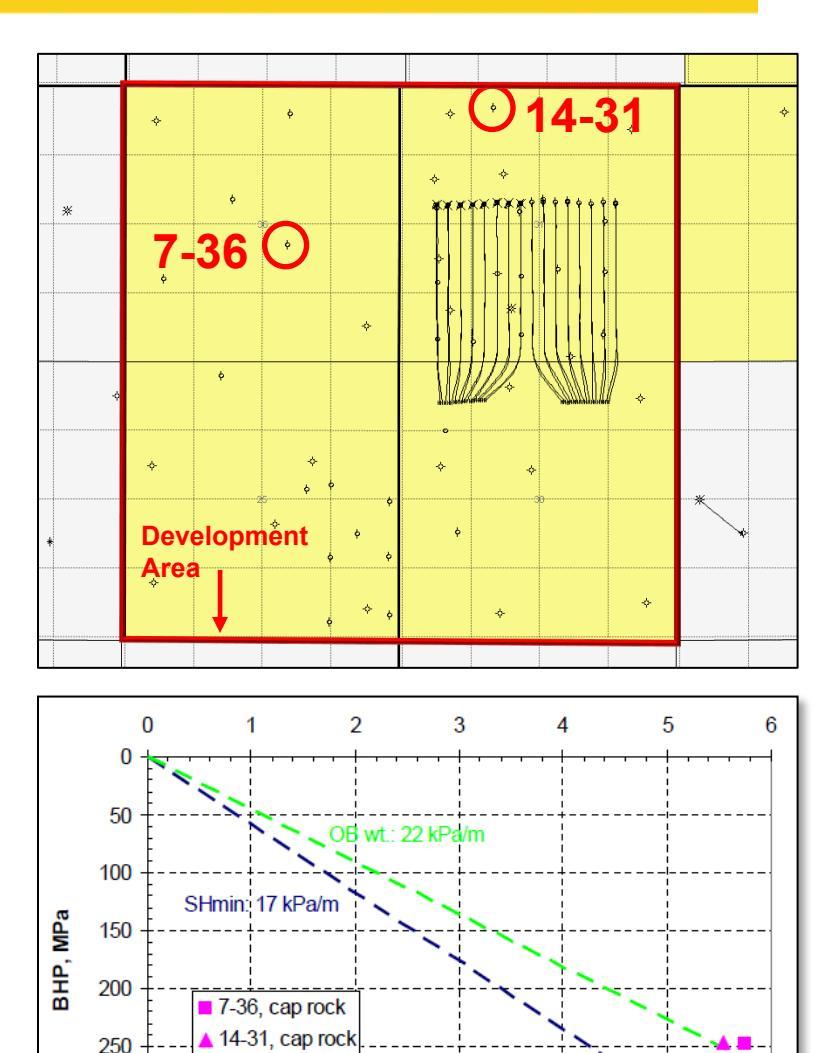
- No geo-mechanical anomalies reported in 2022 as the injection pressure was below MOP\*. The injection pressure in 2022 measured at the heel and toe of the injectors was between 950 and 1,600 kPa
- Mini-frac tests were performed at:
  - > 1AA/14-31-094-17W4/0
  - > 1AA/07-36-094-18W4/0
- Caprock average minimum stress gradient = 22 kPa/m (Wabiskaw Shale Member)

Minimum stress, MPa

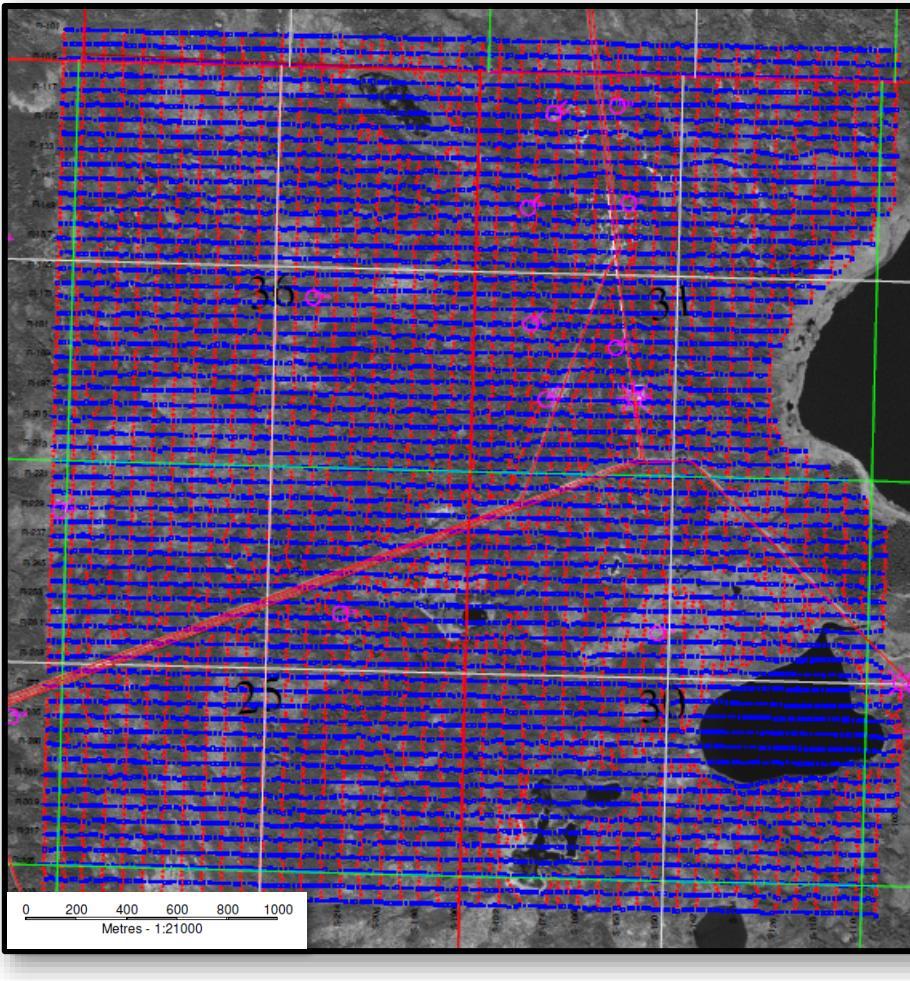
# Survey Layout

<b>Area</b> 10.7 (km <sup>2</sup> )					
Source Informati	on	Receiver Information			
Source interval (m)	20	Receiver interval (m)	20		
Source line interval (m)	80	Receiver line interval (m)	60		
Line orientation	N-S	Line orientation	W-E		
Total km of line	167.1	Total km of line	194.9		
Number of source points	7078	Number of receiver points	9681		
Source depth (m)	6				
Source type	Dynamite

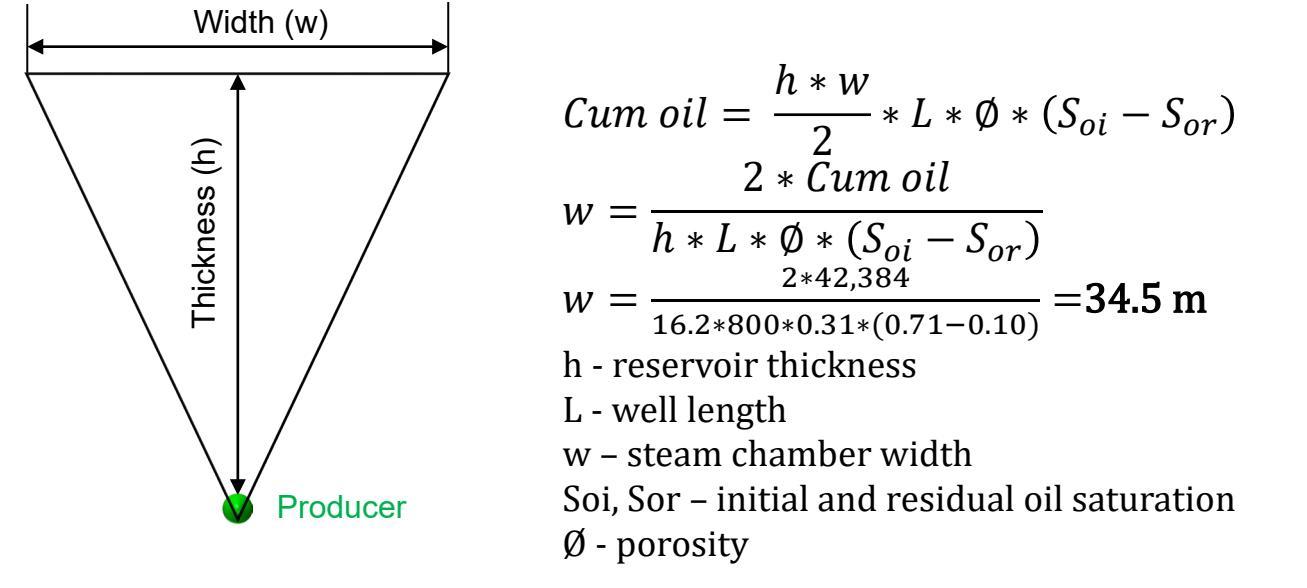
#### **4-D Seismic**

- Based on a volumetric calculation using the average bitumen recovery of a well pair (42,384 m<sup>3</sup>) and assuming steam chamber shape is triangular (see schematic and calculation below), the calculated width of the steam chamber (w) is still quite narrow, about 17.25 m away from the SAGD well pair. Therefore, Sunshine did not plan a 4D seismic acquisition survey in 2022 because it is difficult to image a small steam chamber from the seismic data
- While there are no plans in 2023 to conduct a 4D seismic survey, Sunshine will consider a 4D seismic survey when it is appropriate and provides an advantage for resource recovery

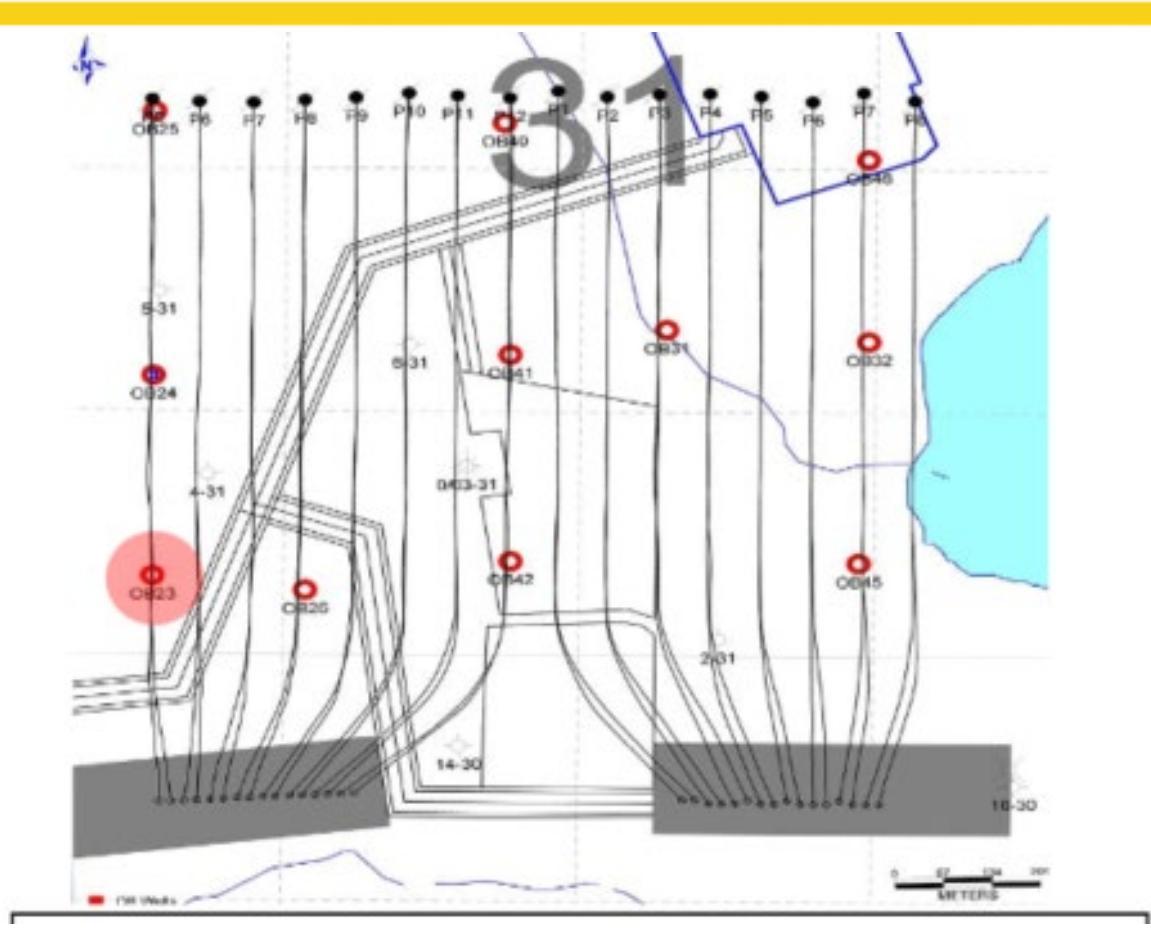
#### West Ells – OBS wells

Steam chamber pressures and temperatures are continuously monitored in the OBS wells during NCG co-injection

- During NCG injection, Sunshine actively monitors:
  - Steam chamber temperatures and pressures in the OBS wells (slide 25)
  - Gas production rate and GOR

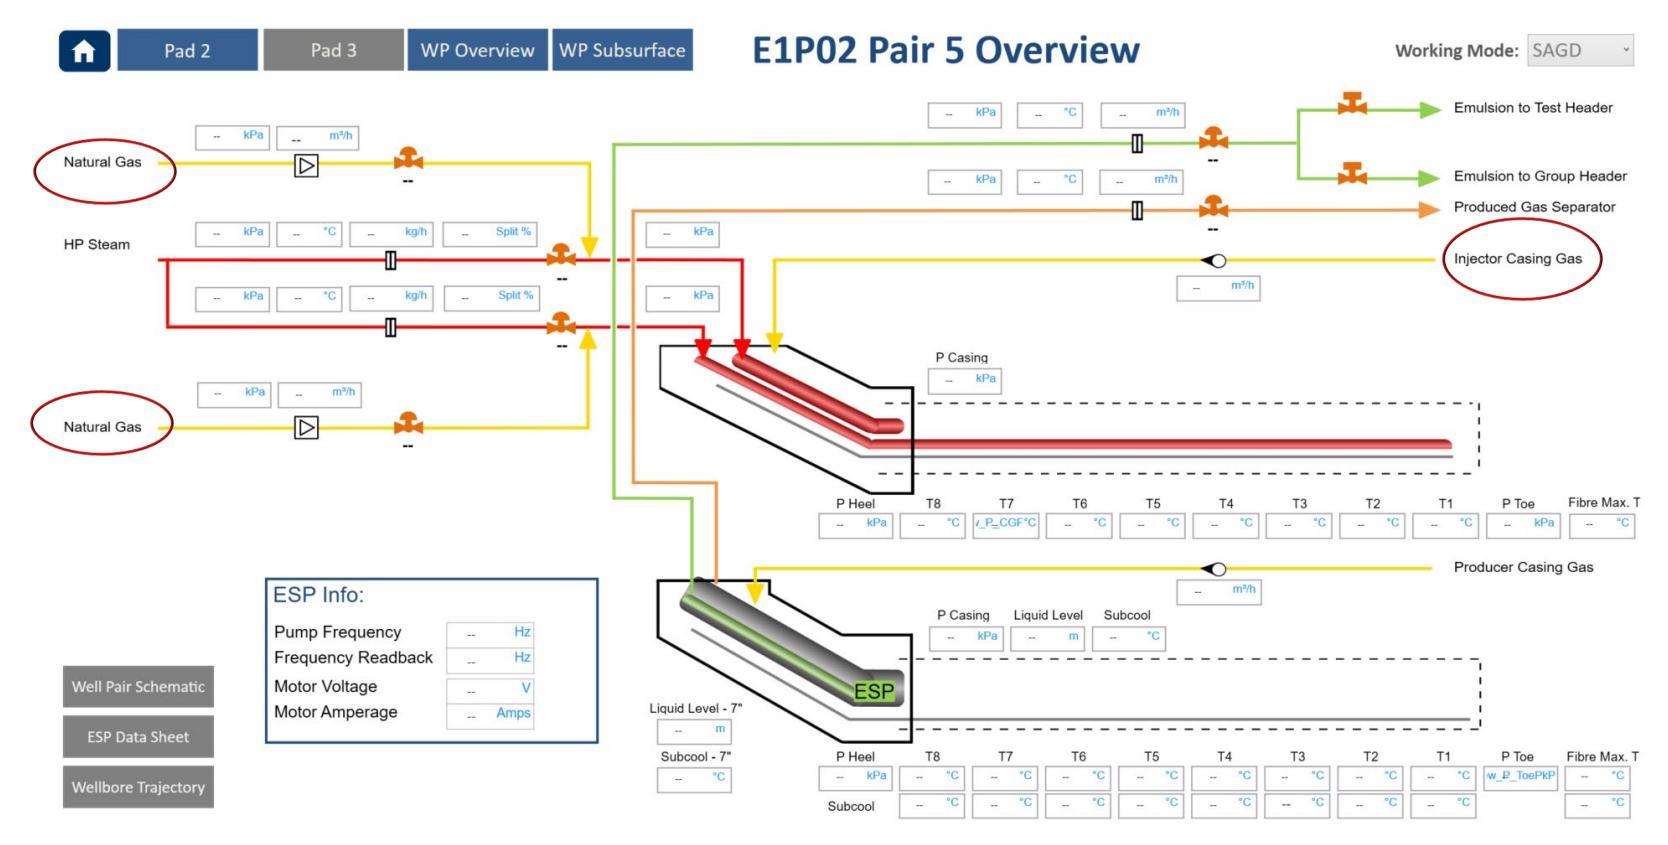
#### **NCG Co-Injection**

- Facility design allows for co-injection down the long or short tubing strings mixed with the steam, as well as down the intermediate casing (blanket gas)
- Injected NCG is natural gas with the following composition for Nov 2022:

N2	CO2	C1	C2	C3	C4	C5+	He
Concentration							
(% Vol)							
0.46%	1.75%	93.40%	3.36%	0.76%	0.22%	0.05%	0.01%

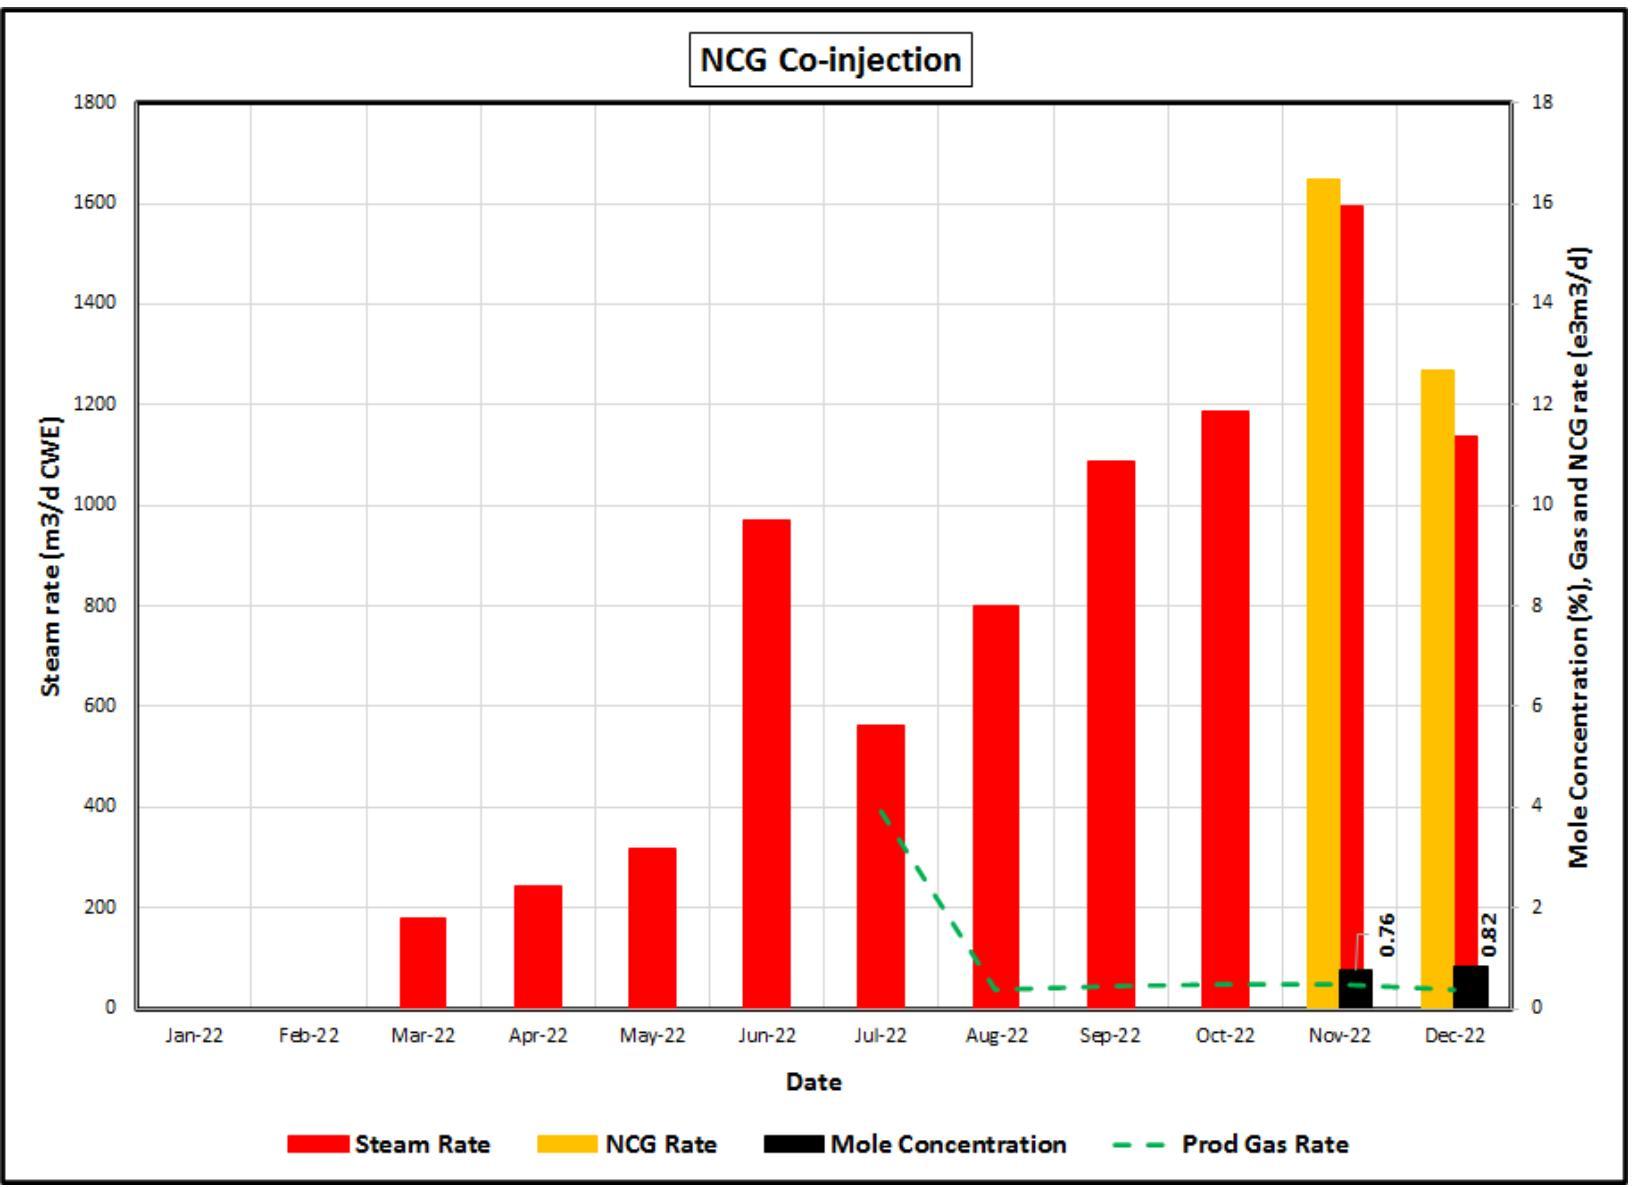
# NCG Co-Injection

Note about the plot: Reporting error for produced gas rate in July, in process of being corrected

- As per AER approval No. 11764F, Sunshine started NCG co-injection at Pad 2 wells in November 2022. NCG co-injection rates as well as steam injection, NCG mole concentration and produced gas rates are presented on slide 26

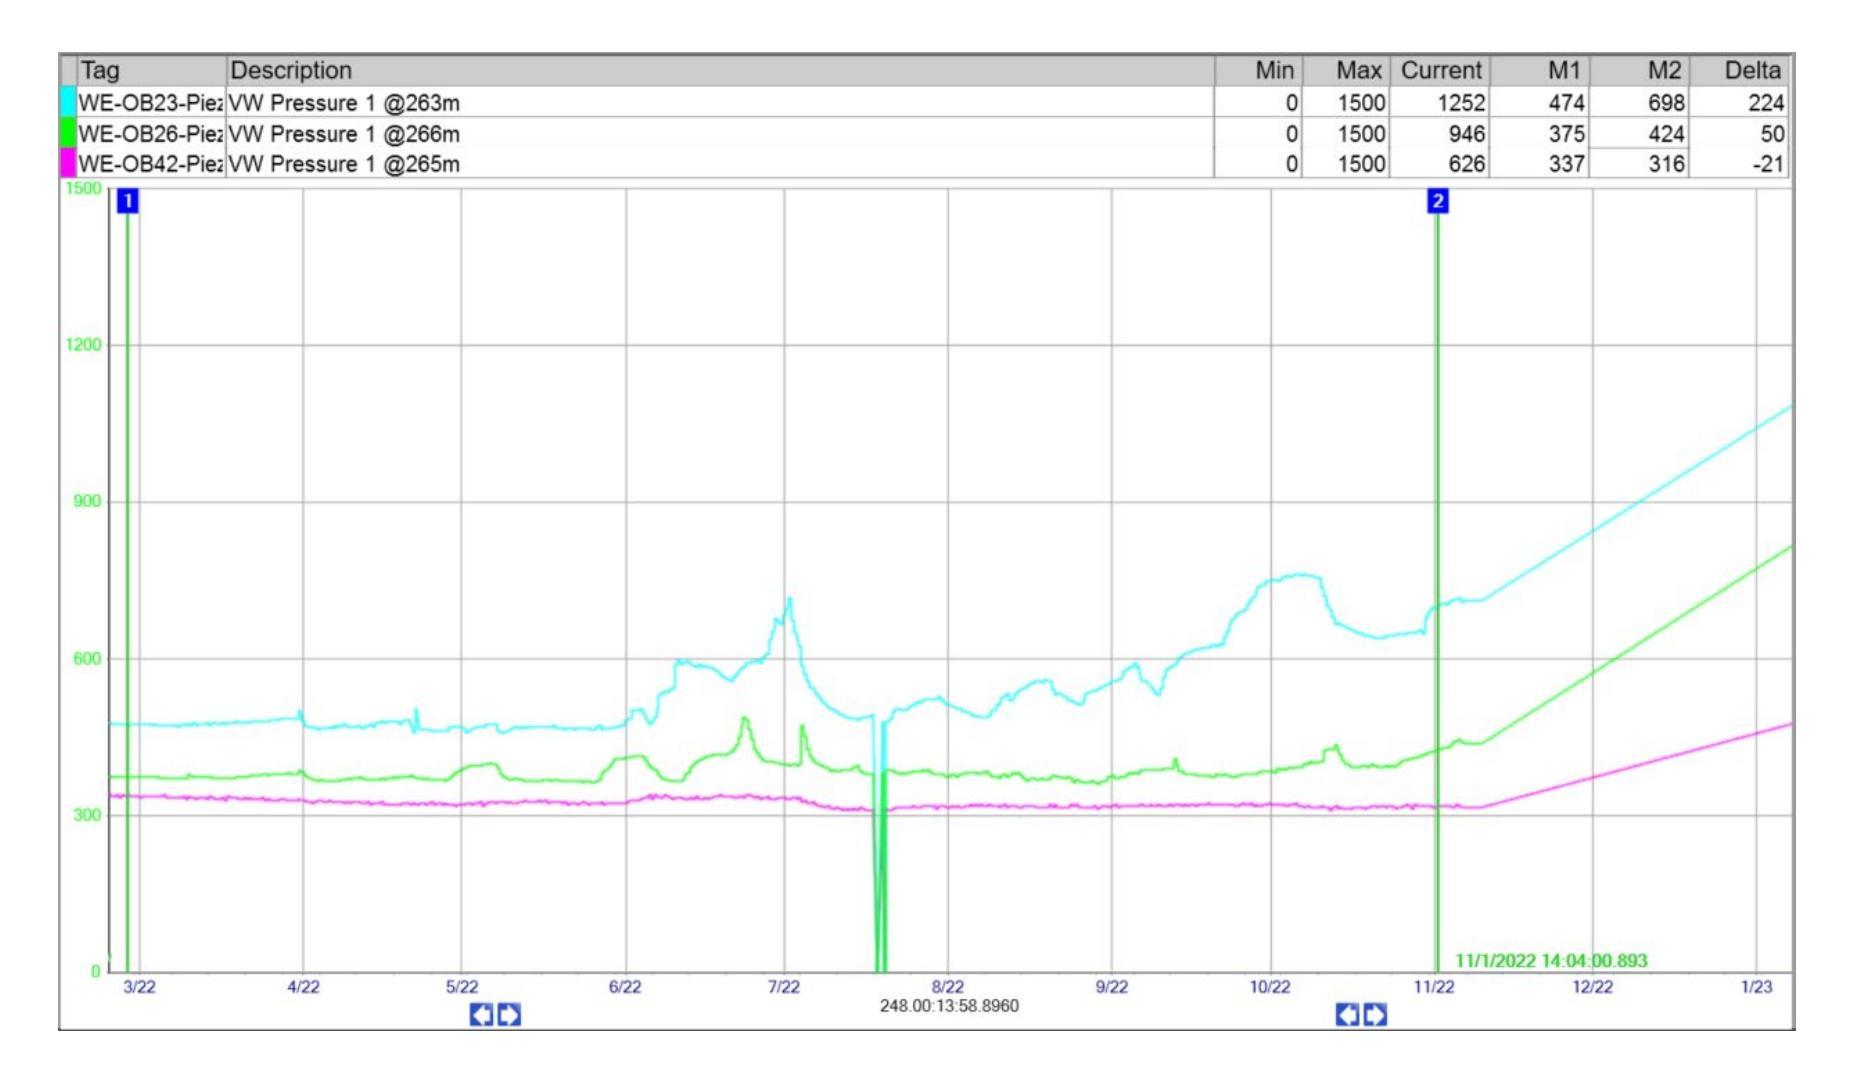
Slope of pressure curves changes in November as a result of starting the NCG co-injection (all pressure measured in the bitumen zone). Marker 1 shows steam injection re-start, marker 2 shows NCG co-injection start

- Sunshine didn't observe any changes in the produced gas rates or GOR's after the first two months of NCG co-injection
- The one positive result observed so far is a slope change of the steam chamber pressure, with a resulting benefit of higher steam saturation temperature that results in lower bitumen viscosity (see plot on slide 27)

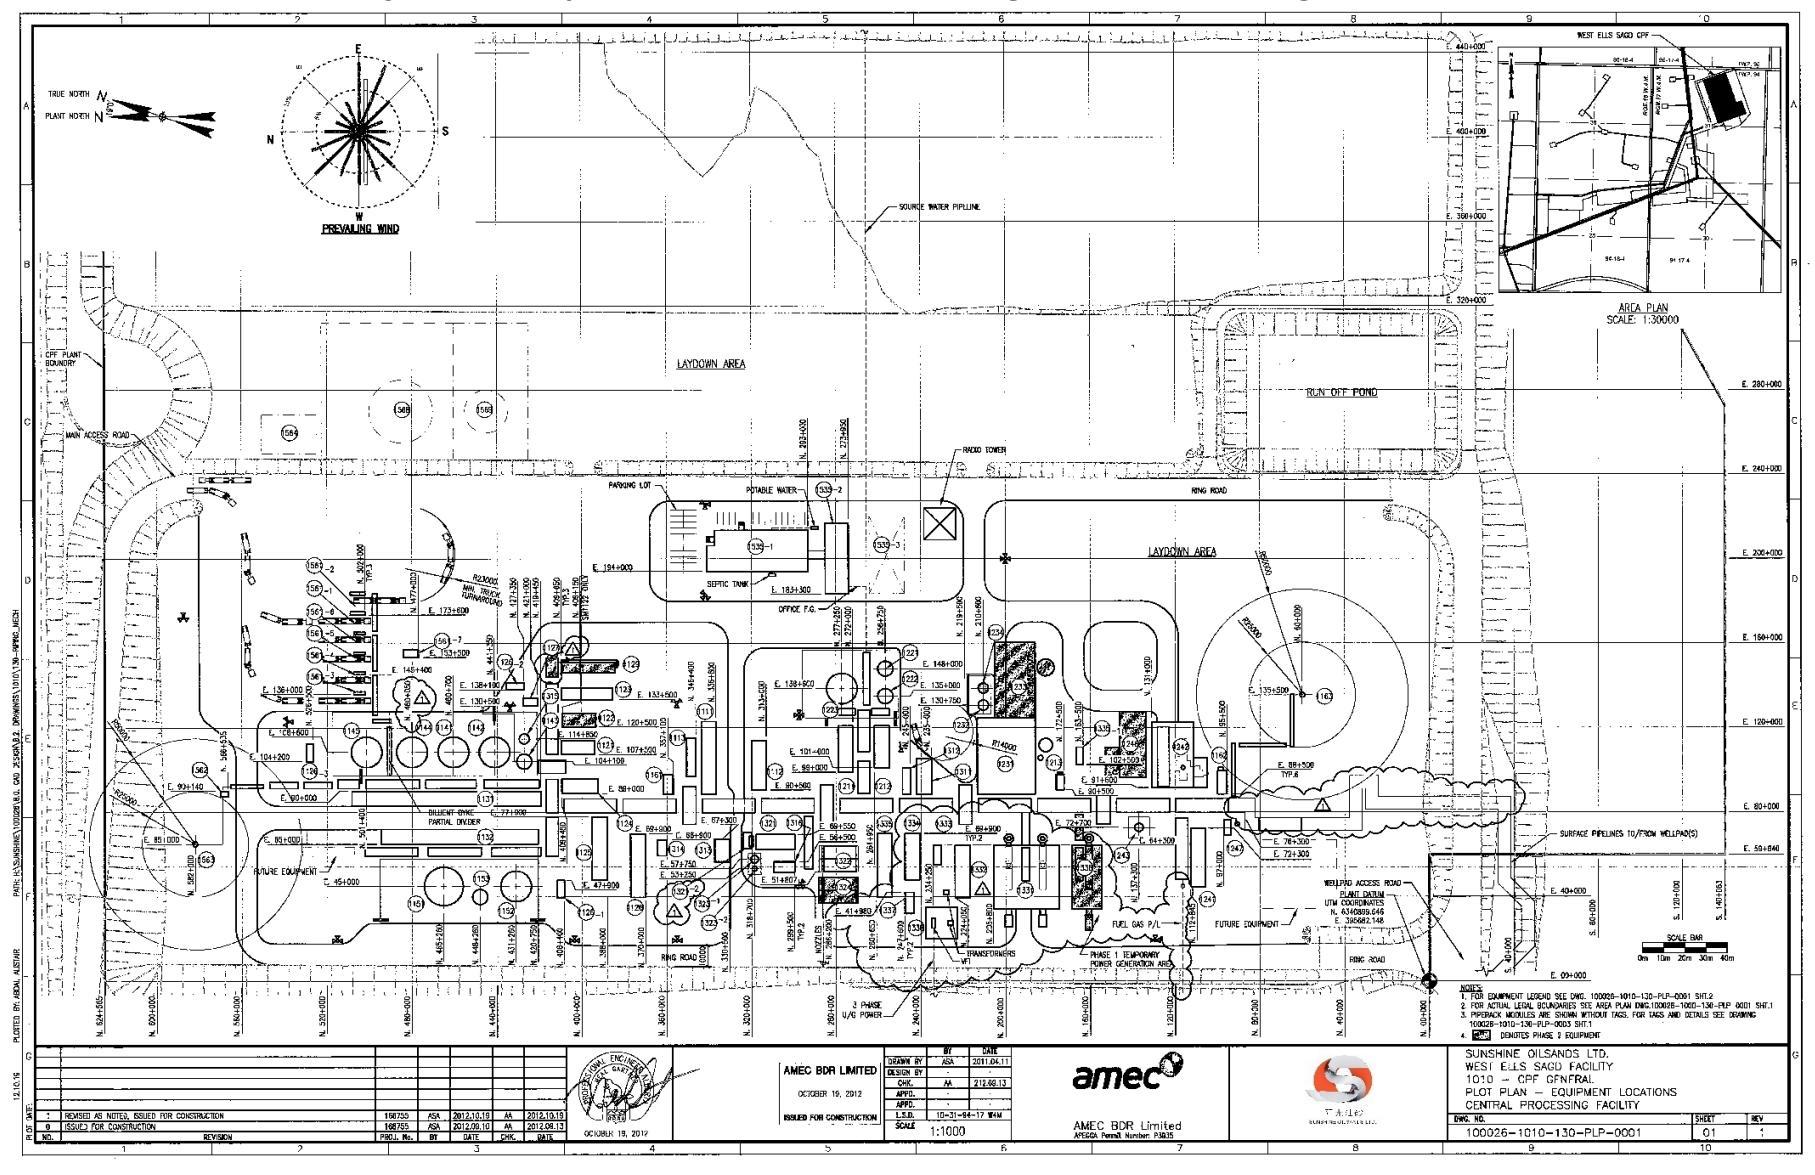
**CPF Plot Plan**

• No major facility modifications during this reporting period

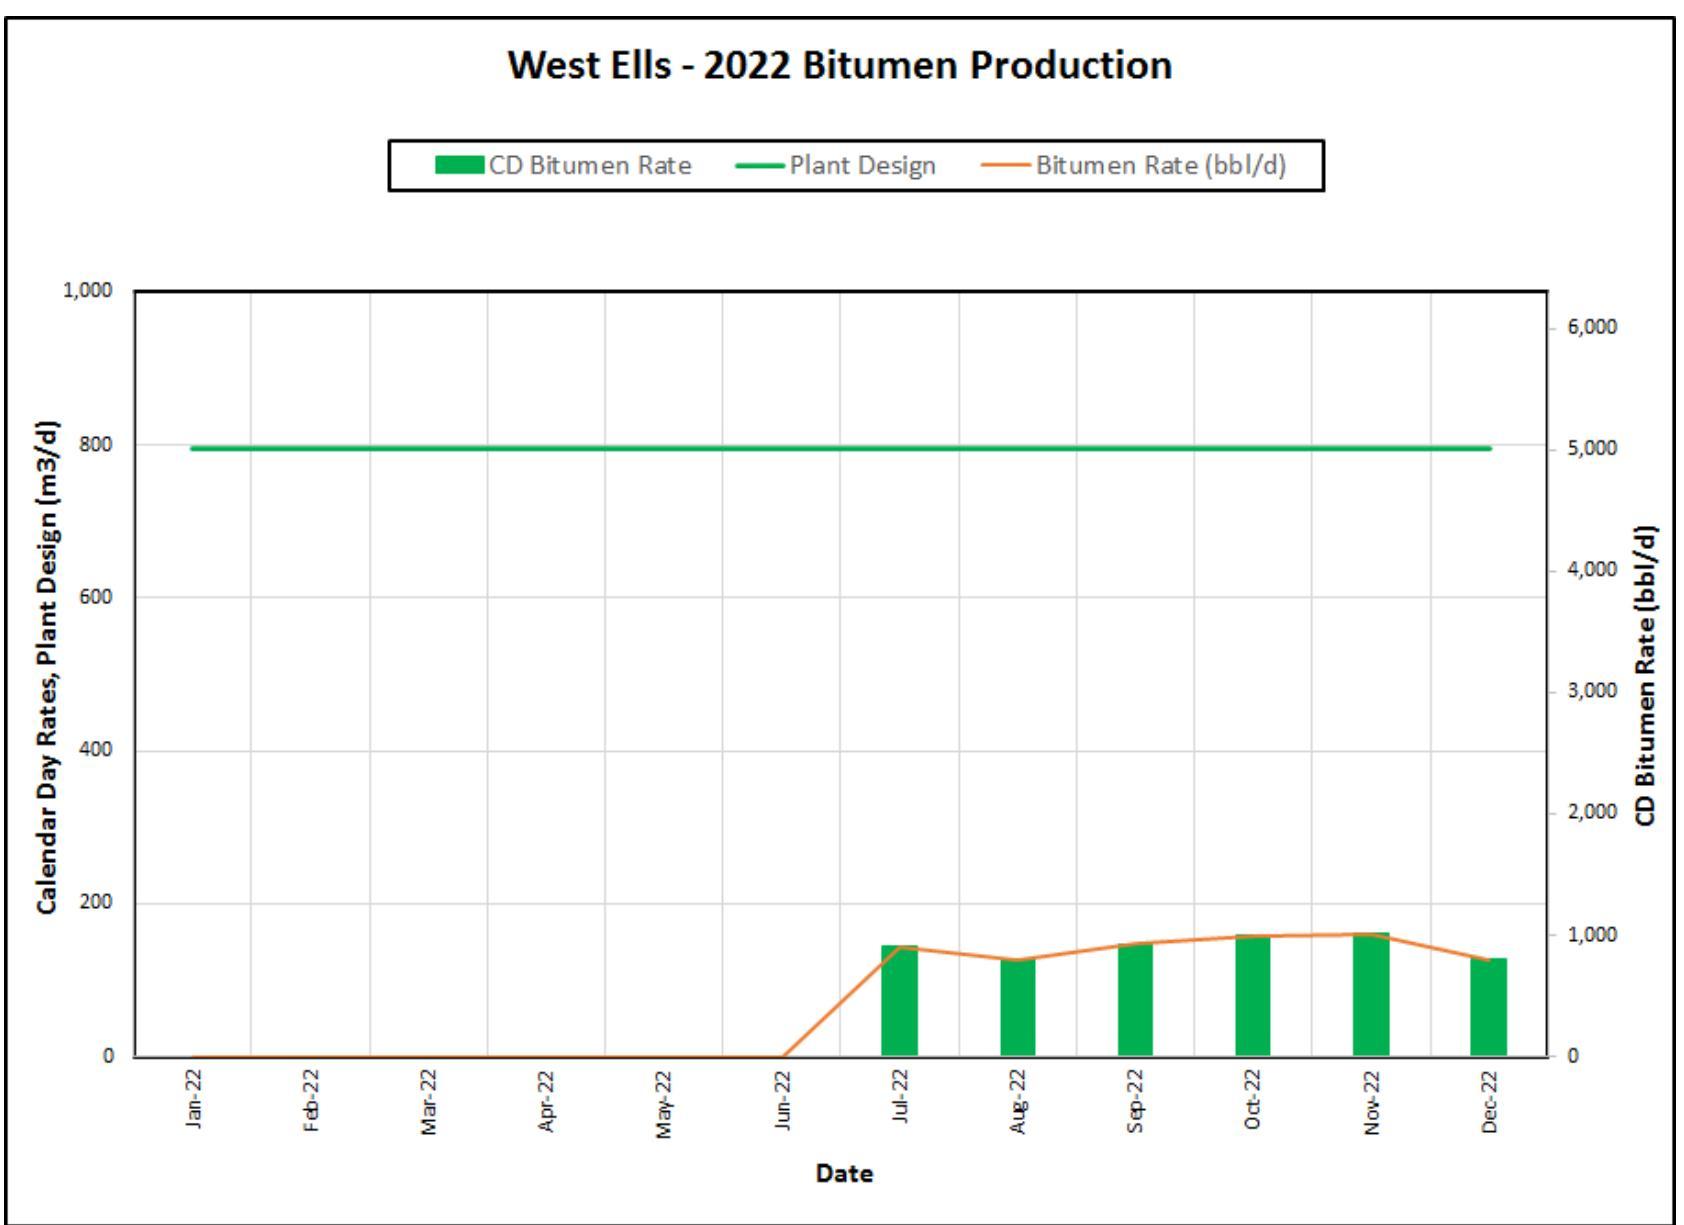
# **Bitumen Production**

- Steam injection was restarted on March 1, 2022 and bitumen production resumed on July 1, 2022
- On December 9, 2022 P12 ESP pump stopped working
- Due to low oil prices, high gas prices and trucks shortage, bitumen production was slowed down in December 2022
